AGEING MANAGEMENT OF CONCRETE STRUCTURES IN NUCLEAR POWER PLANTS

The revised document (NP-T-3.5) planned to be released in 2015 includes state of the art information regarding ageing management of concrete structures in NPPs. It contains background material on ageing related degradation mechanisms that is necessary to ensure understanding of ageing. It also includes new and practical information on current practices and techniques for inspection, monitoring and mitigation of ageing degradation. The document is intended for NPP owners/operators, designers, engineers and specialists to establish, implement, and improve ageing management for NPPs, facilitate dialogue between owners / operators and regulators when dealing with age-related licensing issues, and to consider ageing in new plant design, in modifications, and in approaches to efficiently mitigate ageing effects.

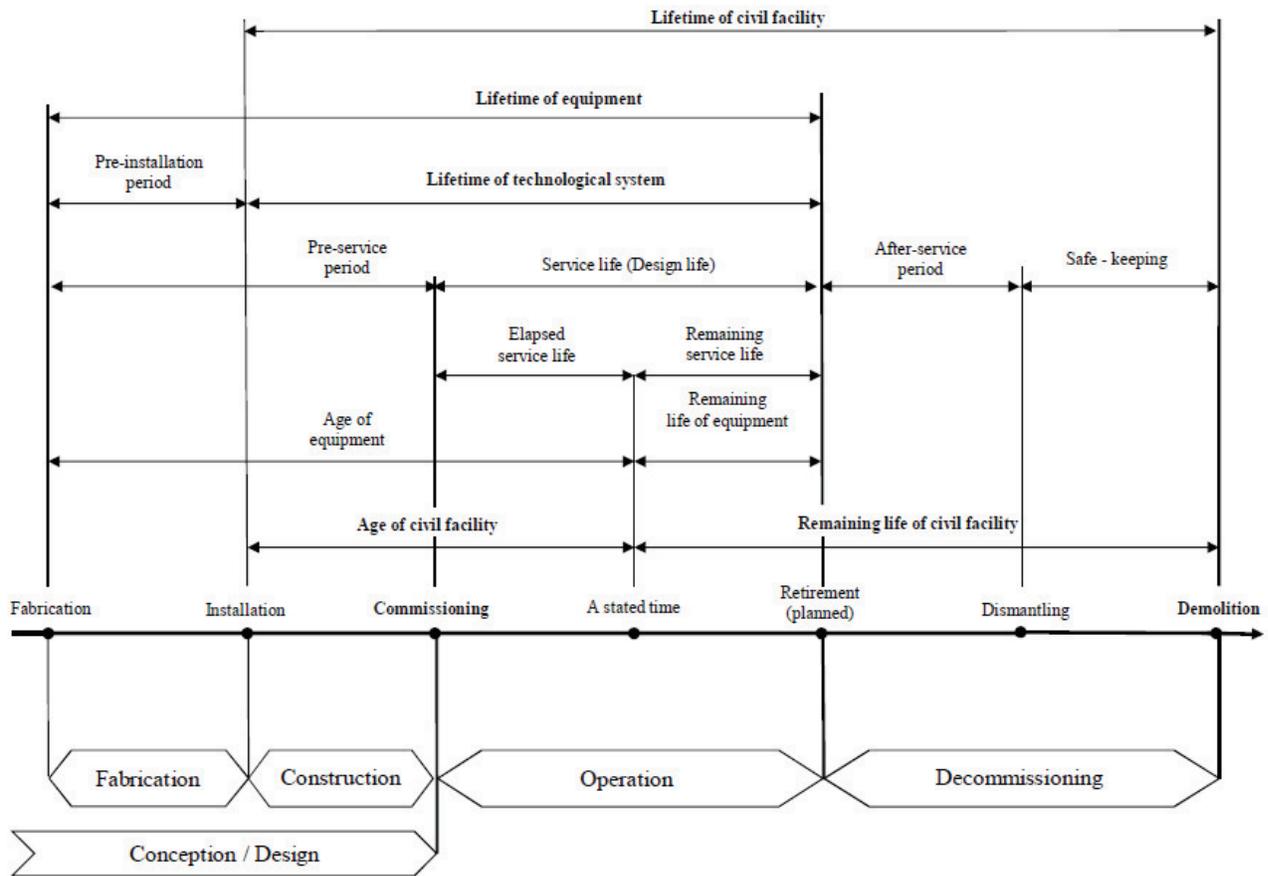
Figure 1 Lifetime Periods of Structures, Systems and Components (based on Figure 4 of [3])

Concrete is a durable material and its performance as part of the containment function in NPPs has been good. However, experience shows that ageing degradation of concrete structures, often caused or accelerated by factors such as faulty design, use of unsuitable or poor quality materials, improper construction, exposure to aggressive environments, excessive structural loads, and accident conditions, can impair safety functions and increase risks to public health and safety. Effective ageing management of concrete structures in NPPs is therefore required to ensure their fitness-for-service throughout plant service life and during decommissioning (refer to Figure 1).

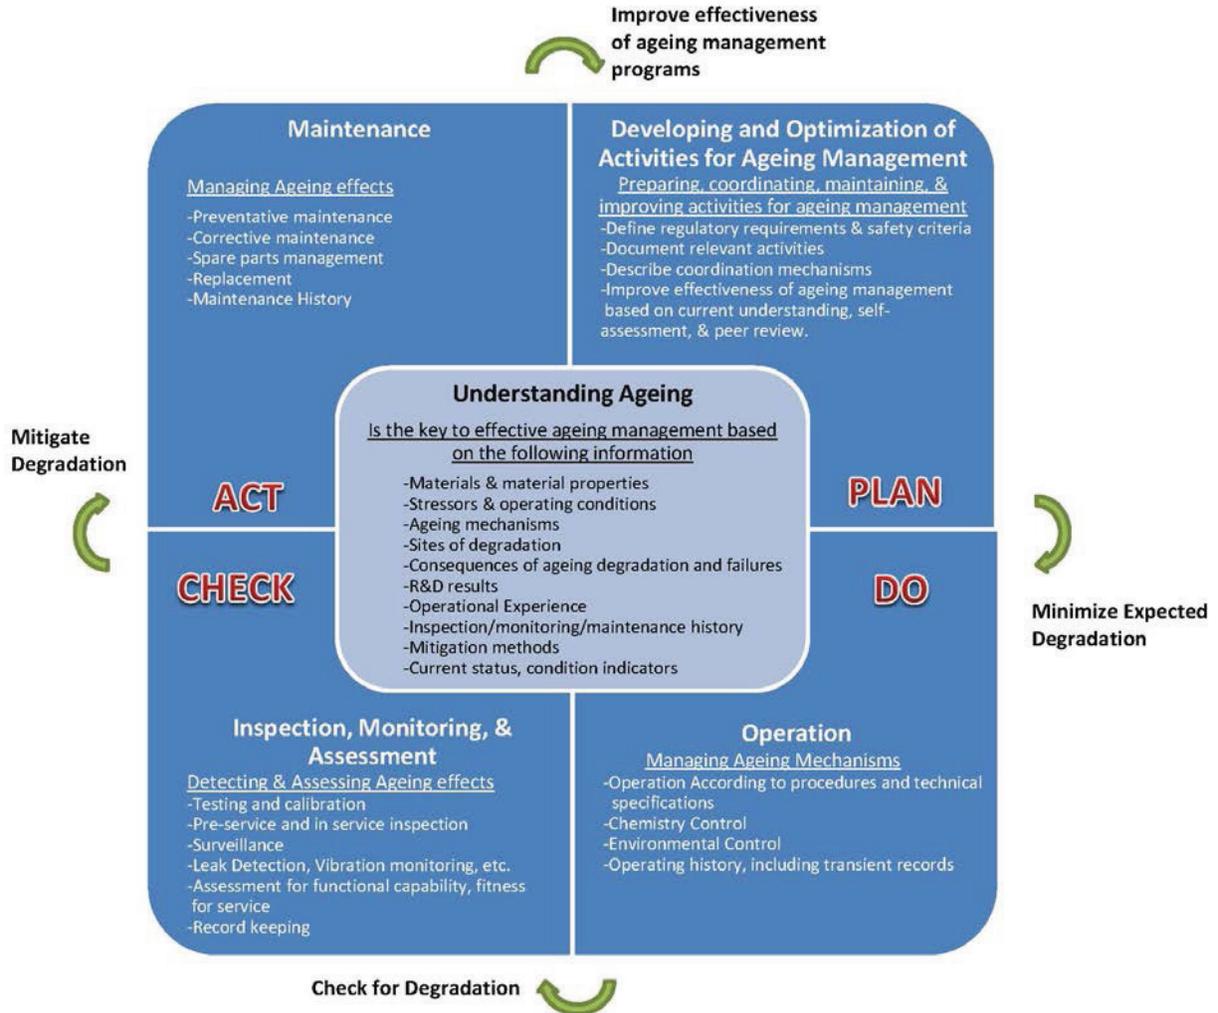
Figure 2 Systematic Approach to Managing Ageing of a Structure or Component (adapted from Figure 1 in [2])

As illustrated in Figure 2, ageing management is a loop process that allows for improvements of effectiveness of ageing management programme based on better understanding of ageing.

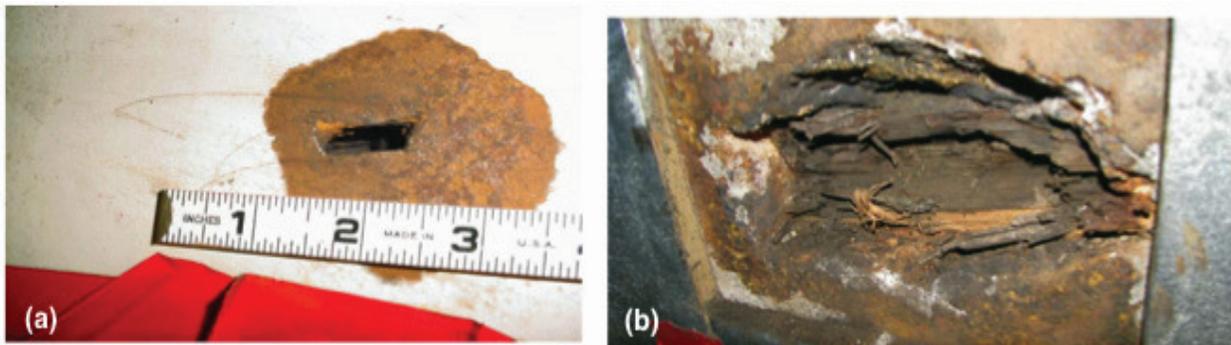
Figure 3 Example of Corrosion Occurrence Originating from the Concrete Side of the Liner [4]: (a) paint blister, and (b) wood embedded in concrete after section of liner was removed

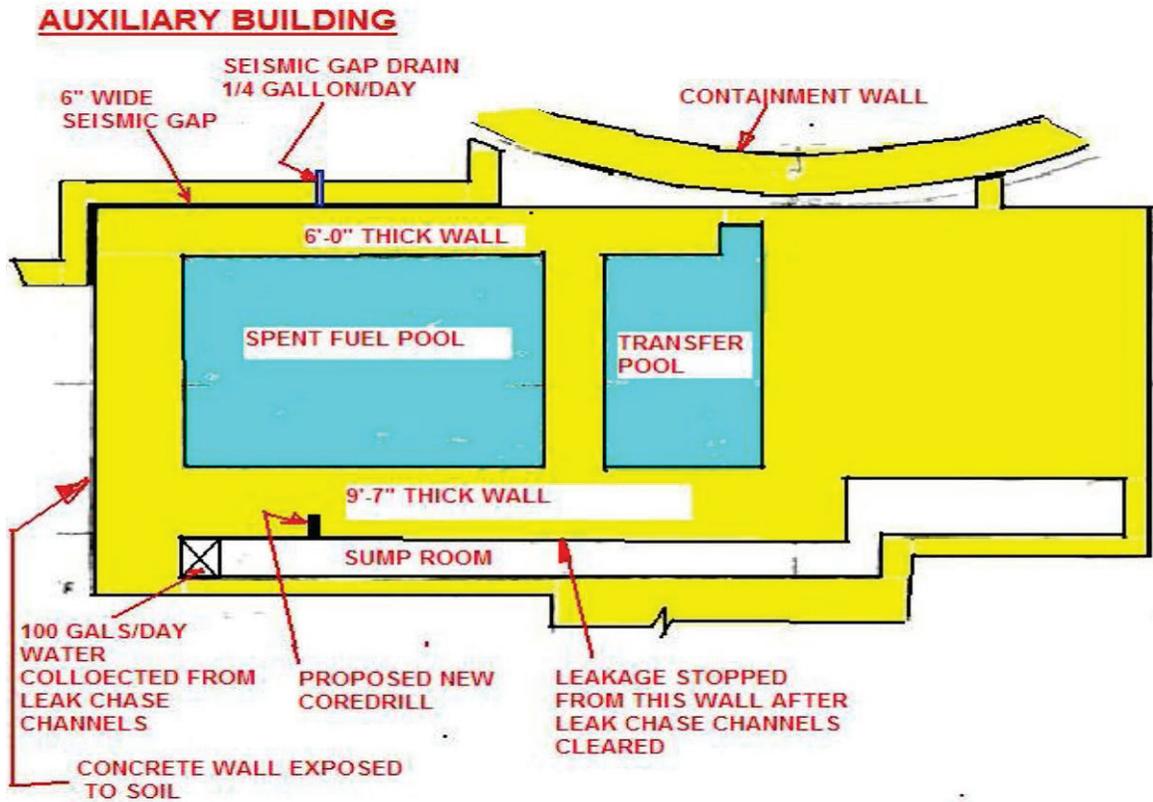
Figure 4 Plan View of Fuel-handling Building Showing Relative Location of Spent Fuel Pool, Transfer Pool, and Containment Building [5]

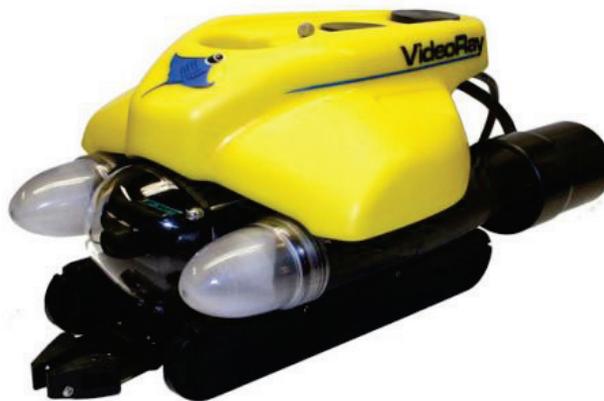
Figure 5 Example of Remote Operated Vehicle (ROV) for Nuclear Application (courtesy Atlantia Marine)

Historically visual inspection methods were primarily used to detect degradation. Development of Remote Operating Vehicles (ROVs) enables enhancing inspection, specifically the inspections of the areas that are not readily accessible (Figure 5 and Figure 6). Recent developments in non-destructive methods and analysis tools allows for faster and more reliable detection and assessment of the degradation (Figure 7). Instrumented monitoring has been proven effective as it can provide verification of design assumptions as well as monitoring short and long term performance of a structure. Finite element analysis has been proven useful to identify areas with high stress concentration in order to focus investigative activities (Figure 8).

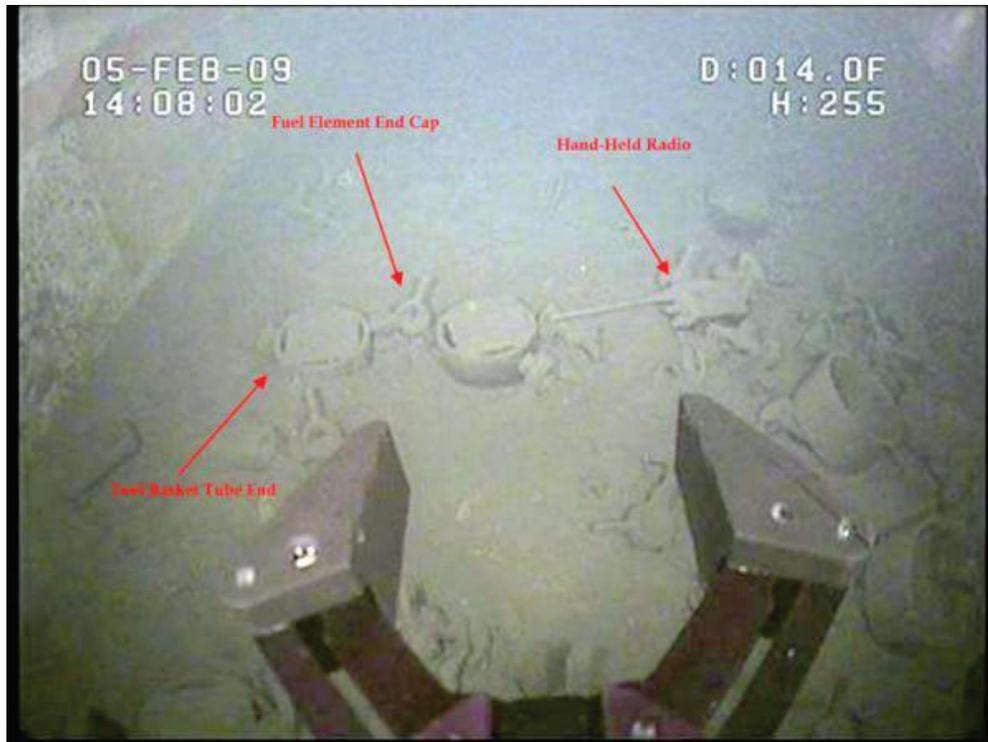
Figure 6 Photograph of Debris in Spent Fuel Pool during Decommissioning Work using ROV (courtesy Atlantas Marine)

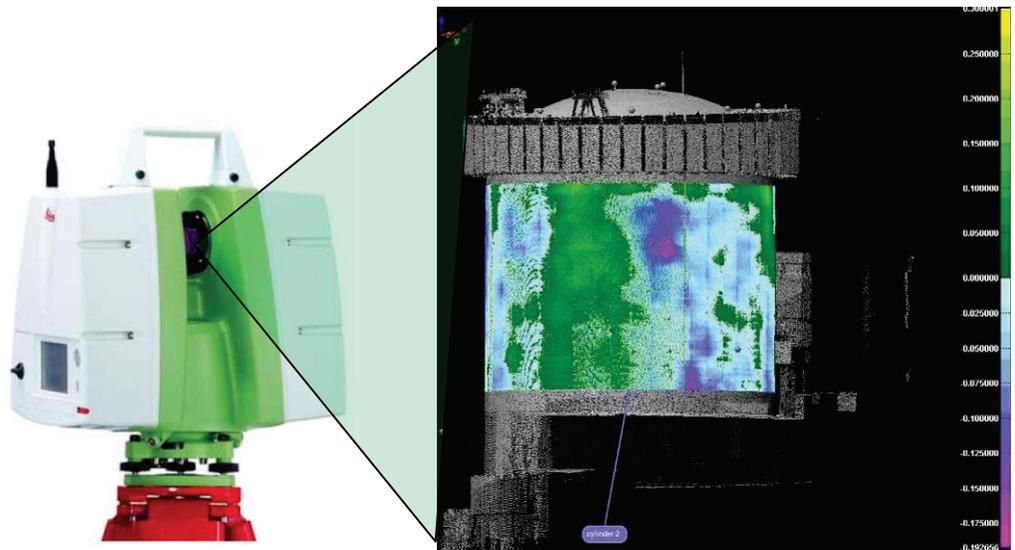
Figure 7 WWER-1000 NPP Containment Laser Scanning to Observe Seasonal Deformations (courtesy Center of Material Science and Lifetime Management Ltd.)

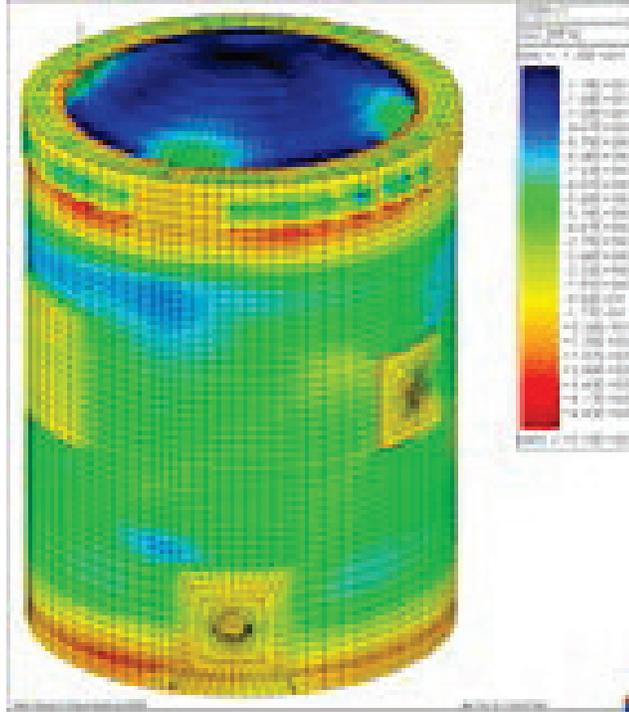
Figure 8 Containment Finite Element Model Showing Areas with Tensile Stresses at Maximum Temperature Gradient (courtesy Center of Material Science and Lifetime Management Ltd.)

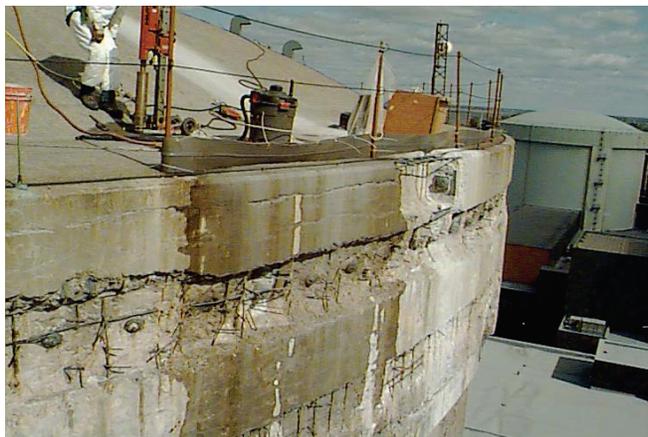
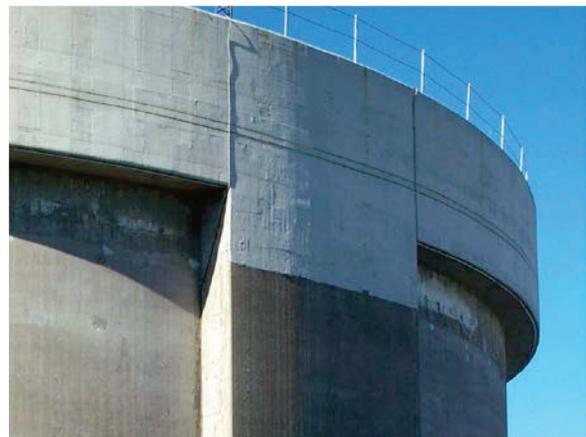
a) Before repair

b) After repair

Figure 9 Gentilly 1 Reactor Building Ring Beam Repair [6]

Strategies to mitigate the degradation have been also discussed in the new document. It is important to address the cause of degradation if possible. This will allow for long lasting repairs. Examples of repairs are shown in Figure 9 and Figure 10.

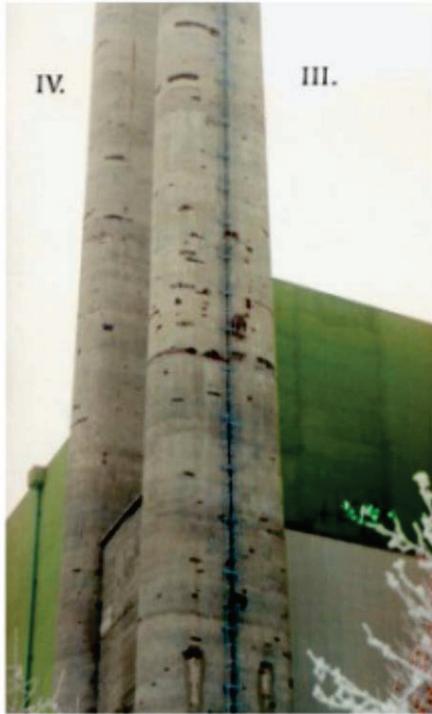
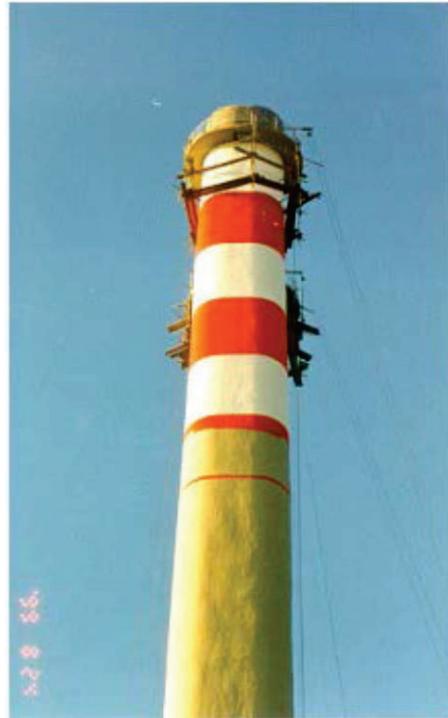
a) Before repair

b) After repair

Figure 10 Repair of a Group of Ventilation Chimneys at Paks NPP [7]
