Impact of Crack Sealant on Pavement Skid Resistance

A thesis submitted to the Graduate Faculty of  
North Carolina State University  
in partial fulfillment of the  
requirements for the degree of  
Master of Science

Civil Engineering

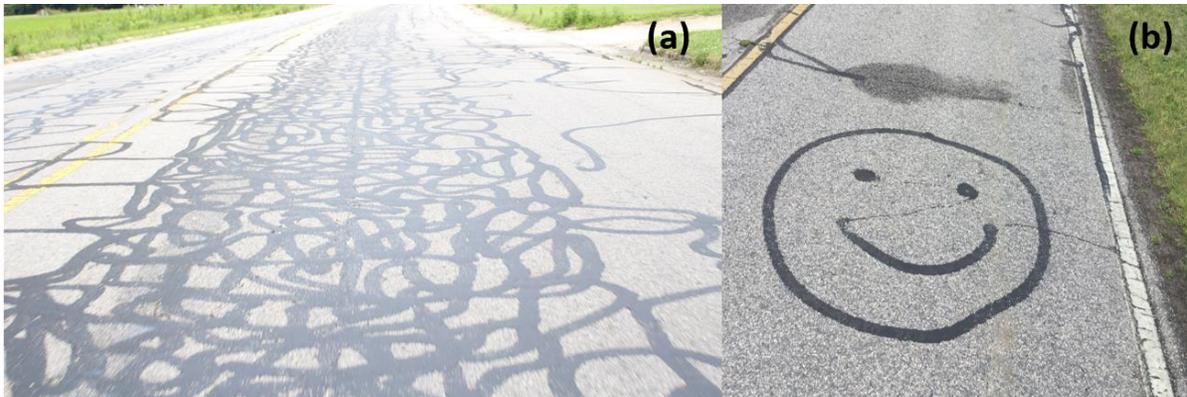
**Figure 1.1** Examples of excessive crack sealant application in North Carolina.

While crack sealing is an effective when applied to pavements in relatively good condition, crack sealing is often applied to pavements with extensive cracking. An example is shown in Figure 1.1 (a). Pavements with extensive cracking are generally structurally compromised, making sealing ineffective. Furthermore, if the crack sealant covers too much of the pavement surface area, it can potentially degrade skid resistance. Skid resistance is critical to avoid accidents, particularly in wet weather conditions. Crack sealant may cover too much of a pavement's surface area if either excessive crack sealant is applied (e.g., overband is too wide) or the extent of cracks sealed on the pavement surface is too high. Furthermore, many agencies pay contractors for projects based on the quantity of sealant applied (NCDOT 2012, Caltrans 2003, MIDOT 2006); therefore, contractors may be indirectly incentivized to over-apply crack sealant even in locations where cracks are absent. Evidence of the application of crack sealant to a pavement area without cracks present is shown in Figure 1.1 (b).

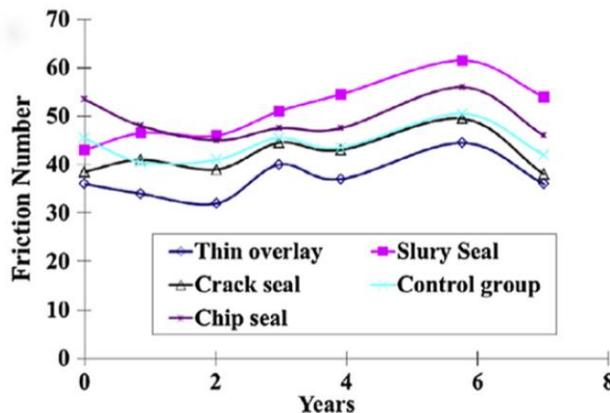
**Figure 2.1** Friction number comparison of different preventive maintenance treatments (Wang 2013).

The underlying hypothesis of this study is that crack sealant application can lead to a reduction in pavement surface friction. A research team at The State University of New Jersey examined the skid resistance of four different types of preservation treatments: thin overlay, slurry seal, crack seal, and chip seal (Wang 2013). Cracking sealed sections had the lowest friction of all treatment types except for thin overlays. The authors rated the performance of the pavements on a scale of one to five with one exhibiting the worst. Ranking performance of pavement preservation techniques in four different climates and averaging the different types of sections, crack sealed sections were found to be the least effective treatment option (Wang 2013).

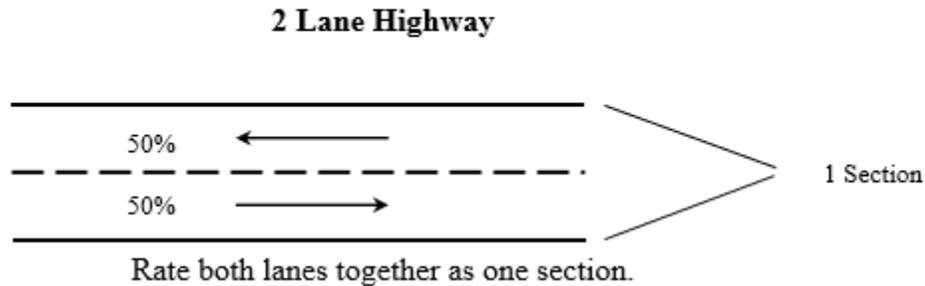
**Figure 2.2** Section showing what is considered one section of pavement on 2-lane highway (NCDOT 2012).

into sections depends on the type of roadway being analyzed. Most routes examined in this study would fall under the description of a secondary, two lane highway, as shown in Figure 2.2. The evaluation of these roadways by NCDOT typically only had one section per route examined, while a few longer routes did have multiple sections.

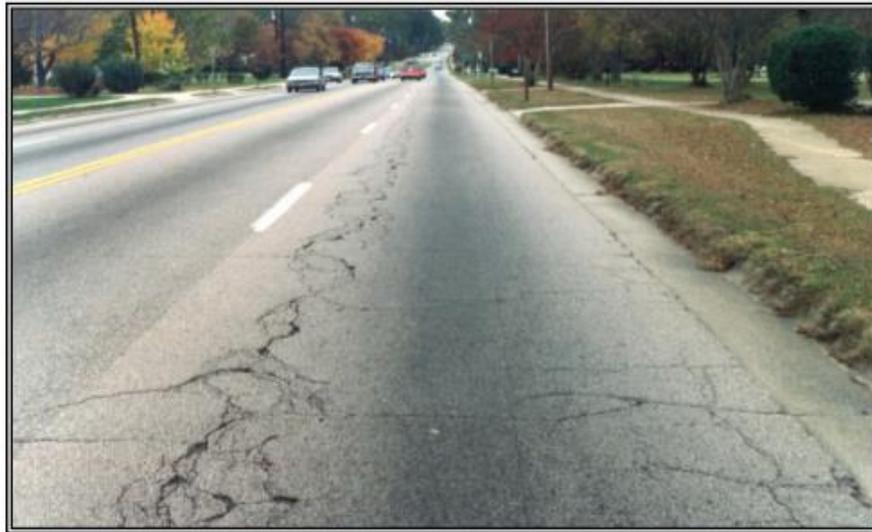
**Figure 2.3** Example of severe alligator cracking (NCDOT 2012).

Moderate cracking is when longitudinal cracks in the wheel path connect together and form cracks that are about 1/4 inch wide. Severe cracking, shown below by Figure 2.3, is when the cracks have advanced to the point where pieces of pavement appear to be loose and the cracks are about 3/8 to 1/2 inch wide (NCDOT 2016). In NCDOT PCS Manual, the alligator cracking also includes longitudinal and edge cracking.

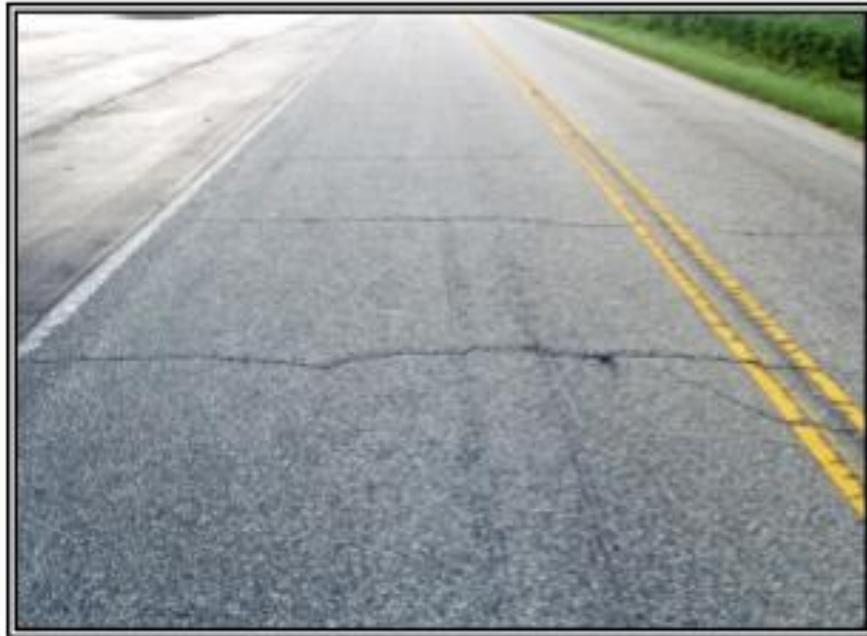
**Figure 2.4** Example of severe oxidation (NCDOT 2012).

The oxidation rating is an indication if there is oxidation on the route being inspected. Oxidation occurs when a pavement hardens from oxidative aging caused by exposed to certain environmental factors. The NCDOT has two ratings for oxidation; none and severe (NCDOT 2016). Oxidation is determined by visually analyzing the entire surface and determining if the pavement is showing significant signs of discoloration. The oxidation index is reported with a value of 100, indicating no signs of oxidation, or a value of 0, indicated severe oxidation. An example of an oxidation index of 0 is given in Figure 2.4.

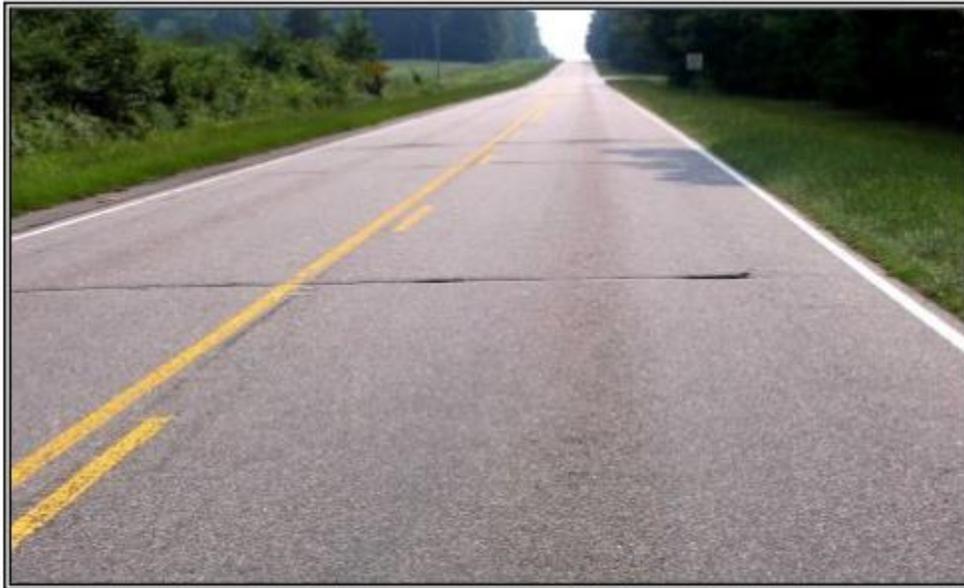
**Figure 2.5** Example of transverse cracking (NCDOT 2012).

The transverse cracking index refers to the amount of cracking that occurs perpendicular to a roadway. These cracks are typically greater than 1/2 inch wide and typically cross both lanes of traffic (NCDOT 2016). Transverse cracking can be caused by thermal stresses and reflective cracking. Reflective cracking occurs when a crack reflects to the surface of the new asphalt layer from the underlying pavement. A transverse cracking index is determined by the width of the crack and the frequency of the cracks; however, the specific formula used to calculate the index is not reported. If cracks are less than 1/4 inch wide and occur less frequently than every 10 to 20 feet, the transverse cracking is classified as light. Moderate cracking is classified as cracks with

width between 1/4 to 1/2 inch that are spaced 5 to 20 feet apart (NCDOT 2016). Severe transverse cracks have a width greater than 1/2 inch and occur 1 to 2 feet apart (NCDOT 2016).

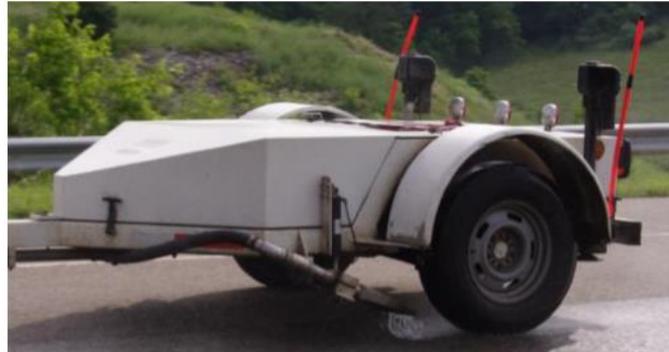
**Figure 2.6** Locked Wheel Skid Tester (McCarthy et al. 2018).

The LWST (ASTM E274) measures the pavement friction at a set interval by periodically locking a tire attached to a trailer, as shown in Figure 2.6. This wheel is locked when the vehicle reaches a consistent speed of 40 mph. Both smooth and ribbed tires are available. The smooth tire is sensitive to changes in mean profile depth (MPD) of the pavement which makes it preferable to the ribbed tire version of the LWST. The primary benefit of using a LWST is that it takes the measurement in the actual wheel path of traffic. The recorded value is reported as a

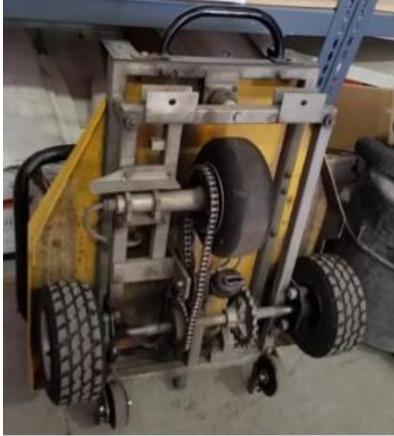
**Figure 2.7** Grip Tester (McCarthy et al. 2018).

The CFT method is a popular method of measuring friction on runways and airfields. The CFT is typically measured using a grip tester. Fundamentally, it works the same way as the LWST by locking up a wheel but the increments at which it locks up are occurring at such short intervals so it is considered as continuous. A grip tester, shown below in Figure 2.7, measures a value that is reported as a GN (Grip Number), which is a measure on the longitudinal force required to slow the middle tire of the grip tester. For most grip testing, the tires used are smooth instead of ribbed, which makes them more reliable for measuring the effect of MPD on a pavement's skid resistance. A GN value is the metric used to measure the friction of the pavement surface and is determined by calculating the amount of friction necessary to bring a wheel to 15 percent of the speed of the trailer. By not fully locking the wheel up, the test is able to record values at short intervals such as every 3 feet. The CFT can be operated at a range of speeds.

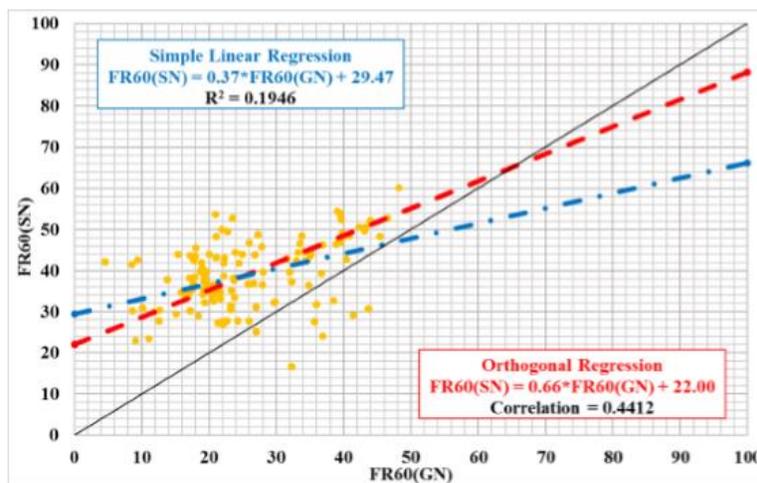
**Figure 2.8** Correlation between SN and GN (McCarthy et al. 2018).

The main differences between the LWST and a CFT are test interval length, speed at which friction value is recorded, sensitivity to MPD, how friction value is calculated, and the location where the wheel records the friction value. The LWST has a test tire that records values that are in the actual wheel path of the vehicle while the grip tester records values in the center or the travel lane. The GN value is also measured without fully locking up the test tire while the LWST locks the tire entirely. McCarthy et al. (2018) correlated LWST and CFT results (both with smooth tires) and found only a weak relationship with  $R^2$  of 0.44 as shown in Figure 2.8. Due to the significant differences in equipment, measurement, and lack of overall correlation it is unlikely that continuous friction tester data can be combined to that found with the LWST.

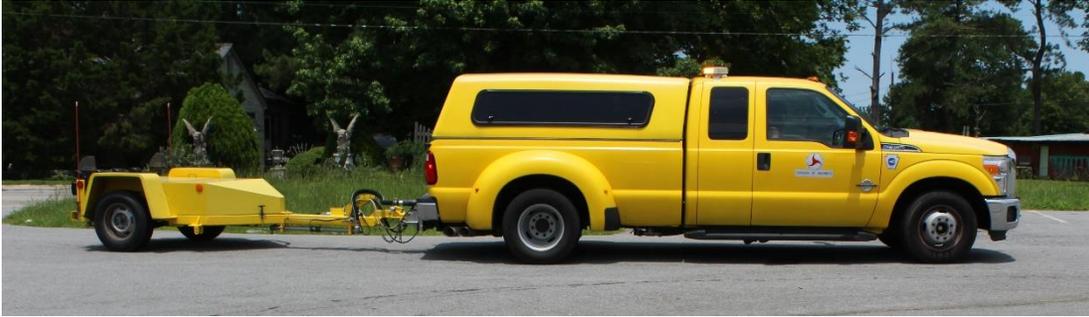
**Figure 3.1** Locked-Wheel Skid Tester.

The LWST was used to measure the skid resistance of pavements with varying amounts of crack in the wheel path in accordance with ASTM E274 (2011). The LWST used consists of a trailer with a test wheel, water supply and dispensing system, and instrumentation system to measure frictional force. The trailer is towed by a vehicle traveling at 40 mph (64 km/h). Once up to speed the LWST sprays water 12 to 18 in in front of the test tire as well as 1 in to the left and right of the tire to ensure a wetted surface for the tire. The trailer's test wheel is positioned in the left wheel path and is locked and dragged over wetted sections of pavement in order to measure the steady-state friction. The LWST used in this study is a smooth, single tire and is shown in Figure 3.1.

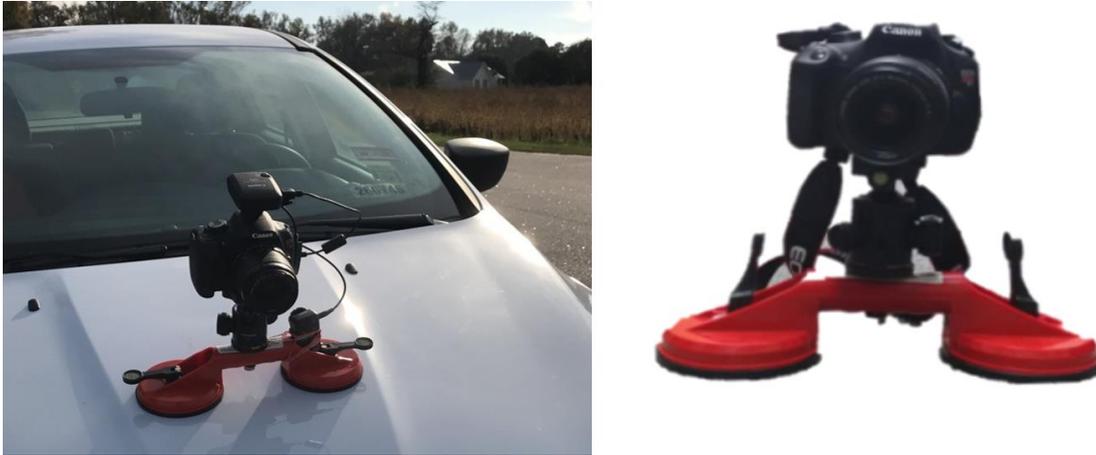
**Figure 3.2** Camera with GPS unit attached mounted to hood of car.

A vehicle with a camera mounted to its hood closely followed the LWST to obtain images of the pavement sections over which SN values were measured to allow for comparing skid resistance to crack sealant coverage. The camera mounted to the vehicle is shown in Figure 3.2. The location of each LWST test was easily identified by the watermark left on the pavement. Two photographs were taken for each skid mark. The camera contained a Global Positioning System (GPS) unit, which allowed for reconciling the images with the corresponding LWST result. A handheld GPS unit was also used to record the location of each photograph in case of failure of the camera's GPS unit.

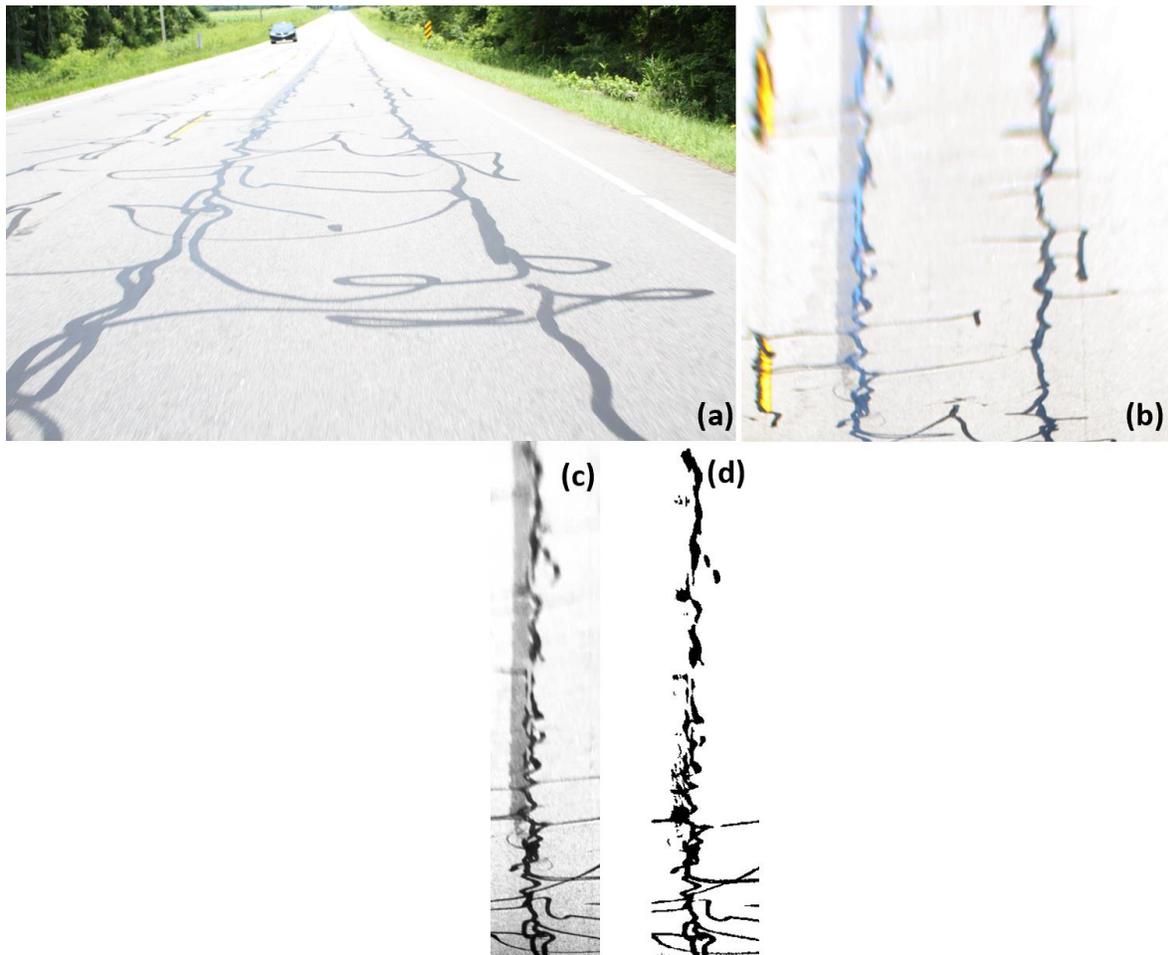
**Figure 3.3** Image analysis process (a) initial image, (b) perspective fixed, (c) contrast increased and wheel path focused (d) binary image.

An example of (a) an original photograph, (b) perspective-corrected, and (c) wheel path only and (d) final binary wheel path image is shown in Figure 3.3. The algorithm was verified using a subset of images by overlaying final binary images with the initial perspective-corrected color image to ensure that the crack sealant was properly identified and delineated from the surrounding pavement.

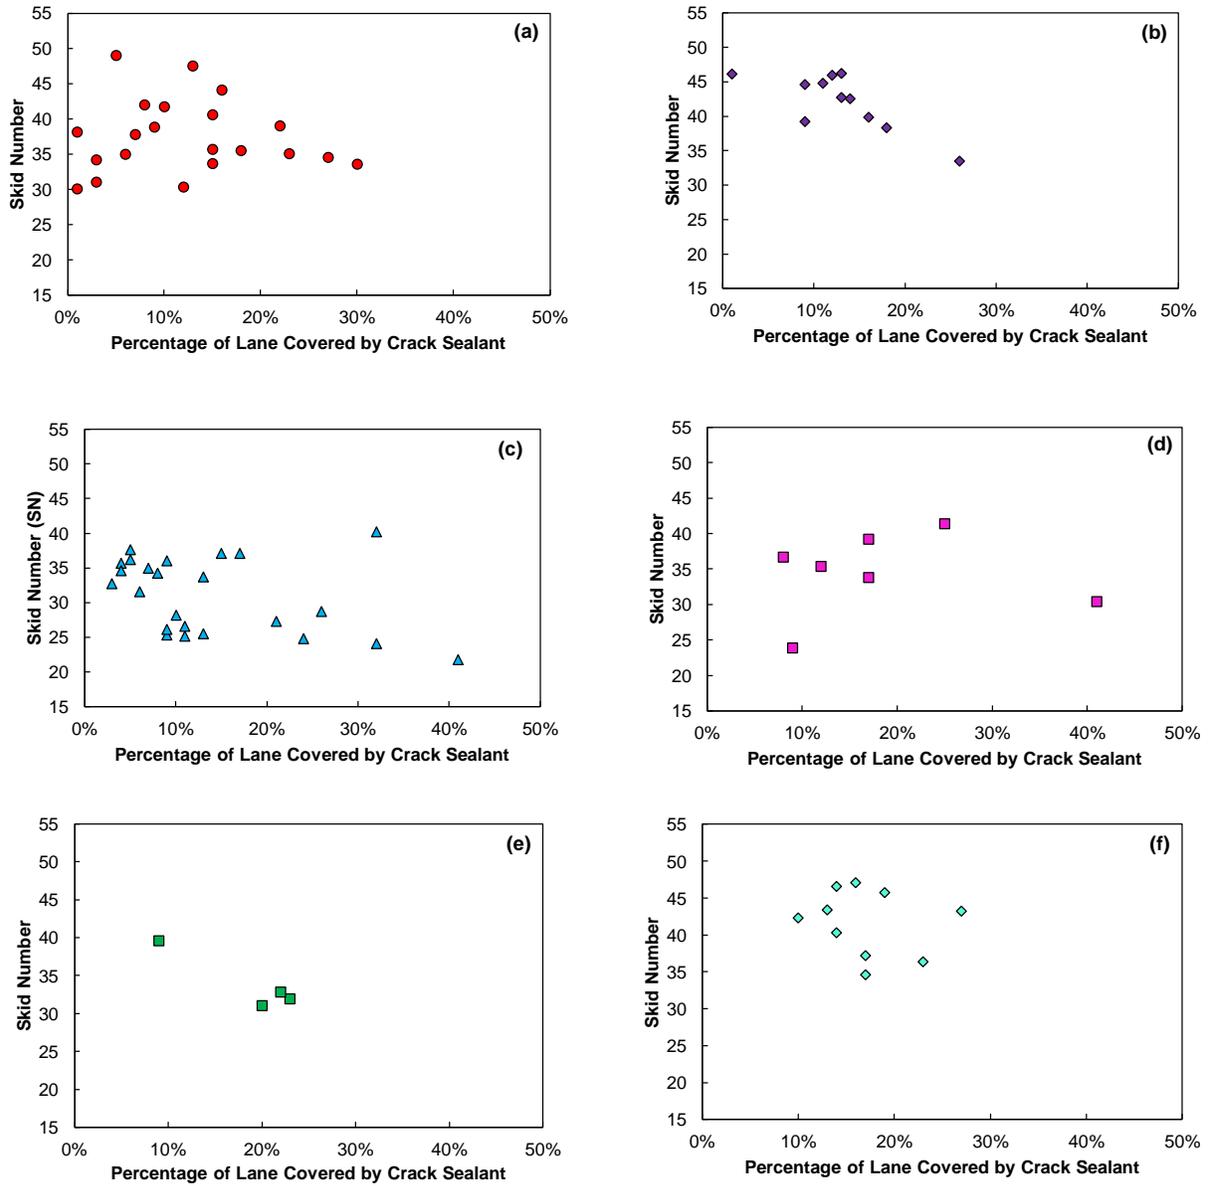
**Figure 4.1** Relationship between LWST skid numbers and the percentage of the pavement lane covered by crack sealant for test sections in (a) Location A, (b) Location B, and (c) Location C (d) Location D, (e) Location E.

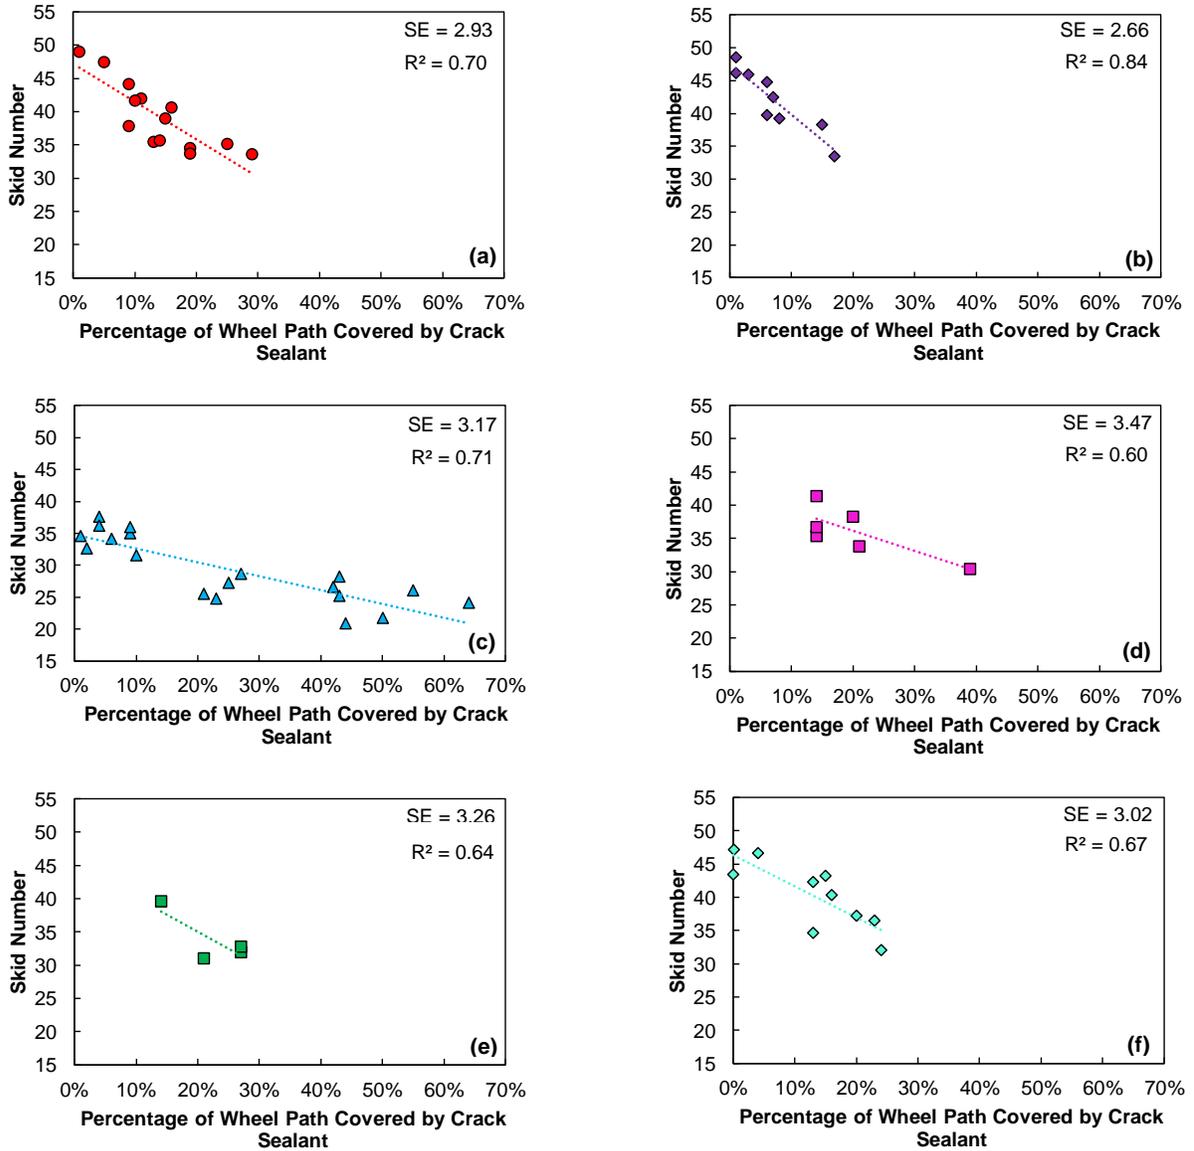
**Figure 4.2** Relationship between LWST skid numbers and the percentage of the wheel path covered by crack sealant for test sections in (a) Location A, (b) Location B, (c) Location C, (d) Location D, (e) Location E and (f) Location F.

Figure 4.2 shows the relationship between SN values and the percentage of the wheel path area where LWST testing was conducted covered by crack sealant. For each location, a linear trend line was regressed to the data and the corresponding coefficients of determination ( $R^2$ ) and standard error (SE) values for each location are reported in Figure 4.2. While there is some scatter in the results, the moderately high  $R^2$  values and low standard error values indicate that SN value is correlated to the percentage of the wheel path area covered by crack sealant. The trends in Figure 4.2 demonstrate that SN values generally decrease as the percentage of the wheel path covered by crack sealant increases for each testing location. These results support the hypothesis that the application of excessive crack sealant can pose a safety hazard. The primary distresses that generally occur in the wheel path are longitudinal cracking and alligator cracking, which makes it more likely that sealant will be applied in the wheel path. In addition to posing skid loss, pavements with alligator and longitudinal cracking are generally poor candidates for crack sealing because these distresses indicate an underlying structural problem in the pavement. Crack sealing does not increase the structural capacity of a pavement.

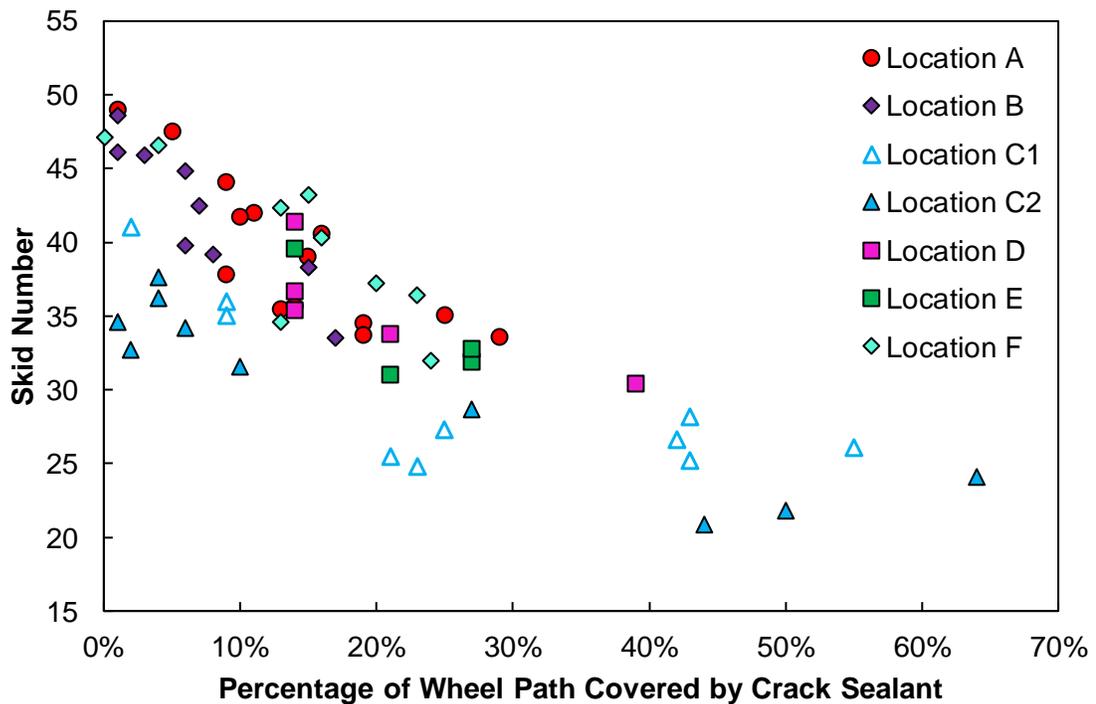
**Figure 4.3** Relationship between LWST skid numbers and the percentage of the wheel path covered by crack sealant for all test sections.

No discernable trend in the relationship between the SN value and the percentage of the wheel path covered in crack sealant for baseline skid values ranging from 43 to 49. As seen above in Figure 4.2, each location displays a different slope of SN vs. percentage of wheel path covered in crack sealant. Location C exhibits a significantly lower slope than the other sections. This is attributed to its significantly lower baseline skid value. For the other sections, there is no clear trend in slope with baseline skid values.

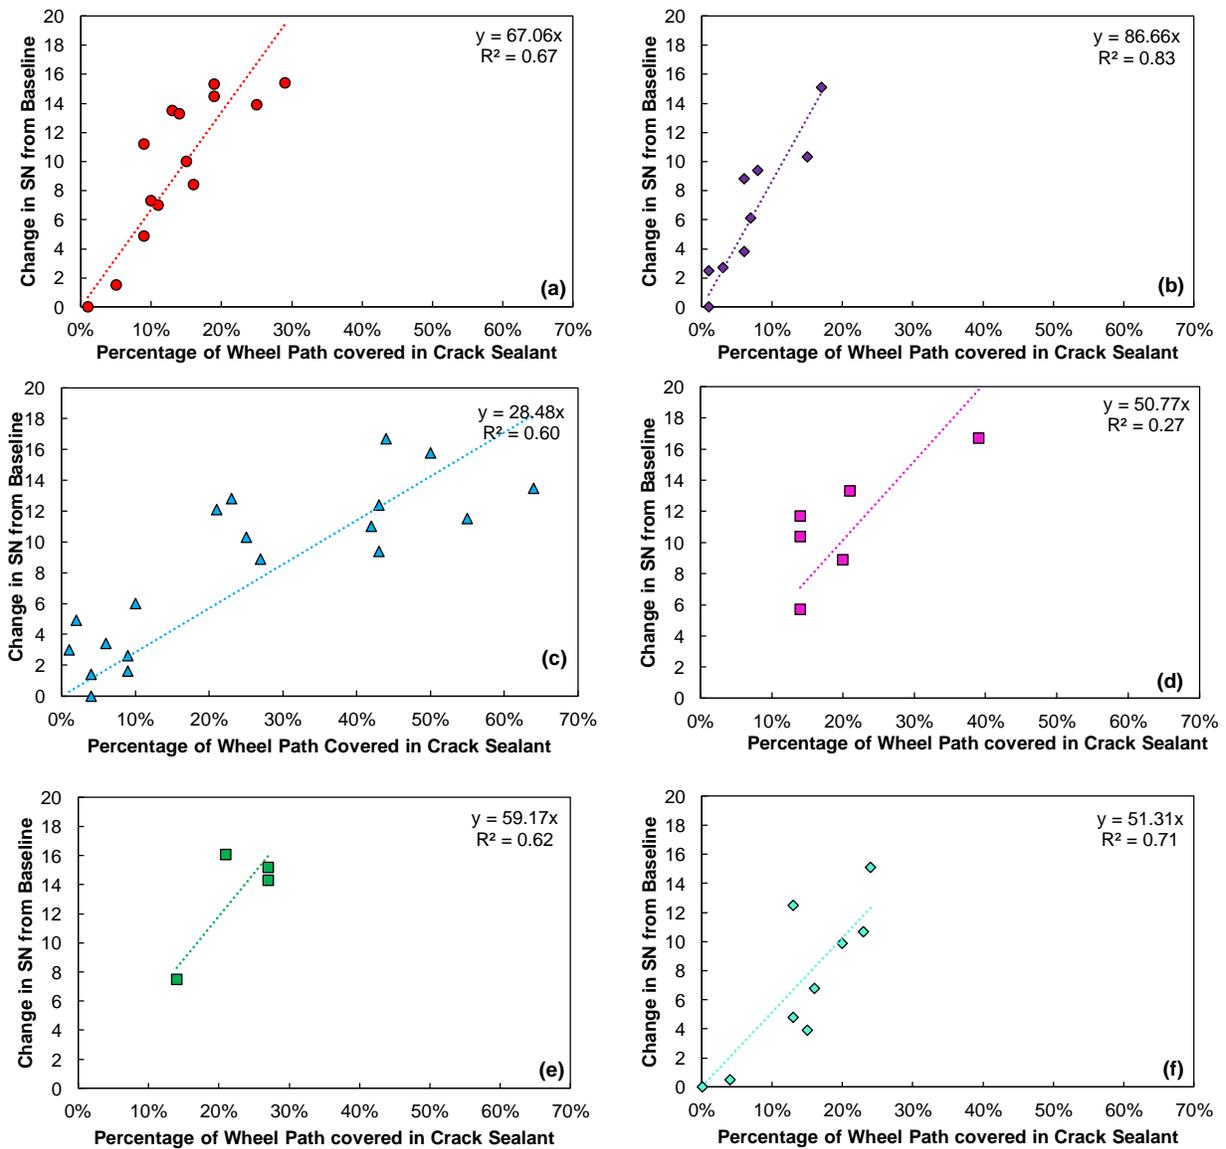
**Figure 4.4** Relationship between the change in skid numbers from the baseline and the percentage of the wheel path covered by crack sealant for test sections in (a) Location A, (b) Location B, and (c) Location C (d) Location D (e) Location E (f) Location F.

In a further effort to unify the results of the different testing locations, the difference between the baseline SN and the SN value measured at each test site with crack sealant present was investigated, referred to as the change in SN herein. Figure 4.4 shows the relationship between

the change in SN and the percentage of the wheel path covered by crack sealant for each testing location. While there is significant scatter in the results, all locations exhibit an overall positive trend, indicating that higher amounts of crack sealant application in the wheel path generally correspond to greater loss in skid resistance. The slope of the relationship between the change in SN and the percentage of the wheel path covered by crack sealant is significantly lower for Location C than the other testing locations, indicating the change in SN due to crack sealant application is also affected by the baseline pavement skid resistance. In addition, the slopes of the individual plots for Locations A, B, D, and E differ somewhat. However, when the results are combined, as shown in Figure 4.5, it can be seen that the results of the different sections are generally in agreement. Due to the differing slopes but overall similar trend, the categorical approach was used, which grouped pavements into good condition ( $43 <$ ) and poor condition ( $< 38$ ). Analysis of additional sections with a baseline value ranging from 38-43 could help inform the trend of baseline skid resistance in future work.

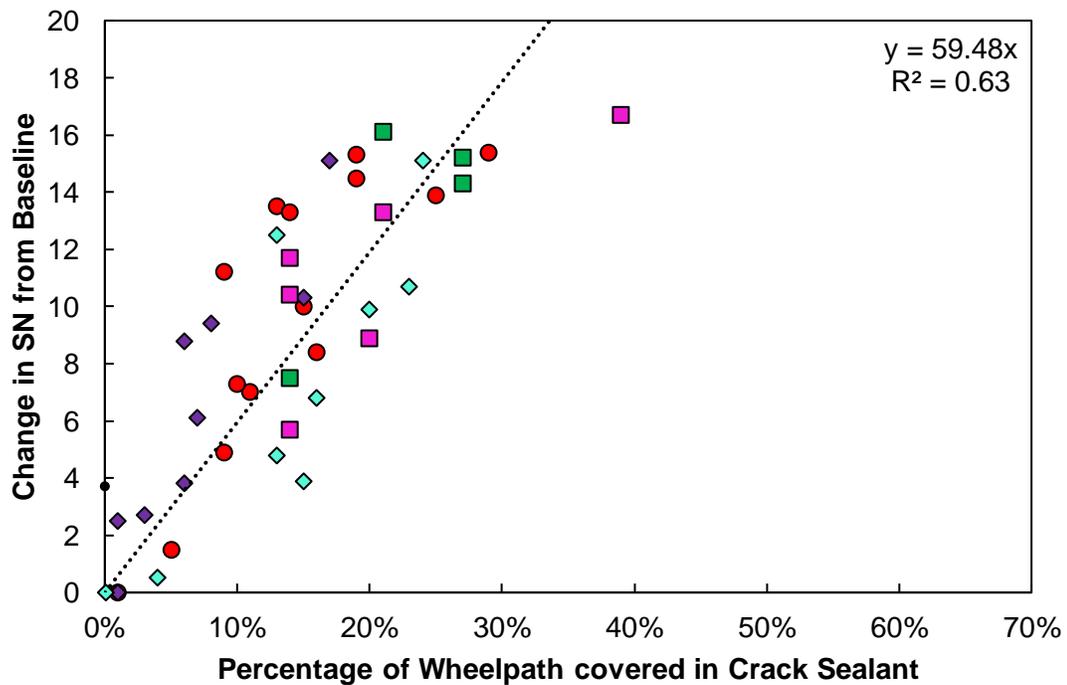
**Figure 4.5** Combined relationship between change in skid numbers from the baseline and the percentage of the wheel path covered by crack sealant for test sections A, B, D, E, and F.

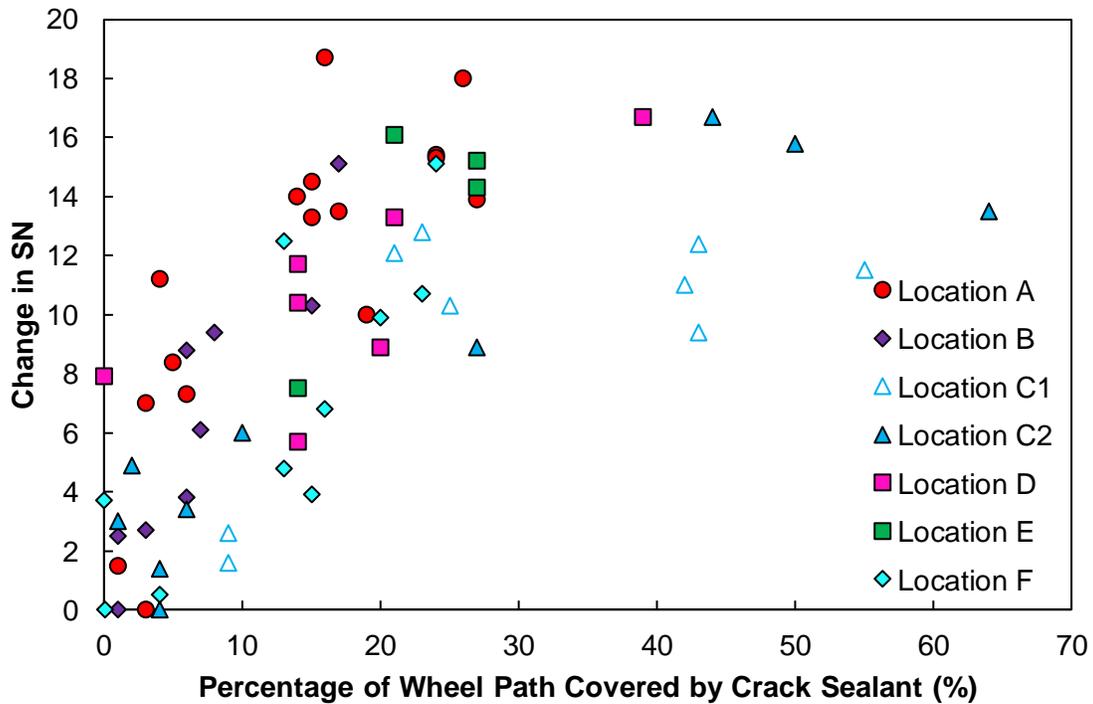
**Figure 4.6** Relationship between the change in skid numbers from the baseline and the percentage of the wheel path covered by crack sealant for all test sections.

The combined results of the change in SN versus the percentage of wheel path covered by crack sealing for all locations are shown in Figure 4.6. The results of Location C fall towards the lower bound of the scatter of the results for the other test sections for relatively low crack sealant wheel path coverages and deviate from the trends of the other sections at relatively high percentages of crack sealant coverage in the wheel path. However, the data corresponding to Location C extend to higher crack sealant coverages than the other sections so definitive trends are difficult to ascertain.

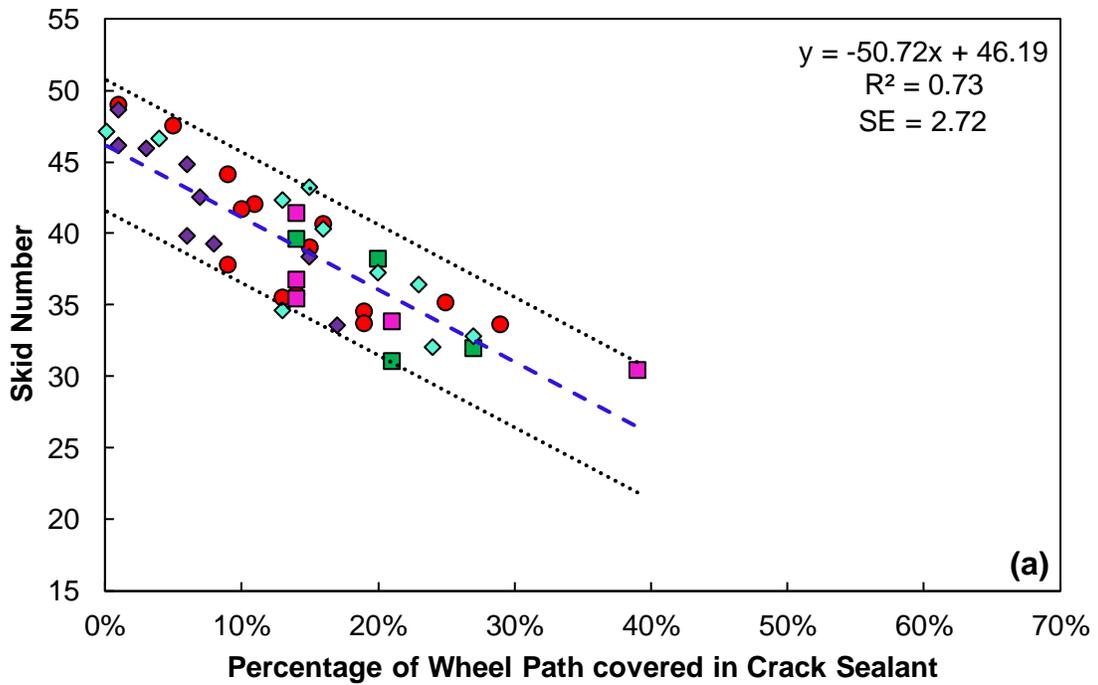
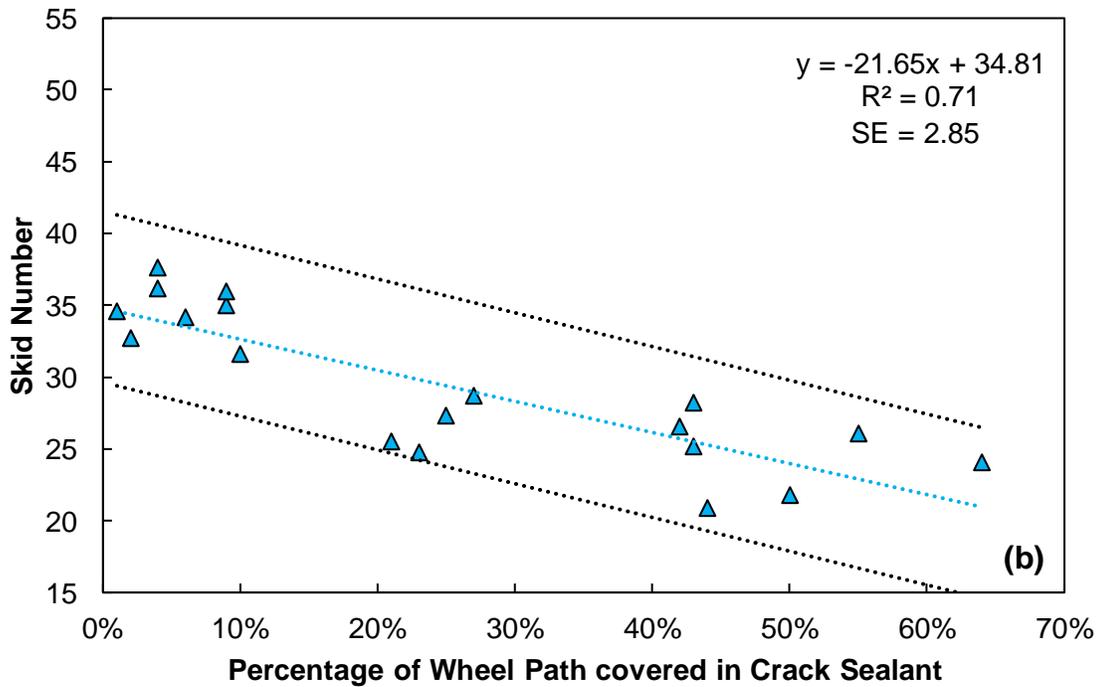
**Figure 4.7** Relationship between LWST skid number and the percentage of the wheel path covered by crack sealant with 95 percent confidence intervals (dotted lines) for (a) Locations A, B, D, E, and F, and (b) Location C.

Where  $\hat{y}$  is the SN value predicted by the regression line,  $SE$  is the standard error of the regression line, and  $t_{crit}$  is the critical value on the t distribution for the desired confidence level. To define the confidence interval bounds, the  $\alpha$  value used to determine  $t_{crit}$  was 0.05, meaning that there is a 5 percent probability of a value falling below the lower bound and 5 percent probability of a value falling 5 percent above the upper bound. Given the sample sizes, the  $t_{crit}$  value for Location C is 2.093 and the  $t_{crit}$  value for the combined results of Locations A, B, D, E, and F is 1.684. The results are shown in Figure 4.7.

The linear regression model and confidence intervals were used to establish limits for the percentage of the wheel path that can be covered by crack sealant without dropping below SN thresholds of 30 and 35. A SN threshold of 30 is often applied to low-volume roadways whereas a SN threshold of 35 is often applied to high-volume roadways (Jayawickrama et al. 1996). When establishing these limits, two reliabilities were considered: 50 percent and 95 percent. To establish these thresholds, a similar approach to the reliability concept implemented in Pavement ME was used (ARA Inc. 2003). The 50 percent reliability threshold corresponds to the Figure 4.7 regression model predictions. The 95 percent reliability threshold corresponds to the lower confidence interval bounds in Figure 4.7; that is, there is 95 percent confidence that the established limit for crack sealant coverage will not lead to an SN value lower than the critical safety threshold.

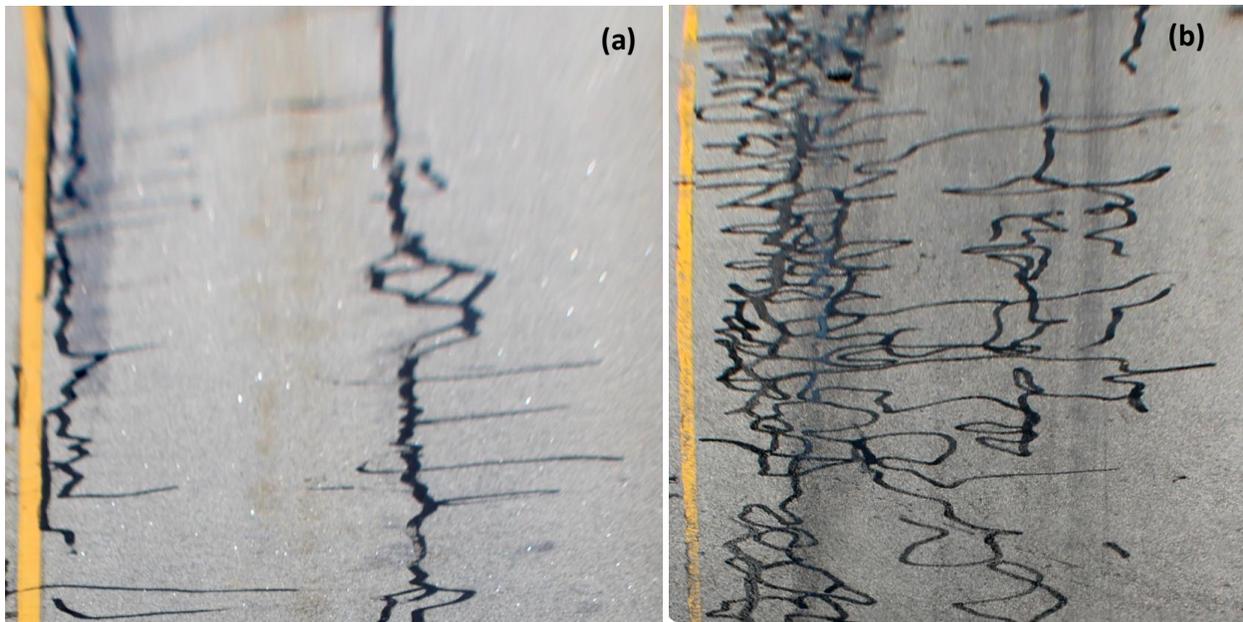
**Figure 4.8** Visual representation of (a) 17 percent crack sealant within the wheel path and (b) 27 percent crack sealant coverage within the left wheel path.

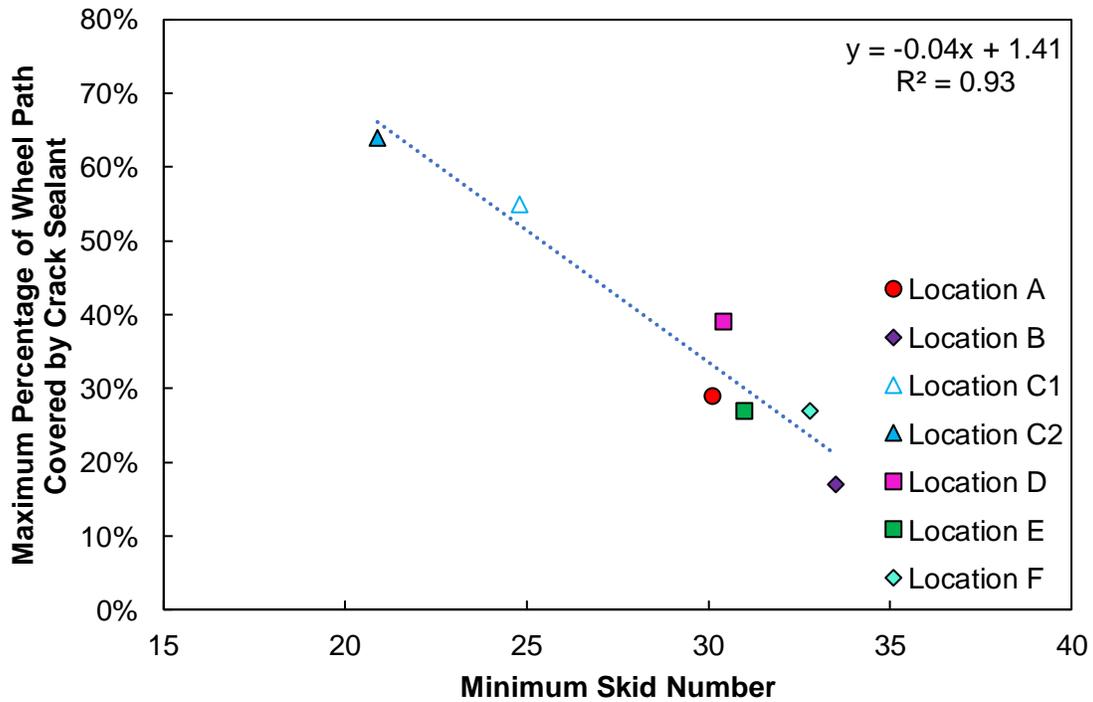
**Figure 4.9** Relationship between location minimum skid number and max crack sealant coverage in the wheel path.

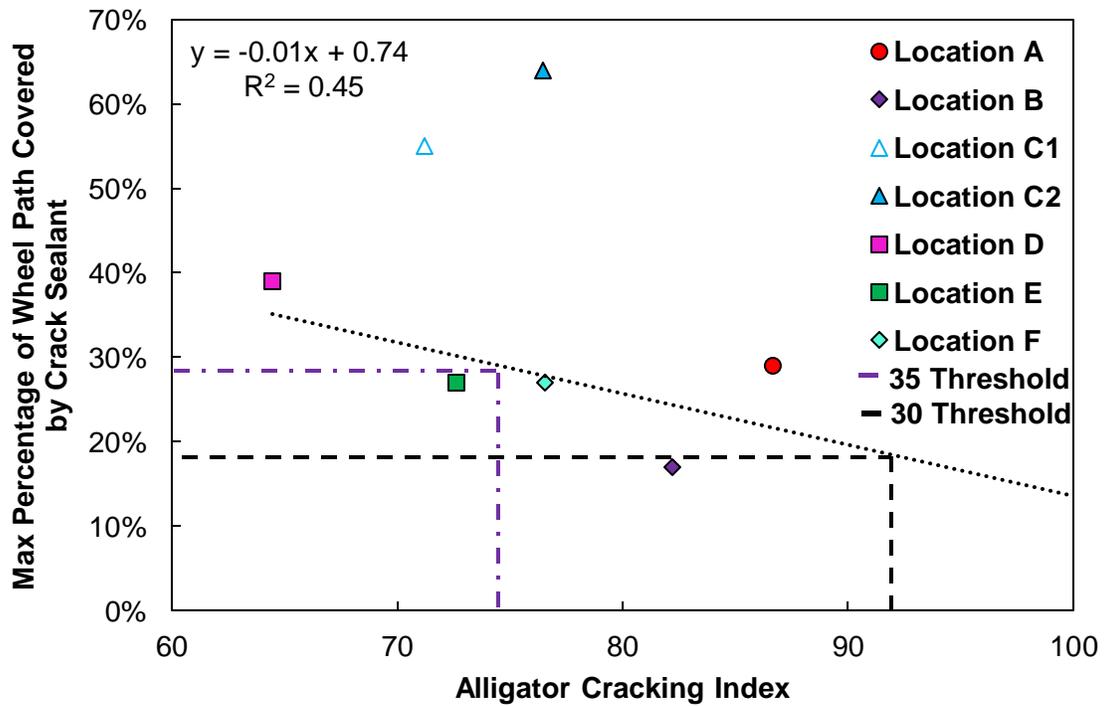
**Figure 4.10** Relationship between alligator cracking index and maximum percentage of wheel path covered by crack sealant.

Table 4.2 to ensure that the established thresholds are conservative. The corresponding alligator index thresholds are shown in Table 4.4. Note that the established thresholds pertain to pavements with good baseline skid resistance (i.e.,  $SN \geq 43$ ). It is recommended that the established threshold be strengthened in the future by incorporating a larger database of locations.
