Transactions, SMiRT-24
BEXCO, Busan, Korea - August 20-25, 2017
Division VI

ASME BLAST TESTS ON PRE-STRESSED CONCRETE SLABS

Nebojsa Orbovic¹, John Grimes², Khaled El-Domiati³, and Jason Florek⁴

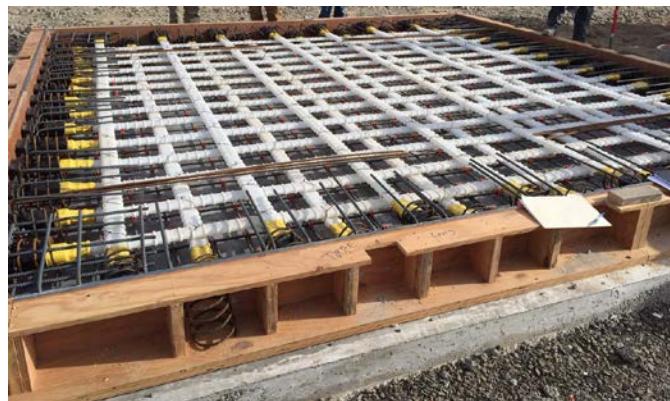
Figure 1. Pre-stressing cables and passive reinforcement in representative panel (Slab Design A).

Slab Design A was stressed to approximately 5 MPa. This panel has 14 ducts (56 strands) in each direction (Figure 1). Slab Designs B and C were stressed to approximately 10 MPa. These panels had 18 ducts (72 strands) in each direction. Slabs were post-tensioned using the VSL 6-4 strand Post-Tensioning System with 15mm strands, Grade 1860 MPa complying with ASTM A416. Lower-level stress strands (

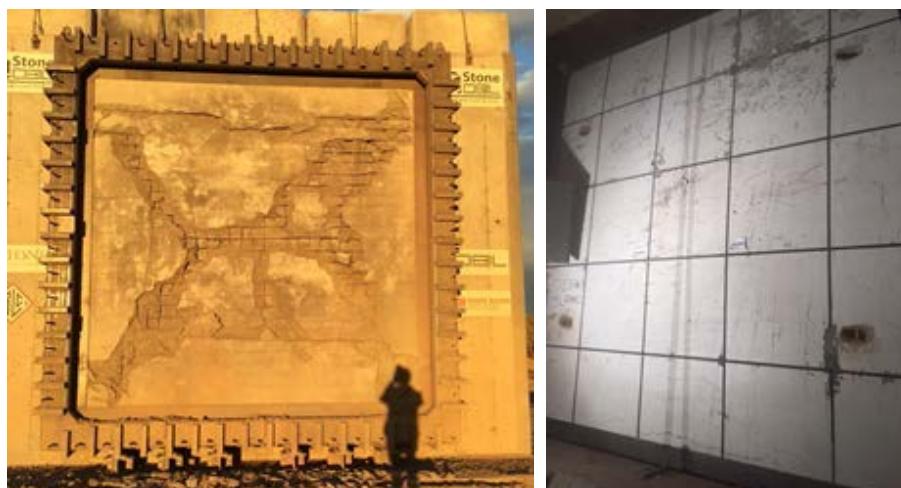
Figure 2. Front and rear face of the slab after Test 1

Maximum recorded reflected pressure at the different gauges was P3: 2.97 MPa (431 psi), P4: 2.6 MPa (380 psi), P5: 3.3 MPa (480 psi), P6: 4.1 MPa (590 psi) and P7: 5.15 MPa (750 psi) (Figure 3). The impulses in the middle of the slab at P4 and P6 were 3.3 MPa-ms (480 psi-ms). The maximum displacement was 120 mm which corresponds to 3.0 degrees of support rotation. Residual displacement was 100 mm. There was no rebound of the slab indicating that the cables had lost the tensile forces probably due to the failure of the pre-stressing cables. The front face experienced heavy damage with concrete crushing through roughly 1/3 of the thickness of the section and buckled reinforcement. The rear face was cracked only without any concrete scabbing (Figure 2). The cable anchorage zone was damaged with through thickness cracking and a crack along the slab edge. These cracks are due to the insufficient burst reinforcement at the slab edges, which was not designed for the forces in pre-stressing cables beyond the yield stress. The crack parallel to the edge at one slab thickness may have been caused by direct shear failure due to the insufficient longitudinal reinforcement over the support lines (Figure 4). Due to the level of damage on the front face it was decided not to increase the amount of explosive and to stay limited to 3 degrees of support rotation instead of the originally targeted 4 degrees.

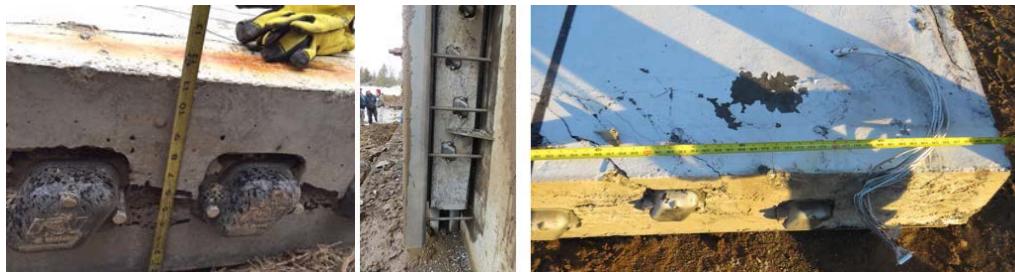
Figure 4. Through-thickness crack at the anchorages of the pre-stressing cables and cracked area at the edges of slab in Test 1

brittle concrete failure in compression and probable loss of pre-stressing in the cables. The maximum displacement was 109 mm, which corresponds to a 2.7 degree support rotation, and the residual displacement was 90 mm. The damage is, like Test 1 (Figure 6) concrete cracking on the front face and cracking on the rear face. No slab rebound was recorded, as in the first test. The cracks on the rear face on Figure 6 are highlighted with a marker. For this reason, they are more visible than the cracks shown in Figure 2. The through thickness cracking at the level of pre-stressing anchorage and damaged slab support zone are present, similar what is presented in Figure 4.

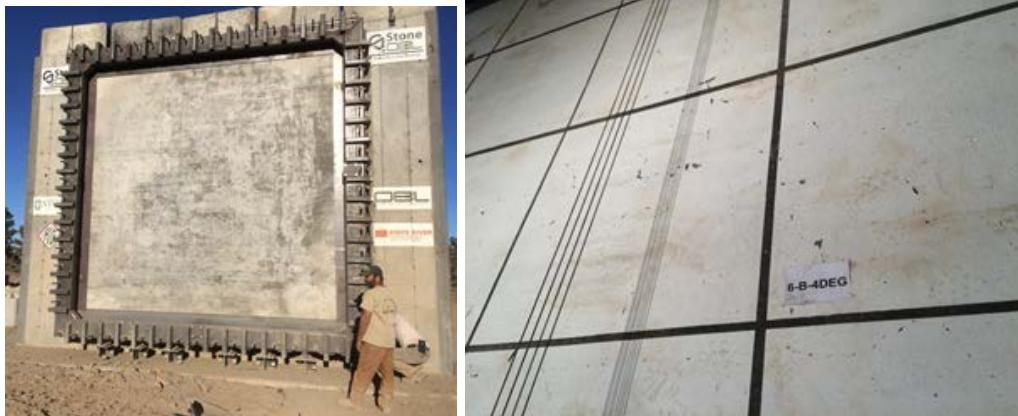
Figure 5. Front and rear side of the slab after Test 2a

Considering the concrete damage on the front face in Test 1, it was decided to reduce the amount of explosive and to see whether the concrete on the front face would stay below its ultimate limit state. The same slab design was used as in Test 1. The concrete compressive strength was $f_c' = 51.8$ MPa. The chosen amount of explosive was 770 kg of ANFO (74% of previous amount) at the stand-off distance of 13.7 m. Peak recorded pressure was in the range of 1.7 MPa (240 psi) to 3.0 MPa (430 psi). Peak recorded impulse was 3.2 MPa (470 psi-ms). The maximum measured deflection was 16 mm, which corresponds to a 0.4 degree support rotation. The slab rebounded and slab oscillations were recorded. There was no observed damage on the slab other than hairline cracks on the rear side. No through thickness cracks at the cable anchorages were observed and no crack was visible at the support zone. The behaviour of the slab was elastic. The reduction of 26% in the amount of explosive resulted in a dramatic difference in the slab response and the level of damage.

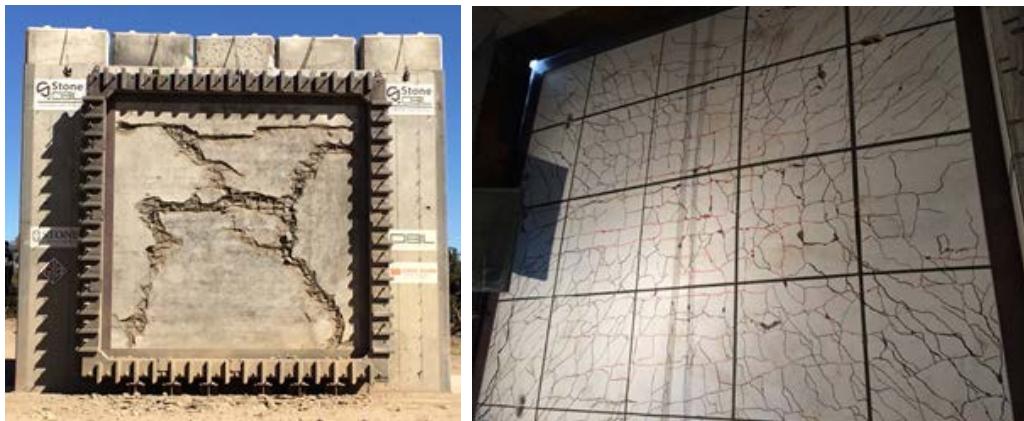
Figure 6. Front and rear side of the slab after Test 2b

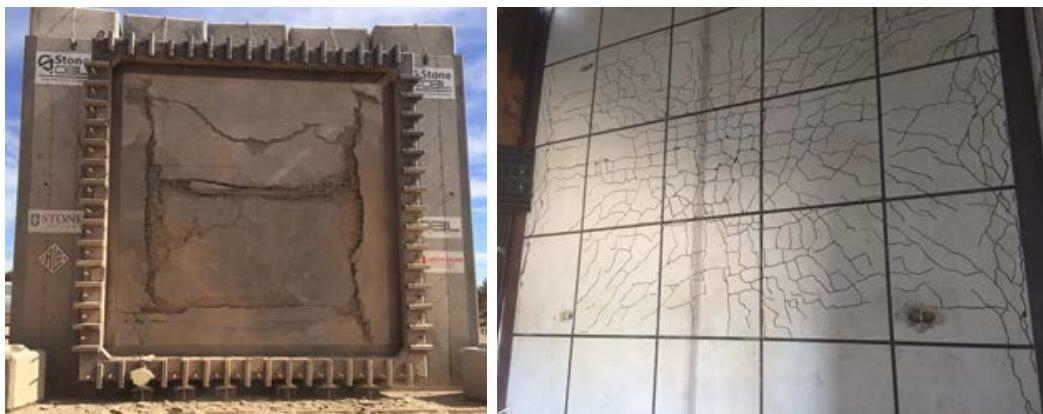
Figure 8. Front and rear side of the slab after Test 3

The peak pressures recorded ranged from P3: 3.2 MPa (470 psi) to P7: 5.2 MPa (750 psi). The positive phase impulse recorded ranged from P3: 3.0 MPa-ms (430 psi-ms) to P7: 5.2 MPa-ms (760 psi-ms). The maximum deflection recorded with the laser sensors was 88 mm, which translates to a 2.2 degree support rotation. The permanent set near the slab center point was 57 mm. The overall damage was lower than in Test 2b despite the higher amount of explosive used. This can be attributed to the higher passive reinforcement ratio in this test. However, the damage at the slab edges was very similar to Test 2b (Figure 9). The damage at the slab edges can be attributed primarily to inadequate burst reinforcement ratio for this level of pre-stressing. Higher level of passive reinforcement reduced the deflection of the slab, compared with Test 1.

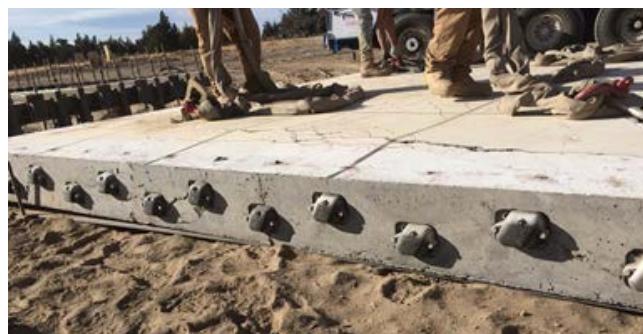
Figure 9. Through-thickness crack at the cable anchors and a crack along the edge at one slab thickness from the edge in Test 3

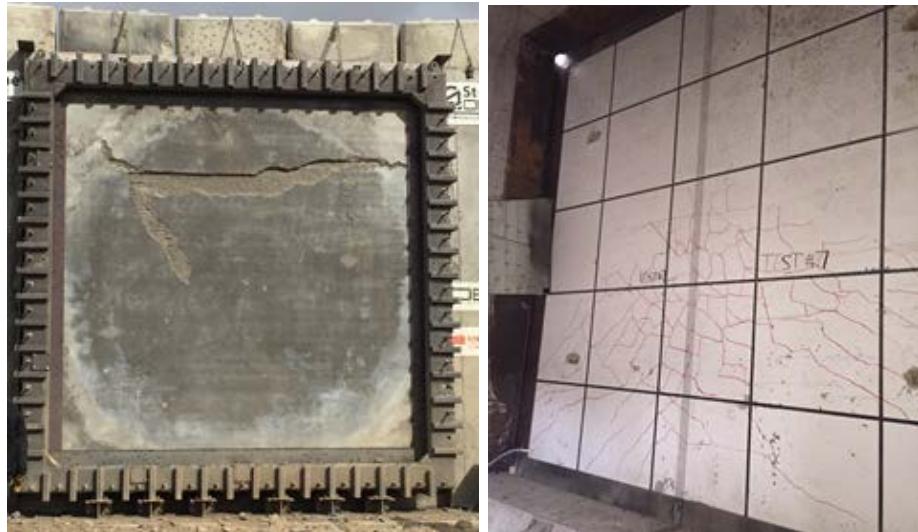
Figure 11. Front and rear face of the slab in Test 4

Test 4 was performed with Slab Design C, with 10 MPa of pre-stressing and a reinforcement ratio of 220 kg/m³. The concrete compressive strength was $f_c = 62.0$ MPa. The ANFO amount was 910 kg. The measured maximum reflected pressure at the different gauges was P3: 2.6 MPa (380 psi), P4: 2.6 MPa (380 psi), P5: 2.6 MPa (370 psi), P6: N/A and P7: 3.0 MPa (430 psi). The impulse at the mid-height of the slab was P4: 3.0 MPa-ms (430 psi-ms). The tests were performed to compare their results with the results of Test 3, to assess the influence of pre-stressing level to the overall damage. Test 4 is directly comparable with Test 3 as the only difference is in pre-stressing level. The maximum displacement was 21 mm, which corresponds to a 0.5 degree support rotation. The slab behaved quasi-elastically with some superficial damage on the front face.
