Seal welding repair technology for J-Groove welds of the reactor vessel upper head

Development of seal welding technology for CEDM nozzles

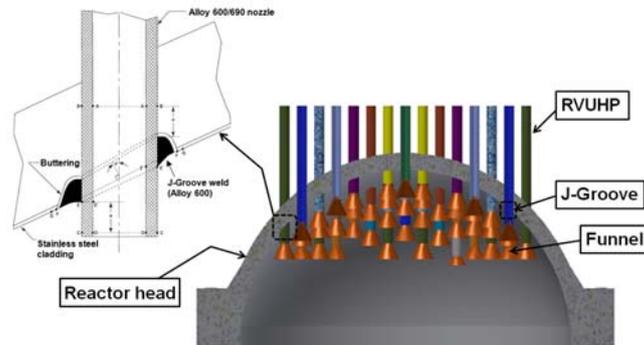
Figure 1. reactor vessel upper head(CE type) and shape characteristics of original Alloy 600 J-Groove welds

Seal welding technology is a preventive maintenance technique that suppresses PWSSCC initiation and growth by isolating Alloy 82/182 welds from primary water that are vulnerable to PWSCC using Alloy 52M filler which is high resistance material of PWSCC. Figure 1 shows a reactor vessel upper head. The reactor vessel head and CEDM Nozzles are welded. CEDM nozzles and guided funnel are connected by threads and a plug weld. Materials of CEDM nozzle are Alloy 690 but materials of J-groove welds are Alloy 600. Therefore, J-groove welds are likely to cause PWSCC. Figure 2 shows design of seal welding.

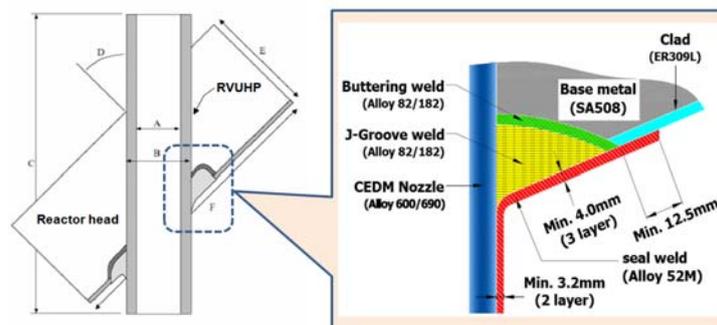
Figure 2. EFR welding design for Alloy 600 J-Groove welds

To prevent PWSCC at J- groove welds, seal welding is carried out with minimum thickness of 4 mm and minimum 3 layers. This technology has been applied and proven since 1992 in United States.

BOP (bead on plate) welding experiments to obtain the available process conditions prior to CEDM Mock-up test were conducted, as shown in Table 1. The welding machine was Max. 500A GTAW. Base metals and filler wire materials were SA240 T304L, Alloy 600 and ER309L, ERNiCrFe-7A, respectively. Based on EFR welding design of Figure.2, BOP welding experiments for Clad and J-Weld parts were

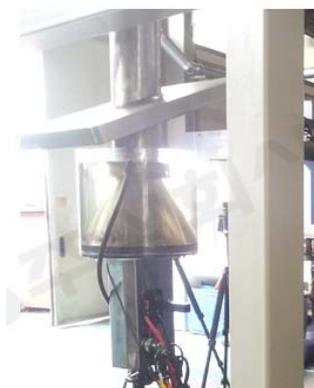
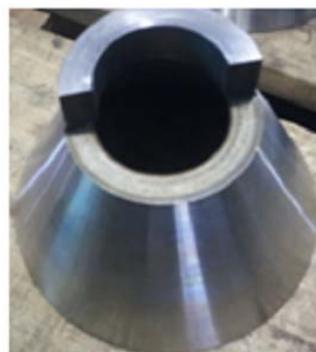
(a) EDM machine

(b) specimen

Figure 3. EDM machine and specimen

In order to install the welding machine and secure work space, Guided funnel must be removed first EDM machine has been developed to quick installation and alignment shown in figure 3 (a) because there is high radiation area under the reactor upper head. It takes about an hour to completely cut the guided funnel shown in figure 3 (b). weight of EDM machine is about 10 kg, it is enough for one engineer to handle

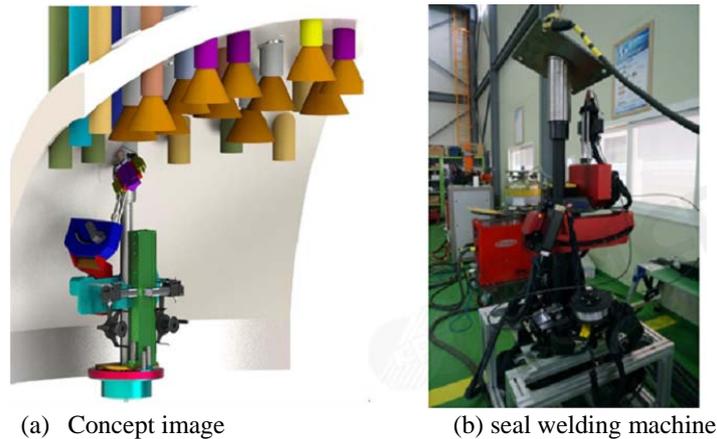
Figure 4. seal welding machine

Seal welding machine employs GTAW machine welding and two filler wire nozzles. Seal welding machine is installed very quickly and alignment is unnecessary because this is fixed inside of CEDM nozzles. The space of J-groove welds is very narrow and in the hemispherical shape, welding arc is unstable. In order to prevent this problem and to control the welding accurately, seal welding machine consists of 6 axes and welding torch maintains the optimum angle depend on the position shown in figure 4. After performing seal welding at J-groove, guided funnel must be installed on CEDM nozzles again. Welding machine is fixed at outer diameter of CEDM nozzles, minimizing the time for installing and aligning the welding machine shown in figure 5.

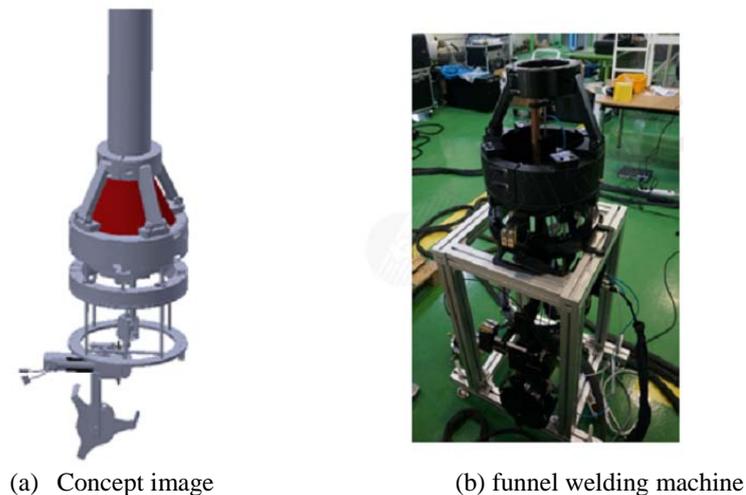
Figure 4. funnel welding machine

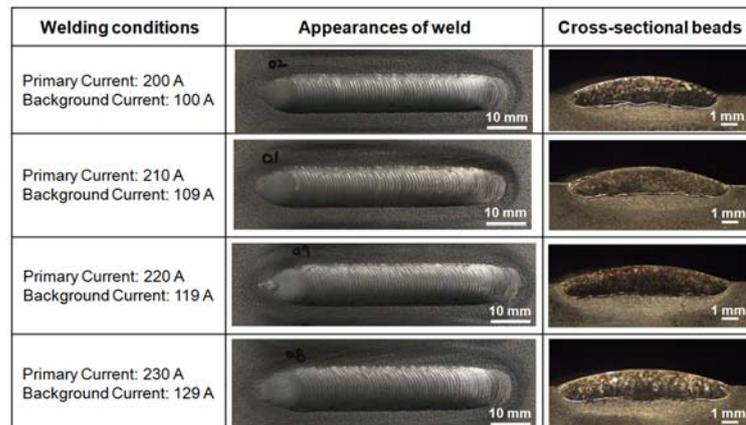
Figure. 5. Top appearances and cross-sectional beads obtained during welding of SA240 T304L and ERNiCrFe-7A

BOP welding experiments for three welding parts were conducted to change current(A), voltage(V), welding speed(IPM), wire feeding speed(IPM), etc. Figure 5 shows top appearances of welds and cross-sectional beads obtained at current of 200A~230A, voltage of 10V, welding speed of 3.5IPM, wire feeding speed of 45IPM. All weld beads with no defects, such as spatters, undercut and cracks at the welding conditions were obtained. Figure 6 indicates welding results measured during welding with two different filler wires on the SA240 T304L base metal. Weld bead width with the increase in heat input of 18.8~42.8 KJ/in increased linearly to about 6~14 mm. Weld bead width of the filler wire with ERNiCrFe-7A had a little longer compared with that of ER309L. The dilution increased with the increase in heat input. And in case of allogeneic material, the dilution measured at the same heat input seemed a higher range than dissimilar material. Figure 7 represents top appearances of welds and cross-sectional beads obtained during overlay welding of Alloy 600 and ERNiCrFe-7A. It was confirmed that a good overlay welding with no defects, such as lack of fusion and cracks at the specific welding conditions could be accomplished.

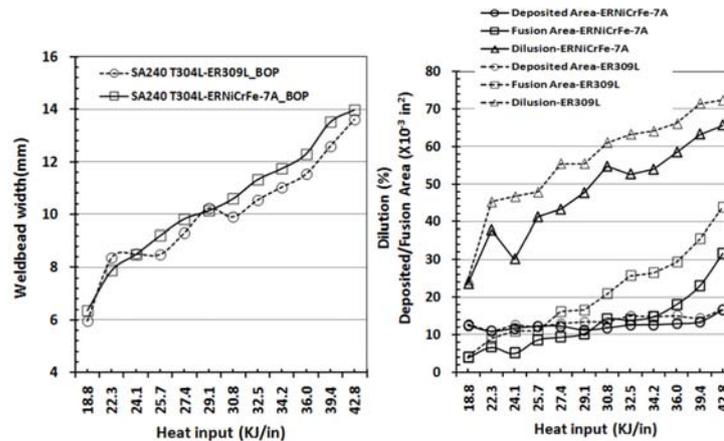
Figure.6. Comparison on welding results obtained at welding of base metal (SA240 T304L) and different filler wires

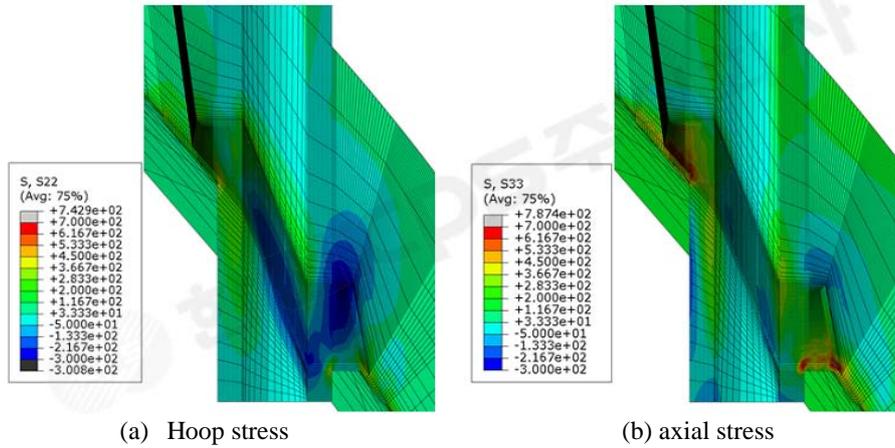
Figure 8. stress distribution after seal welding

Welding residual stress analysis is performed according to welding and operation condition. Figure 8 shows stress distribution. Flaw evaluation is also performed at reactor vessel head and seal welding. At present, non-destructive inspection technology is not able to fully inspect the J-groove welds. So all J groove welds area is assumed to be flaws. Figure 9 shows the results of LEFM evaluation at the reactor vessel upper head. Figure 10 shows the results of fatigue growth evaluation at the reactor vessel upper head. The integrity of reactor vessel upper head and seal welds is evaluated to be maintained

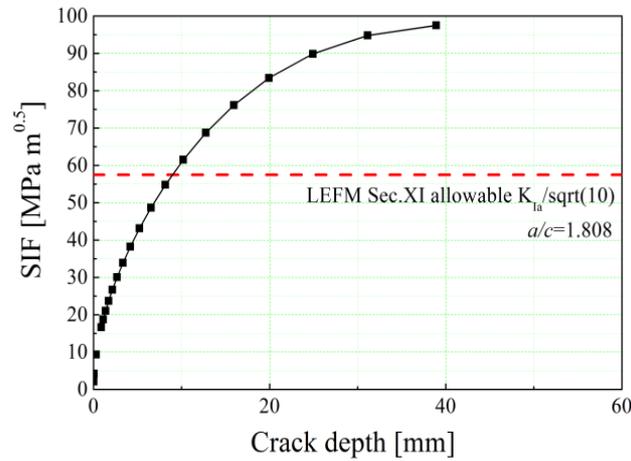
Figure 9. the results of LEFM evaluation at J-groove welds

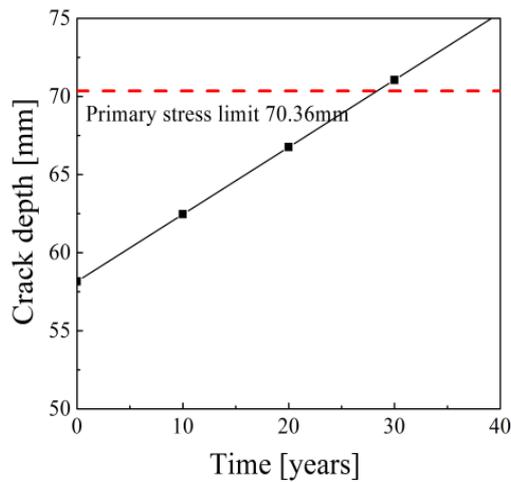
Figure 10. the results of fatigue growth evaluation at J-groove welds
