Transactions, SMiRT-25
Charlotte, NC, USA, August 4-9, 2019
Division XI

LEAK TEST ON POLYUREA LINING POOL WALL AGAINST SEISMIC AND ACCIDENTAL LOAD

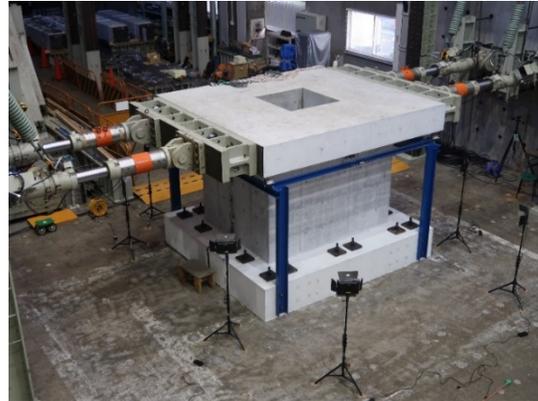
Fig.4 Loading set up

4/1000, $\pm 6/1000$, $\pm 8/1000$ twice each After a total of 12 cycles of reversed cyclic loading, the deformation angle was increased to $R = 12/1000$ to check the final condition. The measurements were carried out on shear force, total deformation, vertical section displacement in the test section to separate deformation components, rebar strain of wall. The loading set up is shown in Fig.4.

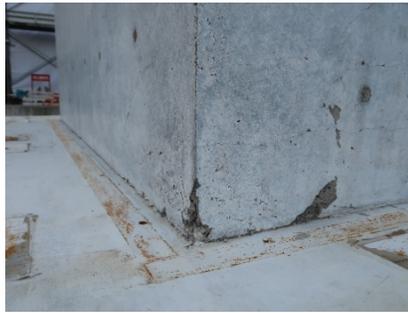
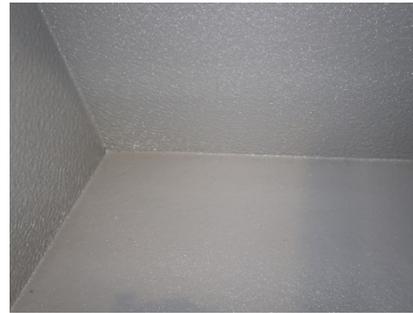
Fig.8 Outside and inside surface at the corner of the leg of wall

Fig.8 shows the peeling of concrete at the corner of the leg and the resin coating on the inner surface. No damage was observed in the resin coating, not only at the wall surface but also at the corner where the damage was large, and no water leakage was observed at the position where the concrete was crushed and peeled off. The major width of crack at $R = \pm 8/1000$ was 0.2 to 0.4 mm, and the total length of wall cracks was about 15m. The maximum crack width was 1.1 to 1.2 mm, and the average crack width was about 0.3 mm.

R reached 8/1000, the shear deformation angle γ exceeded 4/1000, but no water leakage from the crack was found for this deformation angle. In addition, when the deformation angle to be the final loading step is 12/1000, a vertical crack indicating crush of concrete occurs in the legs of surface of the compression side flange wall. Then, some peeling of concrete is occurred, but water leaks at this part is not occurred, and no water leakage occurred even 12 hours after the test. Also, in the inspection after draining, there was no breakage in the resin coating, and the coating film followed the cracking of the concrete.
