Preliminary Investigation of the Potential for River Sediment Transport of
PCBs from the Horton Iron & Metal NPL Site to areas within a 3.9 mile
Cape Fear River Study Area near Wilmington, NC

Submitted to the Graduate Faculty of
North Carolina State University
in partial fulfillment of the
requirements for the degree of
Master of Environmental Assessment

December 5, 2014

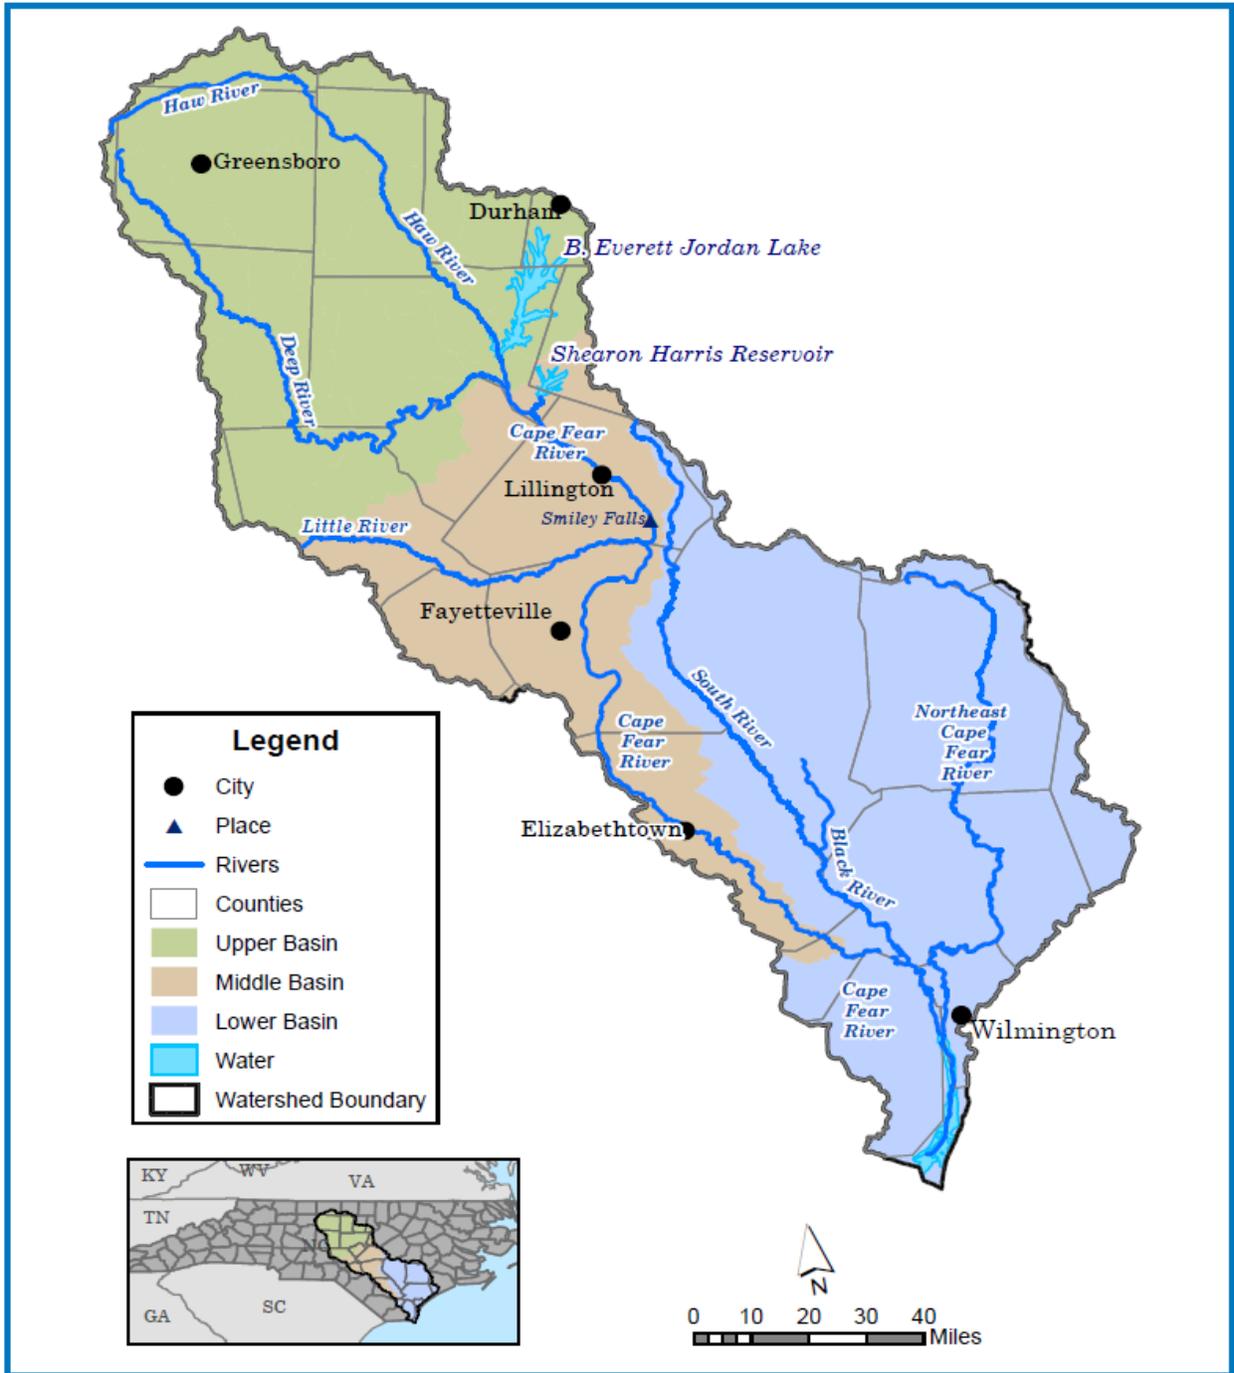
Figure 1. Cape Fear River Basin

Depiction of the main-stem and major tributaries of the Cape Fear River.

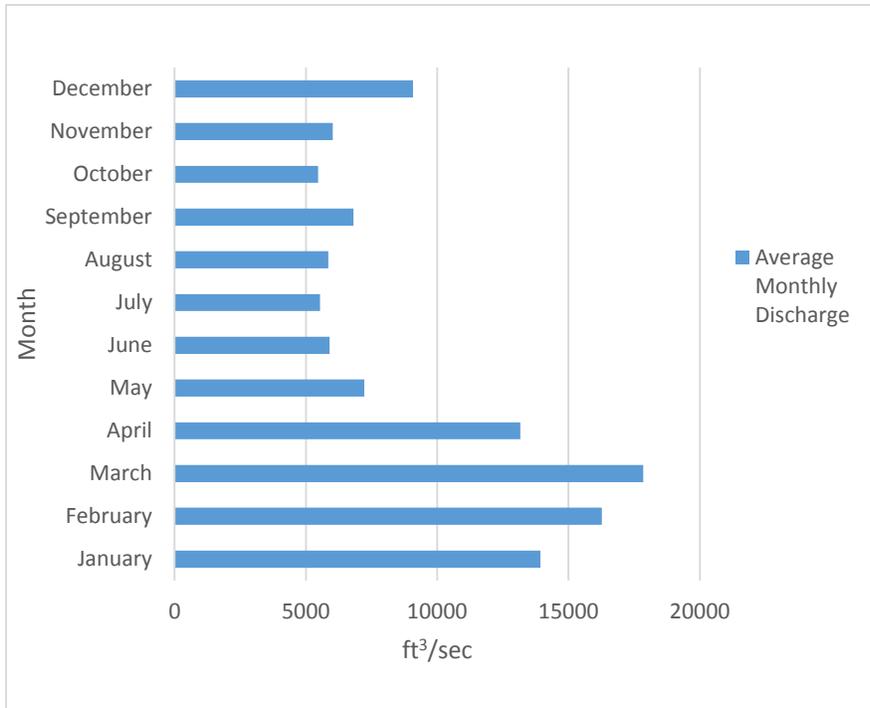
Figure 2.
Cape Fear River Monthly Average Discharge.

Average discharge calculated based on CORMP streamflow data collected from four monitoring stations: (1) Black River near Tomahawk, (2) NECFR near Chinquapin, (3) Lock and Dam #1 near Kelly, NC, and (4) Cape Fear River Discharge at mouth. This dataset was averaged from daily averages available on the CORMP website from September 1, 1969 through October 26, 2014.⁸

Flow speeds of the Cape Fear River fluctuate seasonally with minimum flows occurring in the late summer and early autumn months, and peak flows arising in the winter and spring (Figure 2). Overall, this flow pattern results in an annual mean discharge of approximately 267 m³/s.^{4,8} Most of the flow in the river originates from its piedmont tributaries with the last 34 miles of the river having a tidal influence resulting in an estuarine environment in the lower reaches that includes approximately 43 square miles of essential estuarine habitat.¹

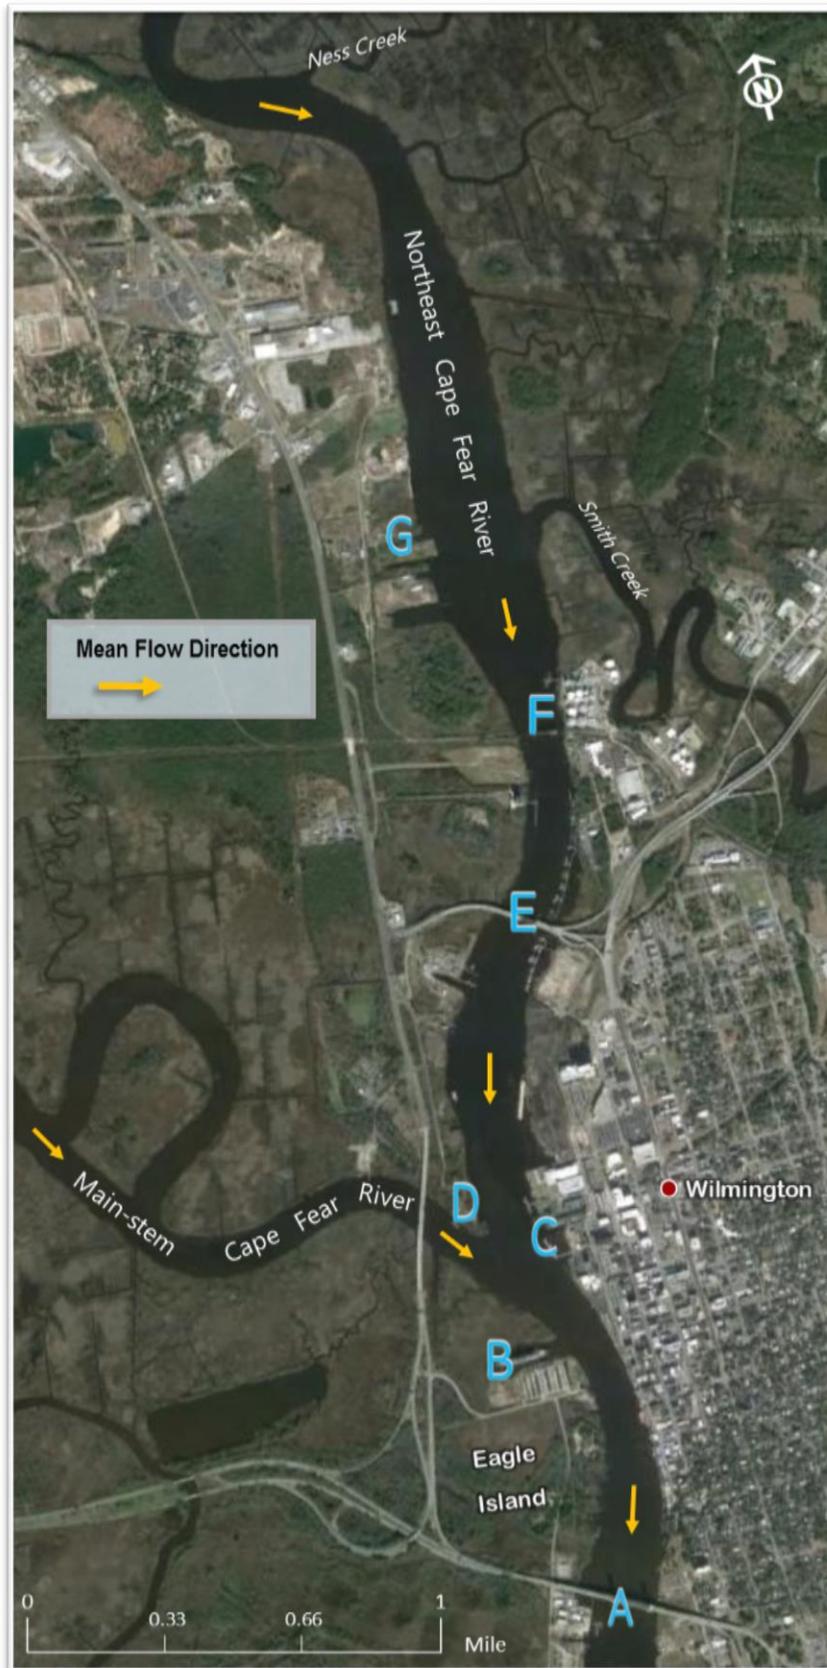
Figure 3. Site Locations and Surrounding Areas

(A) Cape Fear Memorial Bridge; (B) Battleship USS North Carolina; (C) CFCC Dock and Basin - sampling sub-site; (D) Confluence of the Cape Fear River and the NECFR, called "Point Peter"; (E) Isabel Holmes Bridge; (F) Hilton Railroad Bridge; (G) Horton Iron & Metal – NPL site.

- 1) The City of Wilmington has two stormwater discharge outfalls located in the basin. The stormwater was tested in 2008 by CATLIN, and arsenic, lead, chromium, barium, silver, and mercury were detected; however, the findings were deemed inconclusive due to issues with sampling methods, and further testing was recommended. However, additional testing was never conducted to clarify CATLIN's report.
- 2) In 2011, the Horton Iron and Metal site was listed by the U.S. Environmental Protection Agency (EPA) on the National Priorities List (NPL). This NPL site (site "G" in Figure 3) is located

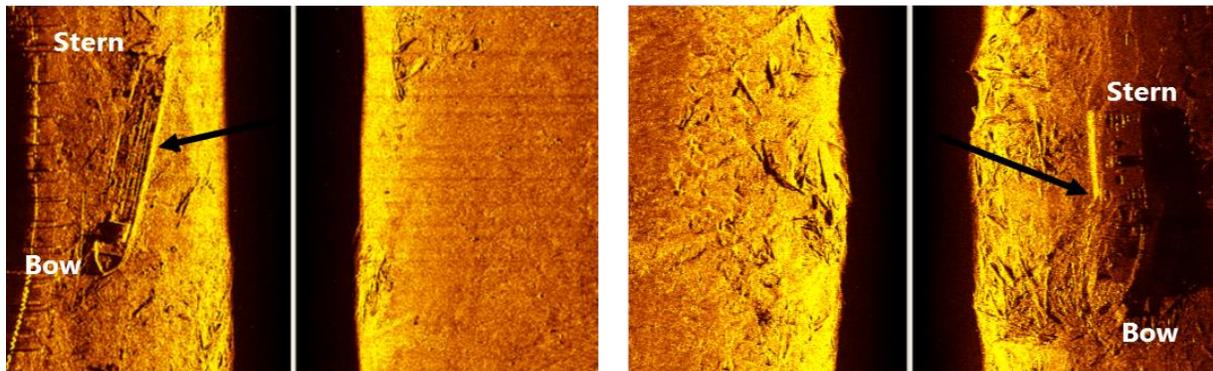
(A) The *A.P. Hurt* is a submerged 135-ft, iron steamboat located in 20-ft of water on the east bank of the LCFR, just north of the Cape Fear Memorial Bridge. The *A.P. Hurt* sank on March 26, 1923 and its remains, as seen here, are nearly fully intact. (B) The *John Knox* is a submerged 80-ft, diesel powered ferry boat located in 15-ft of water on the Eagle Island side (west bank) of the LCFR, directly across the river from the *A.P. Hurt*. The *John Knox* sank in June of 1937; although its superstructure and decking are gone, the hull remains mostly intact. See Appendix A for historical photos of both vessels when they were operable.

(Images were shot using side scan sonar in the spring of 2014 by Tim Shaw (CFCC Marine Technology Department))

(a) *A.P. Hurt*

(b) *John Knox*

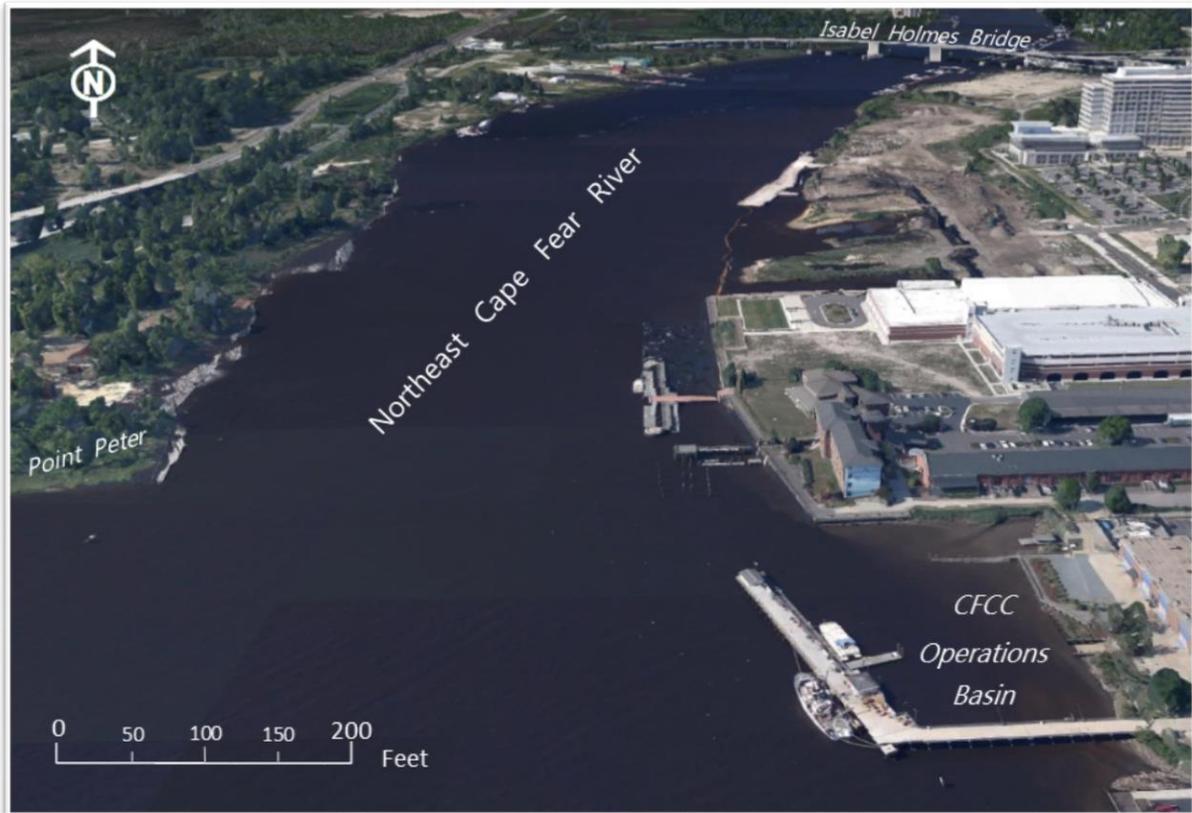
Figure 5. Location of CFCC Operations Basin.

The CFCC Operations Basin is located on the east bank of the Cape Fear River at the confluence of the main-stem of the Cape Fear River and the Northeast Cape Fear River.

Cape Fear Community College (CFCC), in Wilmington, North Carolina, operates a fleet of training research vessels as part of their Marine Technology Program's curriculum. All vessel operations are initiated at the CFCC dock, and movement of many of the vessels to and from this dock is dependent on having a sufficient water depth in the adjacent operations basin (Figure 5).

The CFCC operations basin is located on the east bank of the Cape Fear River directly behind the Burnette building on CFCC’s downtown campus (34°14’24.94” N, 077°57’08.74” W). The basin covers a roughly rectangular area measuring approximately 410 feet along the shoreline and 304 feet from the shoreline to the Cape Fear River proper. Depths vary in the basin based on both tide height and location within the basin, but typically range from 0 to 6 feet. An L-shaped dock has been constructed in the basin to berth both the 135-foot *R/V Cape Hatteras* and the 53-foot *R/V Martech*. Additionally, there is a small boat ramp located near the middle of the basin’s shoreline that serves as a launch area for several of CFCC’s smaller boats, and the City of Wilmington has located stormwater runoff outfalls in both the northeast and southeast corners of the basin.

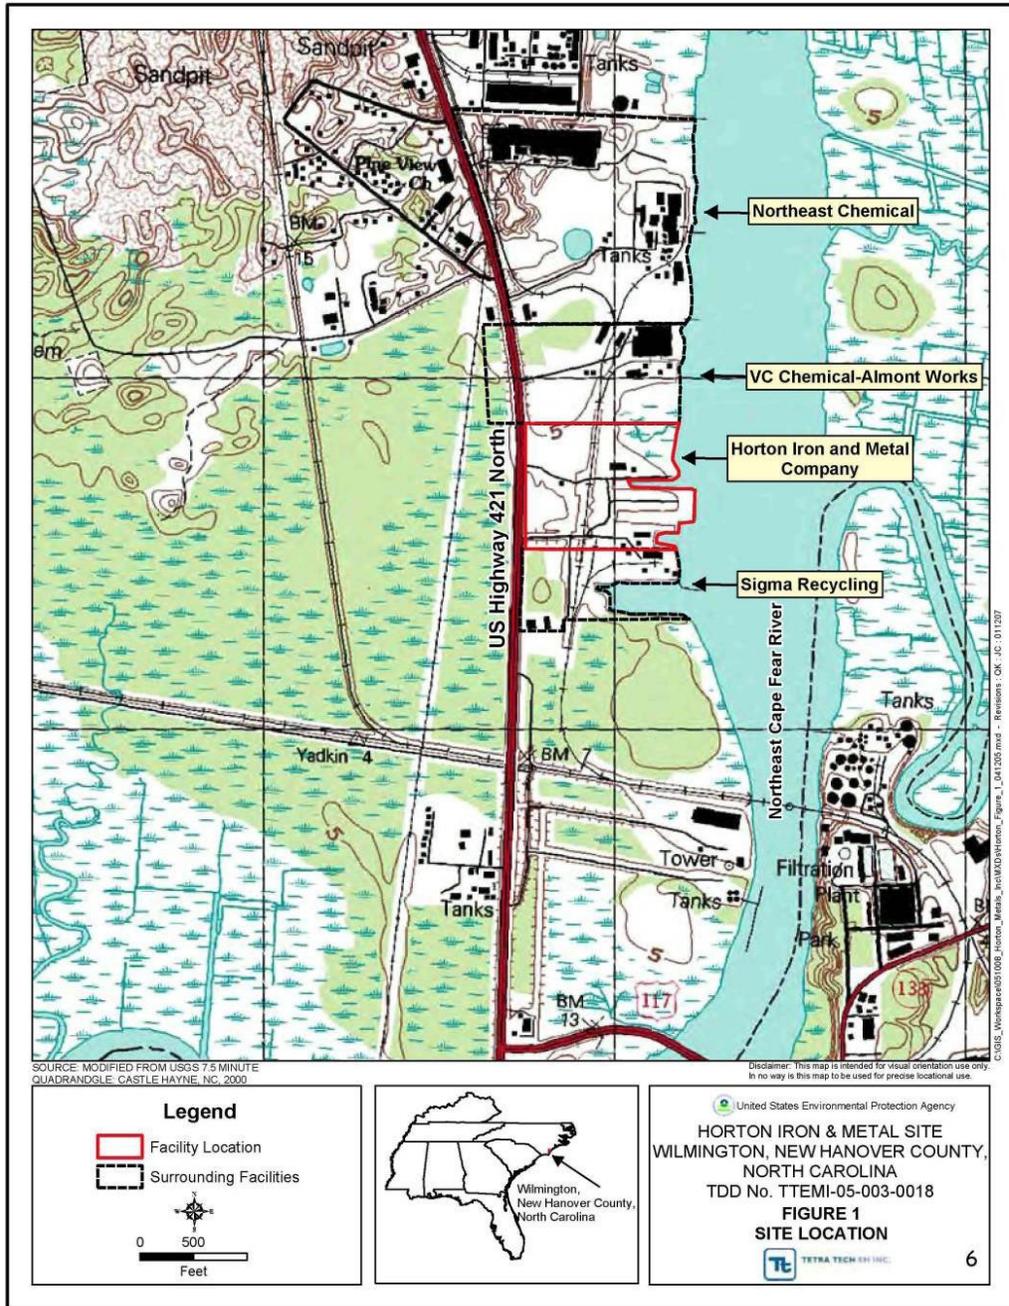
Figure 6. Horton Iron & Metal NPL Site and Surrounding Facilities.

The Horton Iron & Metal Site is located in Wilmington, NC on the west banks of the NE Cape Fear River. It is immediately bordered to the north by VCC-Almont Works (former phosphate fertilizer manufacturing that currently operates as Agrium, Inc. manufacturing nitrogen fertilizers), and by Sigma Recycling (former ship-breaking operations) to the south. Additionally, the Northeast Chemical Company can be found just north of VCC-Almont Works. The Northeast Chemical property previously operated as a phosphate fertilizer facility (1906-1980s) and a portion of that property has been functioning as a sulfuric acid manufacturing facility since 1982.

Unless otherwise noted, the following timeline chronicles the property currently known as the Horton Iron & Metal NPL site (EPA ID: NCN000407480). Some ancillary information has been included for the parcels of land directly bordering the Horton site to the north and south; this information is pertinent because these adjacent properties were used for operations similar to that which were conducted at the Horton site. The adjacent properties have been assessed for contaminants and Removal Actions have been conducted; however, neither property has been proposed for the National Priorities List. For clarification of locations, see Figure 6 in the main text of this document.

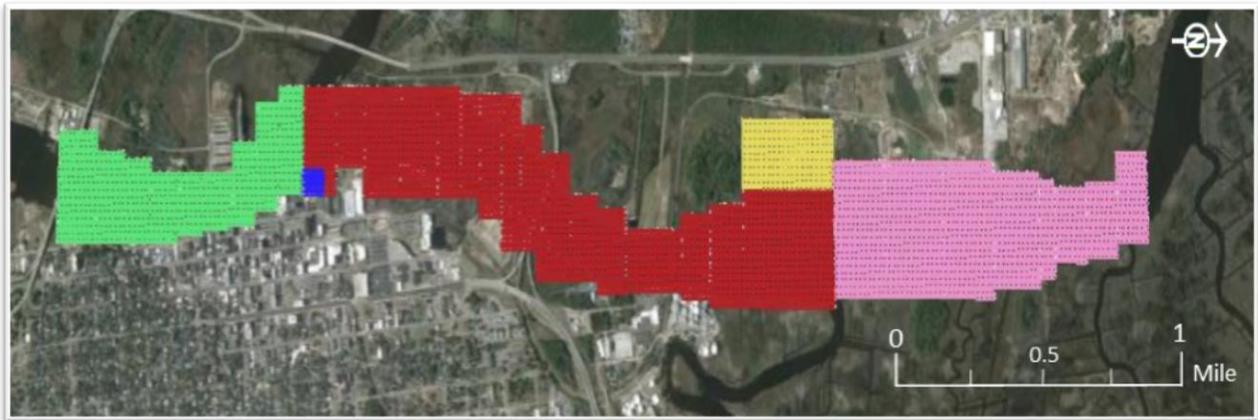
Figure 7. Subsampling Sites.

The gridded subsections are color-coded: Pink = Upriver subsection (“Upriver”); Yellow = Horton Iron & Metal subsection (“Horton”); Red = transition between Horton and CFCC subsections (“Mid-river”); Blue = CFCC operations basin subsection (“CFCC Basin”); and, Green = Downriver subsection (“Downriver”).

Due to budget constraints for the analysis of samples, it was decided that 20 sediment samples and 2 water samples would be sufficient for this preliminary study. In an effort to collect samples from random locations across the entire 3.9 mile study site that would adequately portray the presence or absence of a PCB gradient in the sediments, the site was divided into five subsampling grids – Upriver, Horton, Mid-river, CFCC basin, and Downriver (Figure 7).

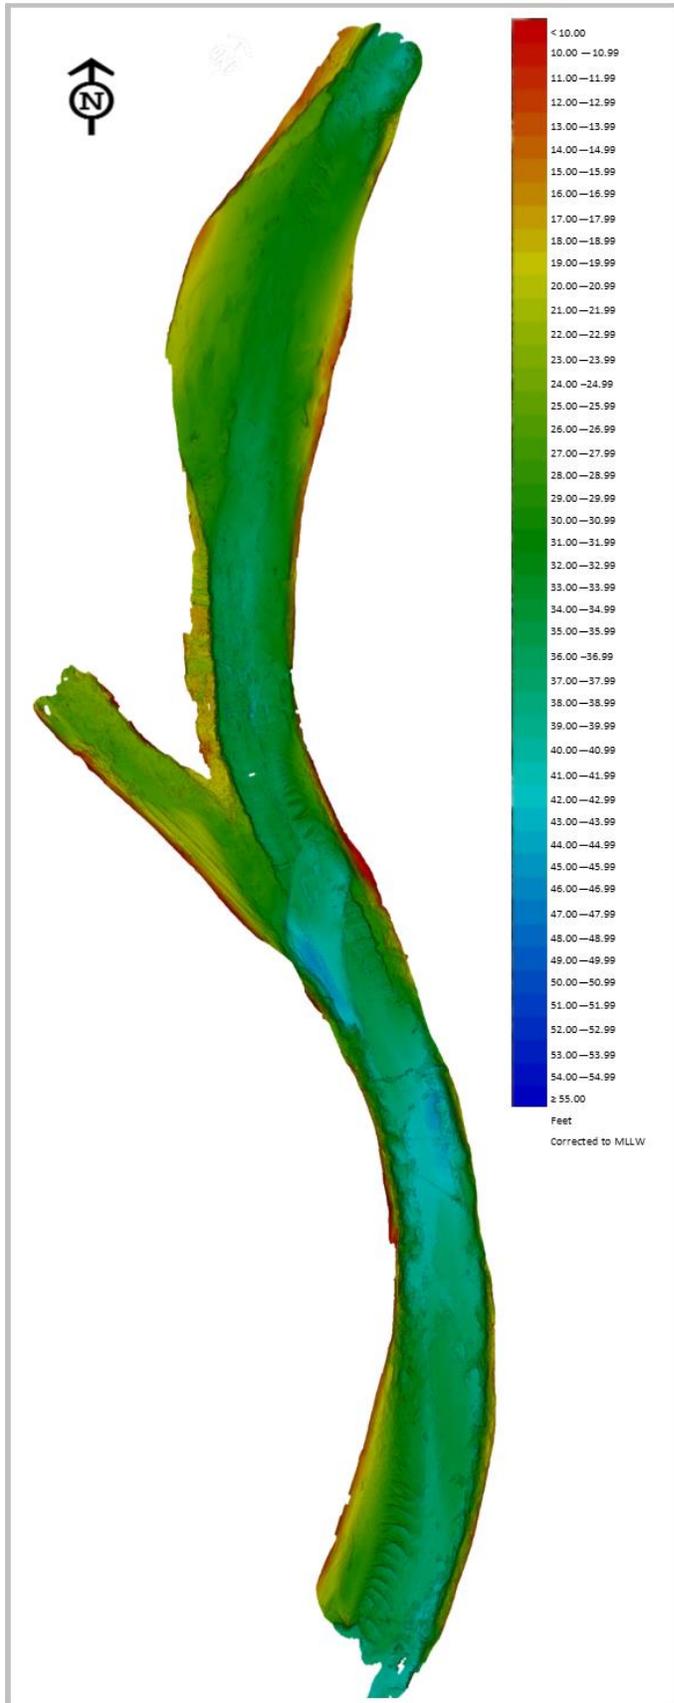
Figure 9. Multibeam Survey.

Multibeam survey conducted over part of the study area – from the Cape Fear Memorial Bridge (most southern location) to the Isabel Holmes Bridge (most northern location). A small portion of the main-stem of the Cape Fear River was also surveyed to view the bottom profile at the bifurcation. Depth measurements have been corrected to Mean Lower Low Water (MLLW) and range from < 10.00 feet (red) to ≥ 55.00 feet (dark blue).

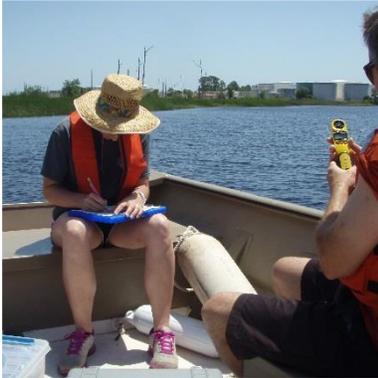
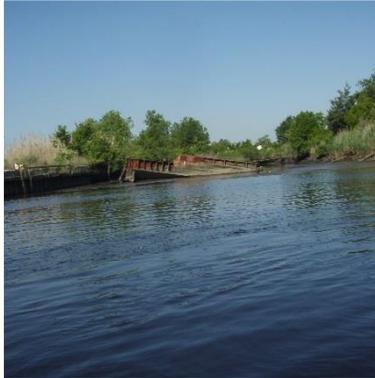
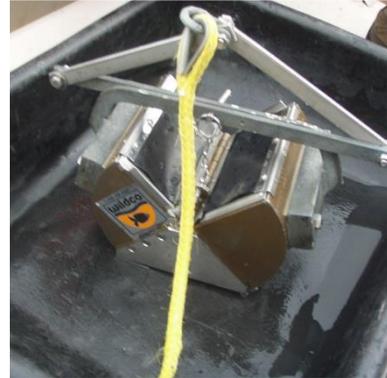
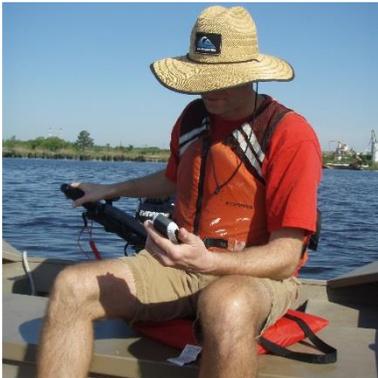
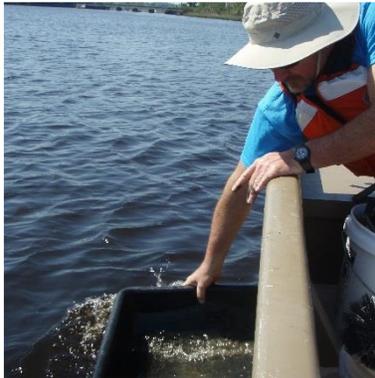
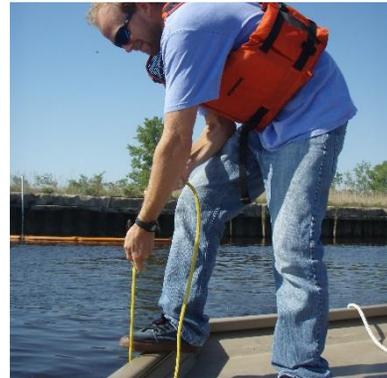
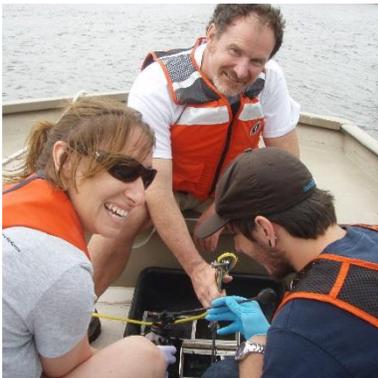
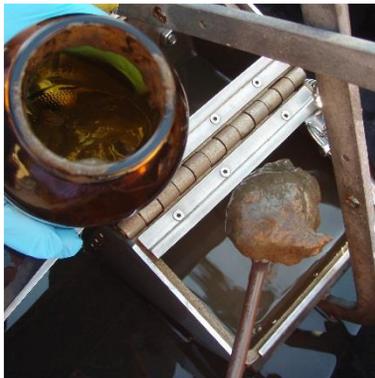
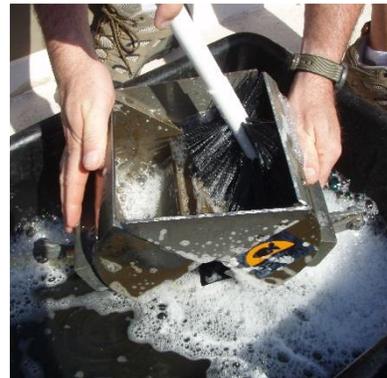
(a) Ambient environmental data being collected with Kestrel (near-field, yellow instrument in photo); (b) site photo at Mid-river B subsampling site – notice a portion of the railroad bridge on the shore; (c) petite ponar grab in Teflon tub; (d) boat captain using GPS to maintain positioning over subsampling site; (e) site water rinse of Teflon tub; (f) deployment of ponar grab off bow of boat; (g) sediment sample being scooped from ponar into jar; (h) sediment sample on pre-cleaned Teflon coated spoon being transferred into jar; (i) Liquinox cleaning of ponar.

Once on site of a sampling location, a common lead line was used to ascertain depth, a YSI-ProPlus multiparameter meter was used to collect water parameters (temperature, salinity, conductivity, pH, and DO), a Kestrel weather meter was used to ascertain weather data (air temperature, barometric pressure, and wind speed), and a Garmin GPS was used to record the precise location of the sample as well as accurate tide/current data (Figure 10a). After ambient conditions were recorded, a digital field camera was used for photo documentation of the site (Figure 10b).

The samples were then collected using a Wildco stainless steel petite ponar grab attached to a polypropylene rope. The grab and a Teflon-coated, stainless steel sample spoon were cleaned prior to the commencement of any field work each day by soaking in a large Teflon tub filled with a Liquinox solution for several minutes, followed by a thorough scrubbing with a cleaning brush. The grab, Teflon spoon, and Teflon tub were then rinsed with deionized water and allowed to air dry. During field collections, when not in use, the grab and Teflon spoon were placed in the Teflon tub to maintain a barrier between the sampling equipment and the boat in order to prevent contamination (Figure 10c). Sediment sampling was performed using a “live-boat” sampling technique in which the boat captain attempted to maintain a static position in the water, but no anchor was set (Figure 10d).

When the boat was in position, the gear technician rinsed the pre-cleaned sediment grab, Teflon spoon, and Teflon tub in site water (Figure 10e). The grab was then lowered slowly over the edge of the boat to the bottom ensuring that the grab did not cause a wash-out of the surficial sediment layer (Figure 10f). Once lifted to the boat, the grab was placed into the Teflon tub.

Photos were taken of the undisturbed sediment surface before removal from the grab. Sediment was scooped from the grab by a second technician wearing clean nitrile gloves using the pre-cleaned Teflon spoon (Figure 10g). Approximately 300-350mL of sample were scooped from the center of the grab, representing the top 5-13 centimeters of surficial sediments. Samples were kept in certified, pre-cleaned, 500mL, amber glass jars with PTFE-lined polypropylene caps. Care was taken not to touch the

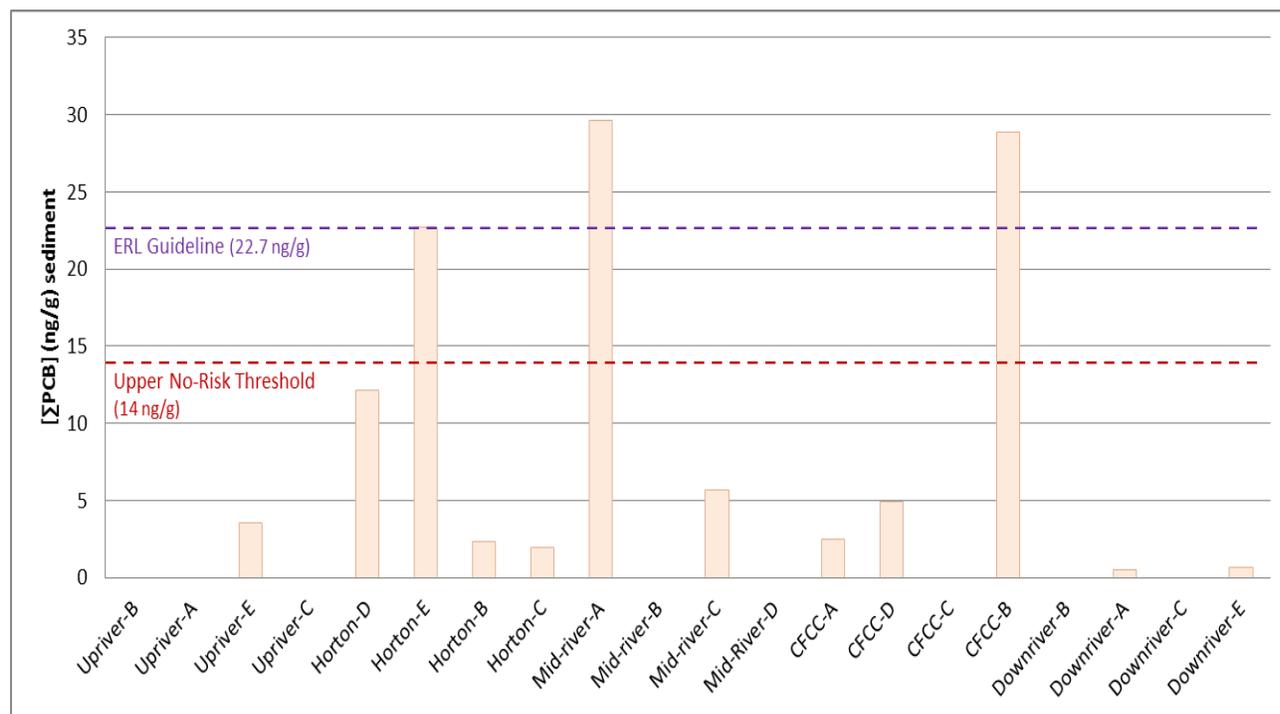
Figure 13. Σ PCB (ng/g) by Sample for 20 Sediment Samples.

Upstream data are shown on the far left and downstream data on the far right (downstream gradient from left to right). As described in the text, concentrations below the Effects Range-Low (ERL) guideline value (shown in purple) for total PCBs have been shown to rarely be associated with harmful effects in aquatic organisms. The No-Risk Threshold used for this study ranged from 3.6×10^{-6} to 14 ng/g for total PCBs in sediment (dry weight). The upper limit of that no-risk threshold is shown in red.

Σ PCB concentrations were found in excess of 10 ng/g for two sediment samples in the Horton basin (Horton-D and Horton-E), one sediment sample in the mid-river grid (Mid-river-A), and one sediment sample in the CFCC basin (CFCC basin-B) (Figure 13). Furthermore, Σ PCB concentrations were found to be the highest within the approximately 34-acre area of the Horton basin sub-sampling grid (39.15 ng/g). The next two highest Σ PCB concentrations were found within the approximately 300-acre Mid-river (37.53 ng/g) and the approximately 3-acre CFCC basin (36.20 ng/g) sub-sampling grids. Only one sample from the Upriver grid (approx. 187-acre area) and two samples from the Downriver grid (approx.
