Performance Surveillance of Gentilly-1 Reactor Building GFRP Repair Using Fiber Optic Sensors and Strain Gauges

The primary purpose of this paper is to present the 8-year performance of the repaired concrete and the sensor technologies used. The outcome of this study does promote confidence in the new repair technologies adopted in the Gentilly-1 containment ring beam.

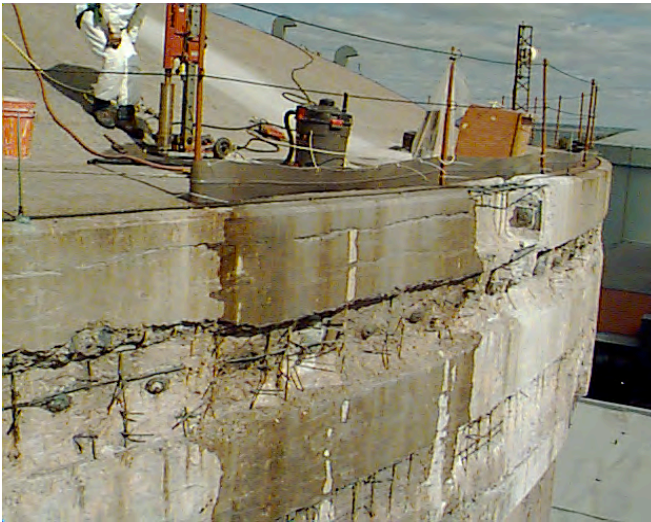
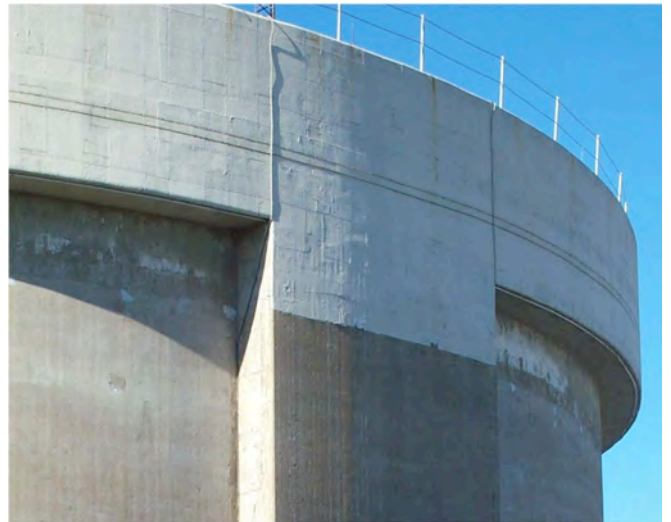
a) Before repair, 1999

b) After repair, 2008

Figure 2 Ring Beam Before and After Repair

Prequalifying work was carried out to test the repair method prior to application. Figure 2 shows condition of the ring beam before and after repair.

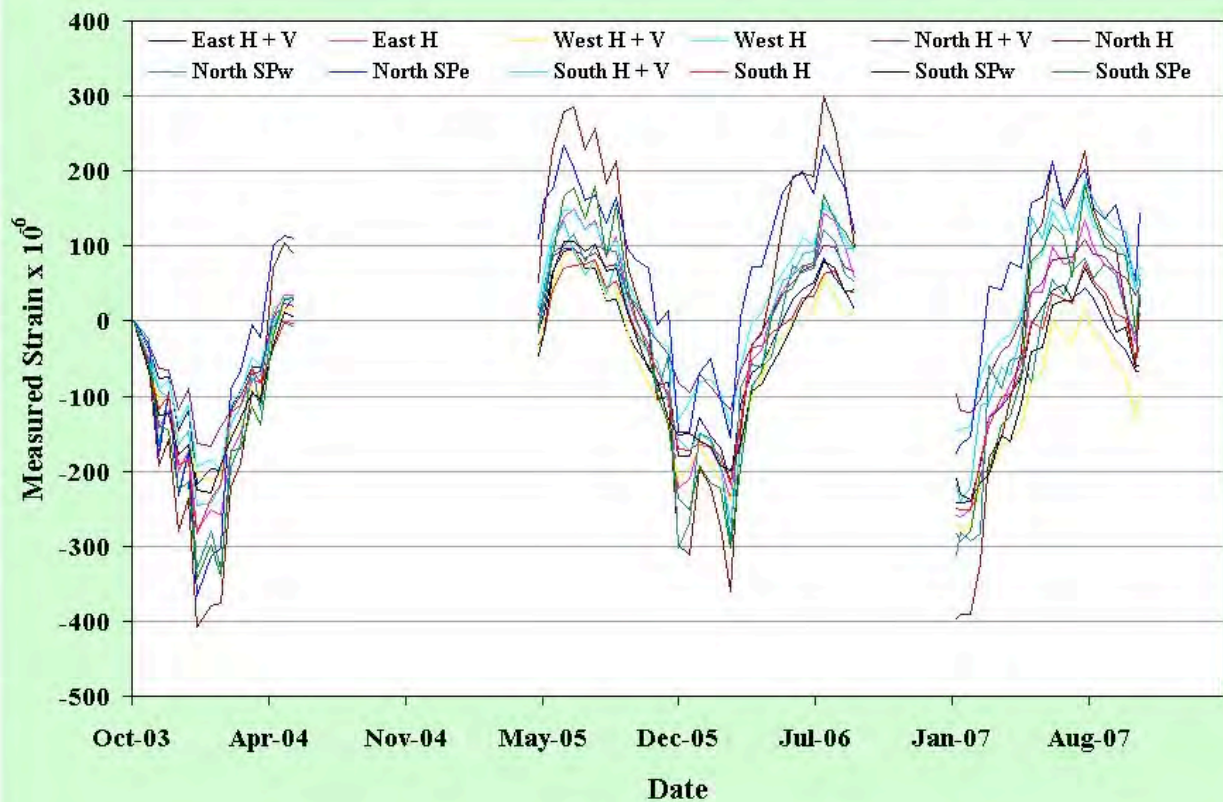
Figure 7 FOS – Measured Strain

The FP-FOS measured strains are illustrated in Figure 7, where all initial values are set equal to zero in October 2003. The coefficient of thermal expansion of the FP-FOS is small ($-0.5 \mu\epsilon/^\circ\text{C}$). Thus, the trend of measured strain shown in Figure 7 is similar to the temperature variations (Figure 8) even without compensation for temperature effect of the FP-FOS. The temperature measured inside the reactor building (shown with thick lines in Figure 8) does not change as fast as temperature outside, which reflects variations in rapidly changing weather conditions, such as presence of sunlight. The difference between inside and outside temperatures indicate a significant temperature gradient; hence the associated stresses in the ring beam.

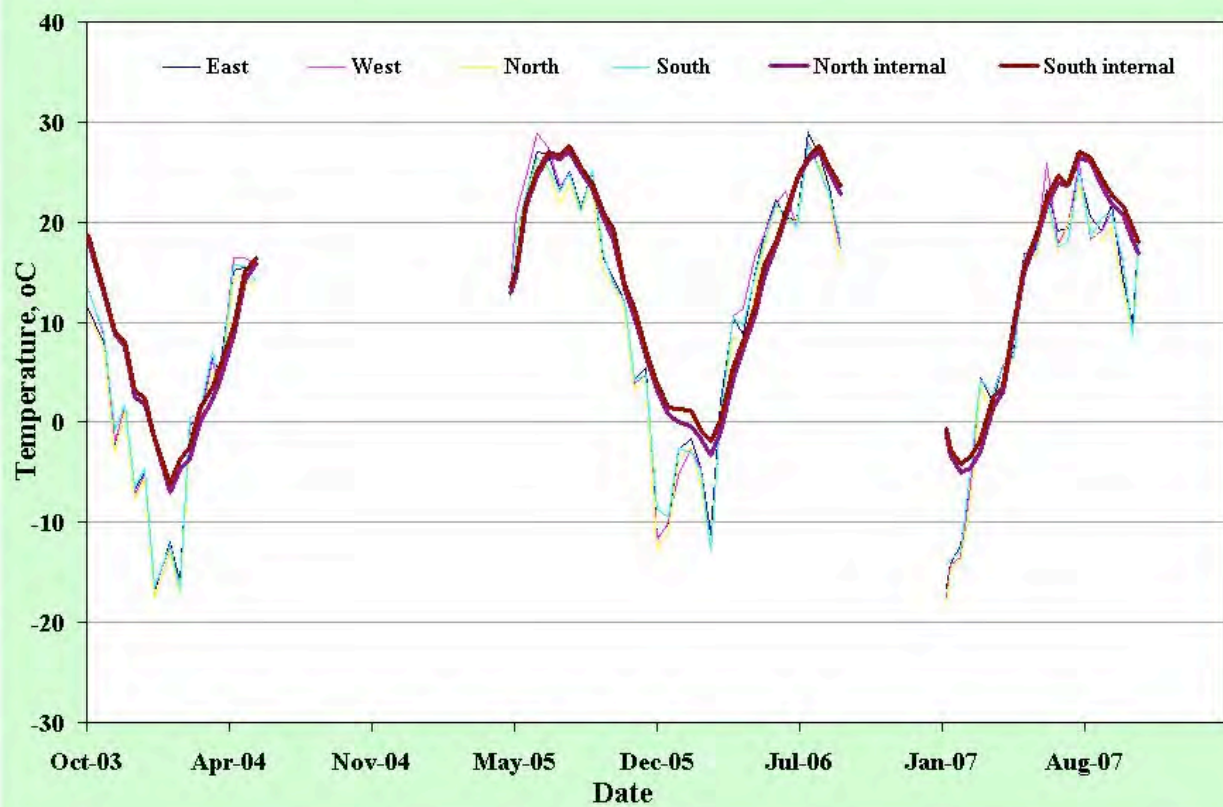
Figure 8 FOS – Measured Temperature using Thermocouples

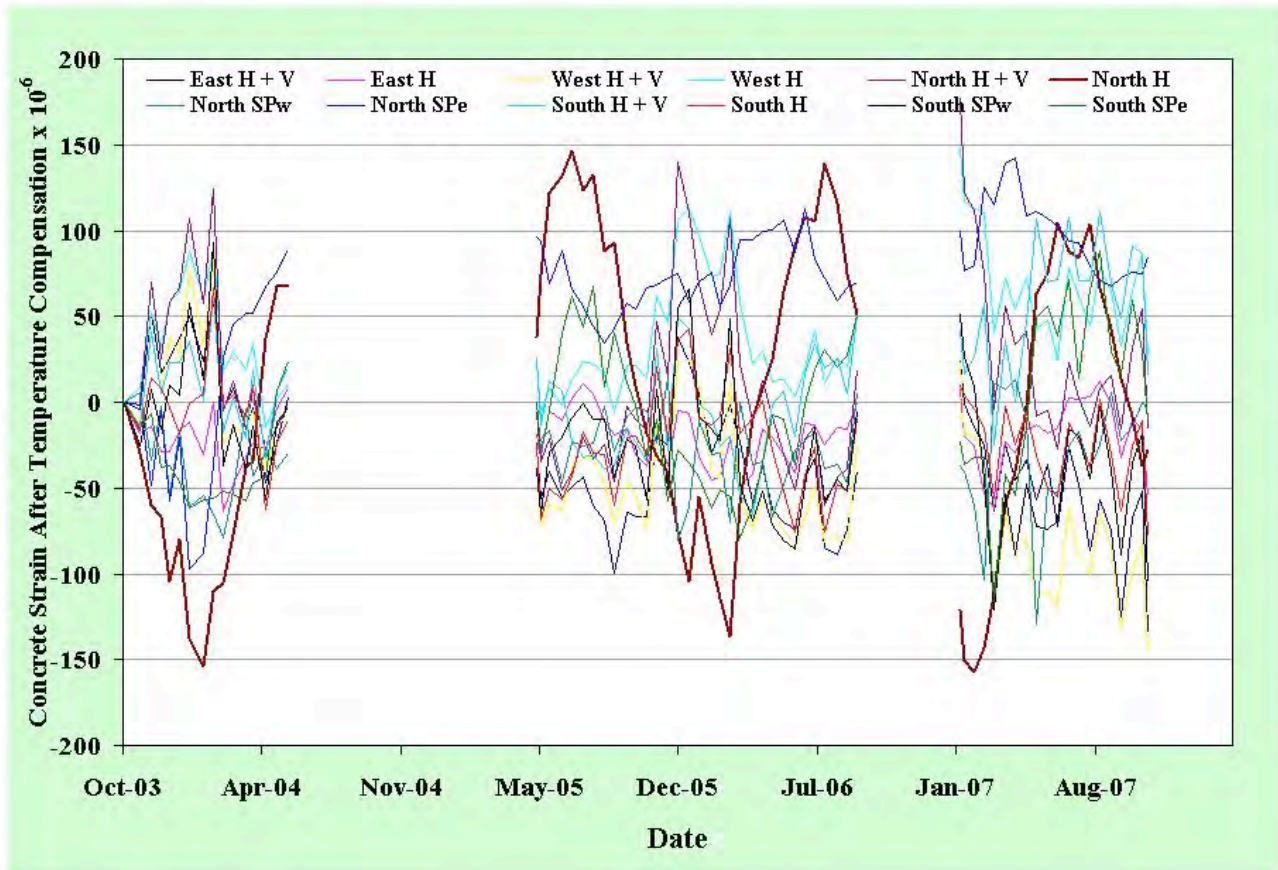
Figure 9 FOS – Concrete Strain after Temperature Compensation

The approximate concrete strain induced due to temperature effects is subtracted from total concrete strain, yielding a relatively uniform strain (oscillating between -100 and $100 \mu\epsilon$). This is shown in Figure 9, revealing that the gauge sensor measurements are strongly controlled by temperature variations causing strain in the concrete. In general, sensors located on North and East side indicate lower strain than those located on the South and West side because of higher temperatures observed on the South and West. It should be noted that the frequency of data collection varies greatly between VWSG and FOS: Figure 5 shows a plot of VWSG data on a monthly and then semi-annual basis, while FOS data in Figure 9 is plotted on a weekly basis.

Sensors located on the horizontal strip (designated H) do not indicate the same strain as those located on the horizontal and vertical GFRP strip (designated H+V) although general trend is similar. It is likely that additional layer of the GFRP provides extra insulation, resulting in different temperature variations, thus strain. The FP sensors in the smart patches are designated SPe and SPw and show similar strain as the other FP sensors.

In Figure 9, the behavior of one sensor, as shown with thick line, is somewhat different from the other sensors. It is located on the North side of the ring beam. This unique behavior is speculated to be attributed to the different coefficients of thermal expansion for different concrete mixes. The coefficients range from 6

to 13 $\mu\epsilon/^\circ\text{C}$. The value of 10 $\mu\epsilon/^\circ\text{C}$ has been used in the calculations. However, repair pockets were shallow on the North side and in some places old concrete that (at the time of the repair) did not show significant deterioration was left in place.
