RUTHRAUFF, ALICIA ANN. The Effects of Pulsatile Fatigue on *in situ* Radiofrequency Fenestrated Endovascular Stent Grafts Deployed Inside a Semi-Realistic Model of an Aneurysmal Abdominal Aorta. (Under the direction of Dr. Martin W. King).

© Copyright 2013 by Alicia Ann Ruthrauff

2013

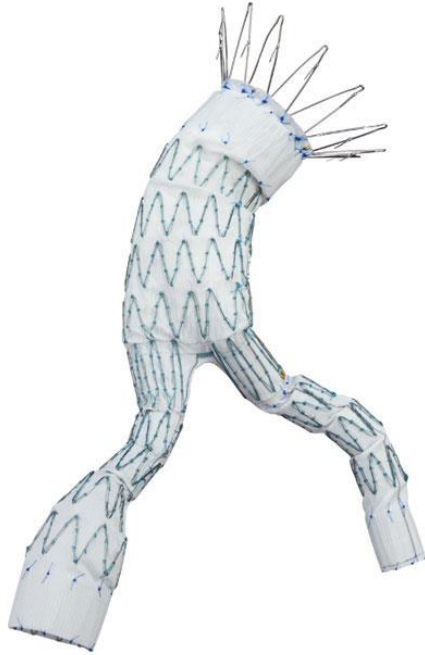
Figure 10: The Cook Zenith Flex[®] Stent Graft with all components assembled. The contralateral limb is on the left in this image. [44]

Both ends of the ipsilateral iliac extension have the last stents sewn inside the lumen to create a better seal when deployed. The contralateral extension is made the same way, and also flares out at the bottom to prevent endoleaks and create a better seal.

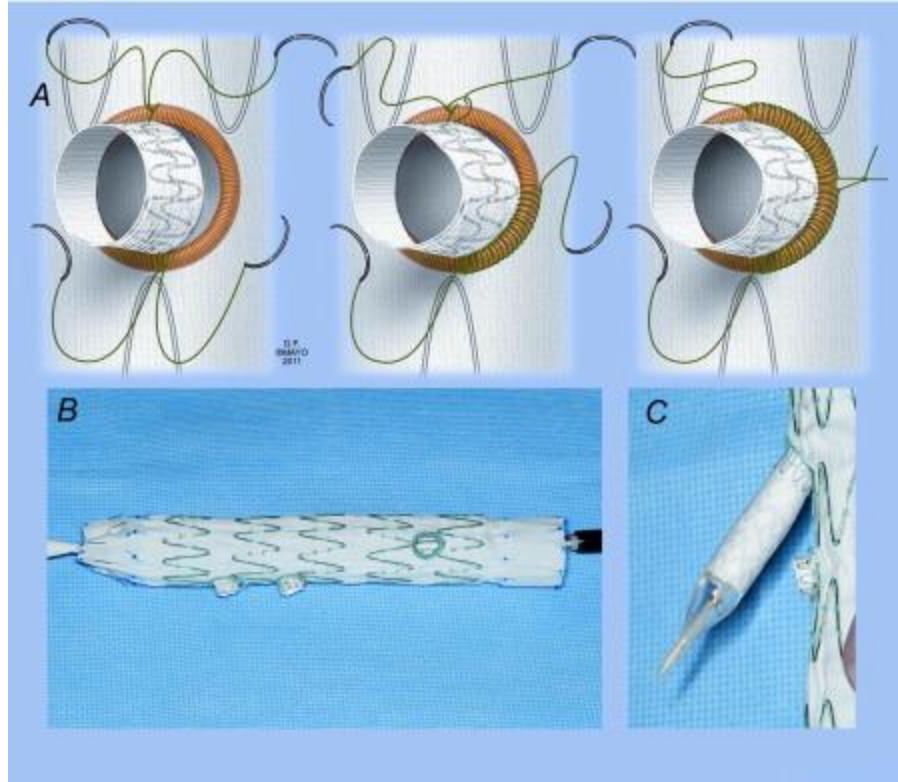
Figure 14: Image from Oderich et al showing mini-cuff reinforced fenestrations [9].

Oderich et al modified a TX2® Cook Medical off-the-shelf pre-fenestrated device by adding reinforced mini-cuffs to the fenestrations. This was done on-site in the operation room. An 8-mm Viabahn stent graft (W. L. Gore, Flagstaff, Ariz) was cut into 3-5 mm long pieces then sewn onto the fenestrations using Ethibond sutures (see Figure 14). The fenestrations were for the superior mesenteric artery, the celiac artery, and the right renal artery, as the patient's left renal artery had been bypassed during a previous open repair. The device was then deployed and the gap between the vessels and the mini-cuffs were each bridged using three different stent grafts deployed inside each other at intervals to reinforce each other and prevent kink. After completion the target vessels were patent and there was no evidence of endoleak [9].

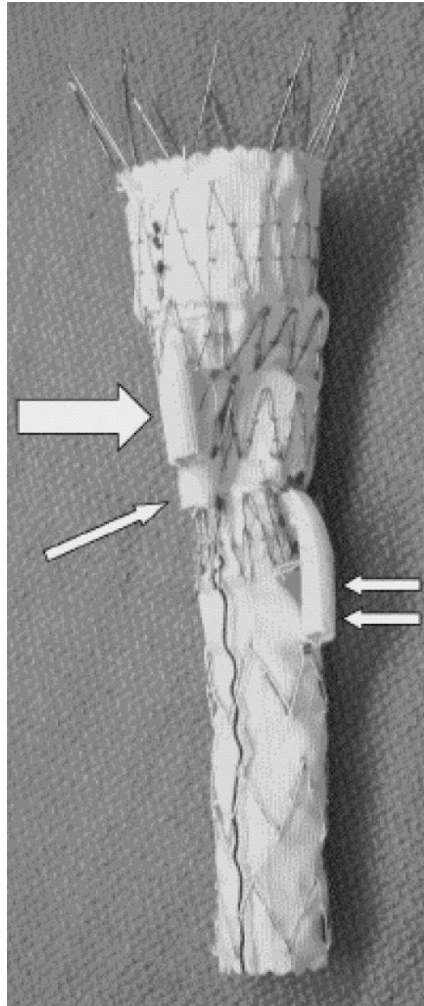
Figure 15: The branched custom structure created by Tse et al. The large arrow is the celiac branch, the small arrow the superior mesenteric branch, and the double arrows the renal branch [13].

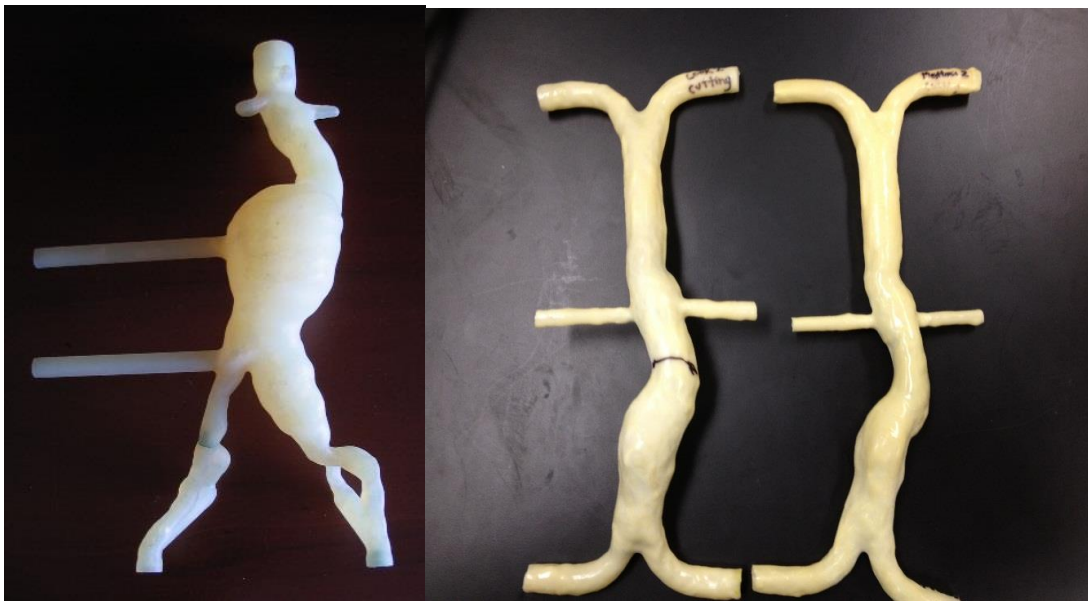
Figure 17: The initial model created by Allard et al on the left, two samples of the modified version on the right [58].

abdominal aneurysm were kept the same. The renal stubs from the original design were hollowed out and lengthened to create full renal arteries. The superior mesenteric stub was removed. The iliac limbs were made the same diameter and given enough length to attach to the ports on the fatigue tester. The biggest change was at the proximal aortic end. The aorta was split into two branches, similar to the iliac limbs, in order to be able to attach them to the fatigue tester. The initial model and the modified version can be compared in Figure 17. Four phantoms were manufactured based off of this design. It should be noted that due to the way the polyurethane was coated on, each phantom was slightly different. The overall anatomy of each was the same, but the wall thickness varied in certain spots. This combined with the different internal geometry of the four different stent grafts made it so that each device had to be tested slightly differently on the fatigue tester.

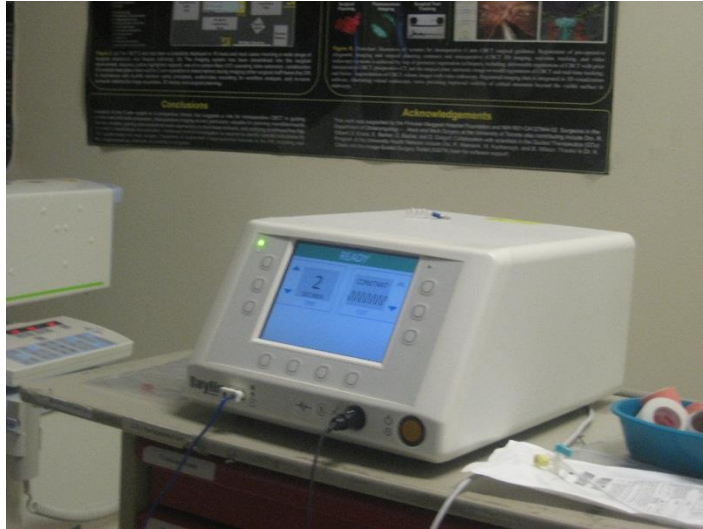
Figure 19: The Baylis Radiofrequency Puncture Generator

manipulated into a shape and stay in that shape, convenient for a tortuous anatomy. It can also be used like a normal guidewire to be physically pushed through occlusions, which was useful in this study as the fabric, especially the Zenith graft fabric, turned out to be quite tough and need the mechanical force in addition to the radiofrequency energy to be fully punctured.

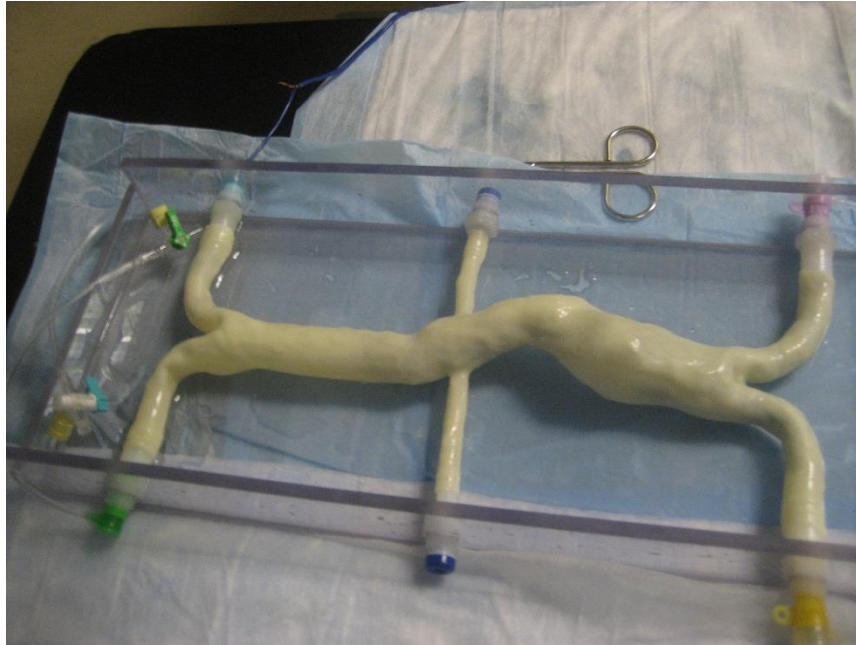
Figure 20: The custom bath with one of the phantoms mounted.

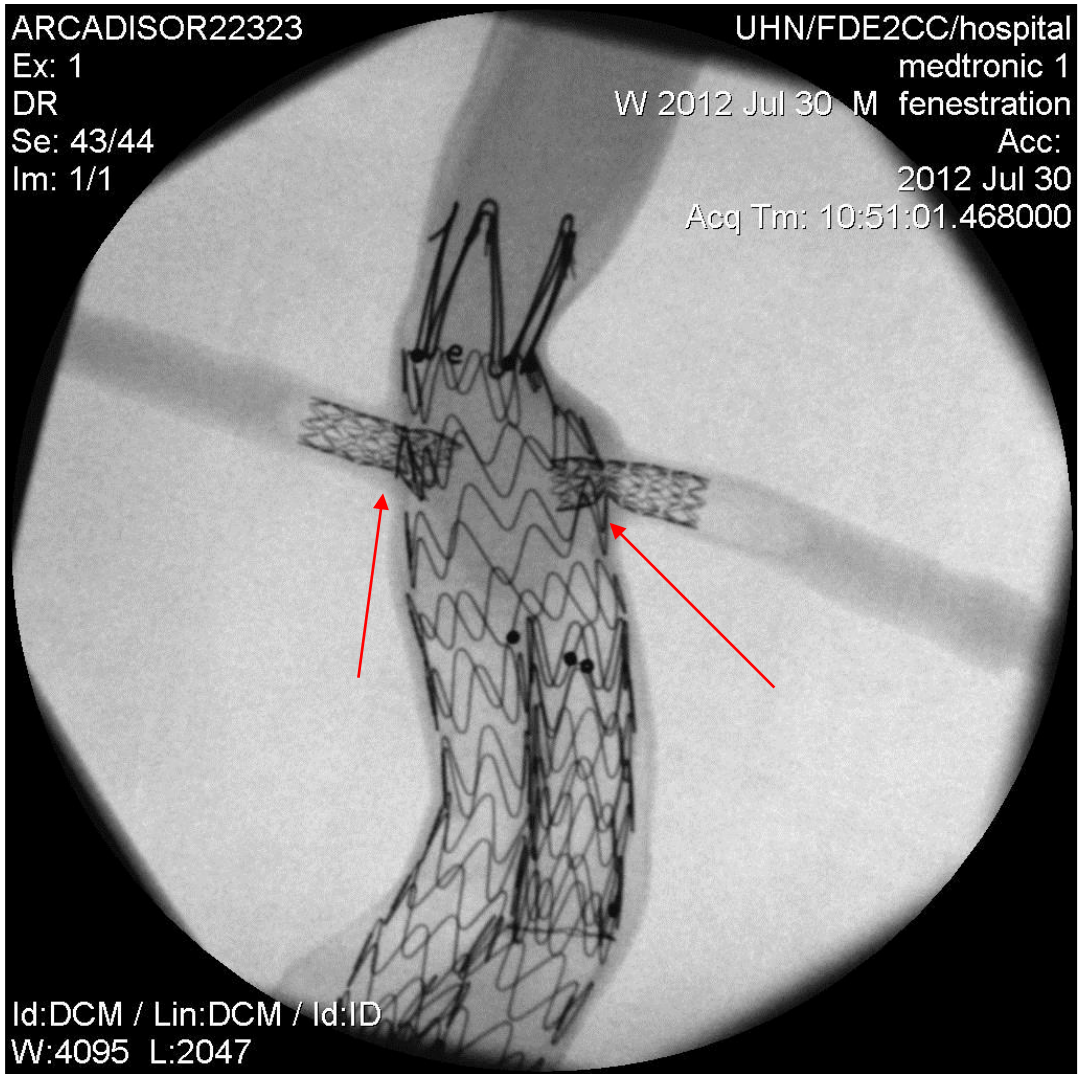
Figure 21: Finished deployment and fenestration of GM1 device. Note the waists, especially at the patient left renal artery.

through the port to 'snare' it. This was done because of the short length of renal artery available. A four French catheter was pushed into the renal artery, and the RF wire was exchanged for a regular guidewire (0.018"). A 3mm angioplasty balloon was inserted through the fenestration and dilated under manometer to 10 atm. No significant waist was seen, which is to say, the fabric did not pinch the balloon to a smaller diameter. The balloon was replaced with a 4mm balloon in the same position and dilated the same way, again not seeing a significant waist form. The 0.018" guidewire was replaced by a stiffer 0.035" support wire and a seven French curved catheter advanced up to the opening. It was not physically able to be advanced into the renal artery itself, so it was left in the aorta while the 6mm balloon-expandable Atrium graft was positioned so that two thirds were in the renal artery and one third was in the aorta. It was expanded under manometry to 16 atm, then 20 atm after a waist was seen. A waist still remained, and it was still impossible to advance the 7Fr sheath. A 10 mm angioplasty balloon was used to flare the end of the stent graft that remained in the aorta. This is done to prevent the renal stent from advancing further into the renal artery. The specimen was examined, and the procedure for the left renal artery was completed and all instrumentation removed. The right side was repeated in the same way but there were difficulties due to the short main body. A combination of several different catheters was required. Eventually the longer angled catheter worked. The finished deployment can be seen in Figure 21. Note the waists at the junctions of the renal arteries and the stent grafts.

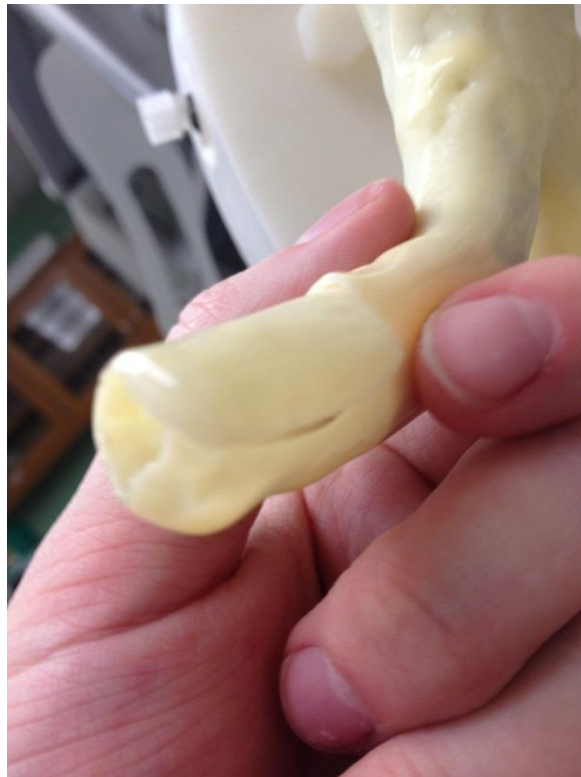
Figure 26: The tear along the contralateral iliac artery of the GM2 phantom

The displacement for this device was set at 1 mL for the high displacement and 0 mL for the low displacement, and a frequency of 50 Hz. There were no unexpected shutdowns during the cycling of this device. The contralateral limb of the phantom had a tear in it that ran up from the edge to part of the way up the limb (See Figure 26). To be able to properly seal it, a small piece of copper tubing was inserted so that the silicone tape could be bound around the torn area and around the port without occluding the limb (See Figure 27).

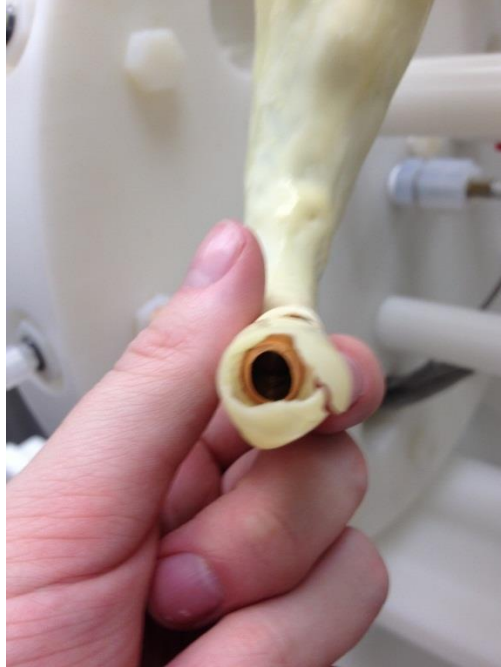
Figure 27: The piece of copper tube inserted to allow silicone tape to be bound around the tear without occluding the limb.

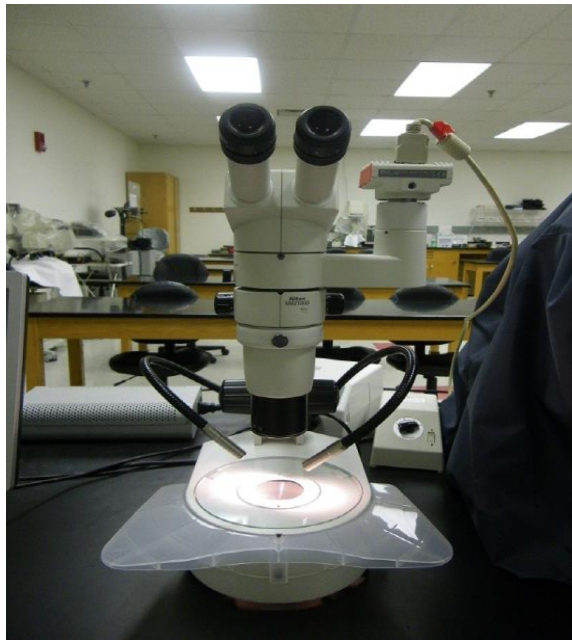
Figure 28: The Nikon stereoscope used to visualize the samples for the microscopic analysis [15].

additional holes that could not be seen during the macroscopic evaluation. Images were taken using the microscope's software from 8x magnification to 80x magnification.

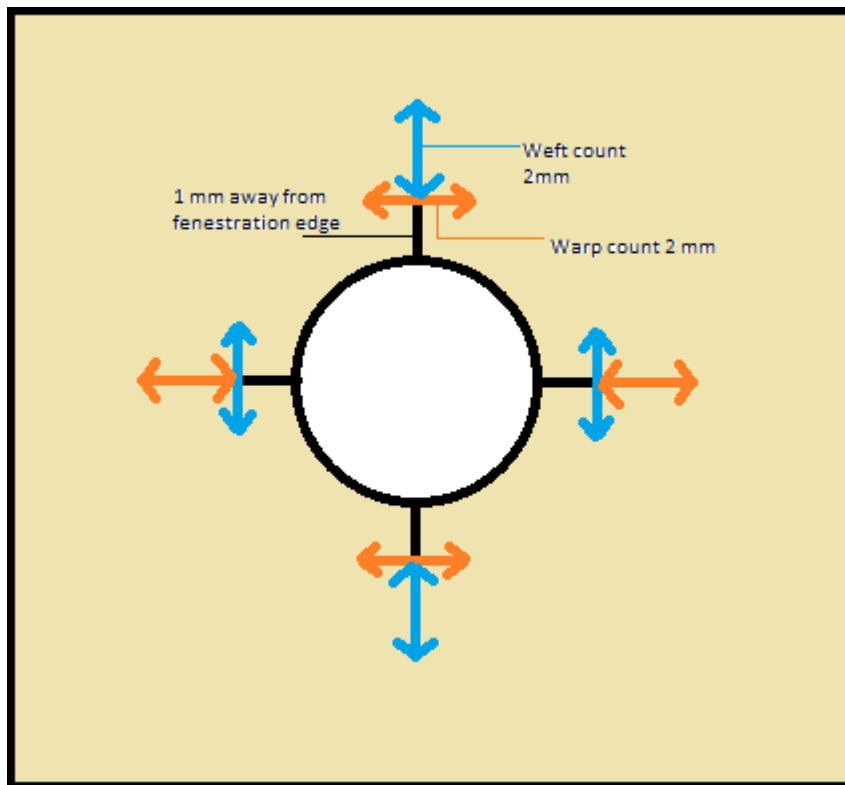
Figure 29: Showing the distance away from the fenestration where the weft and warp counts were made in each direction.

(See Figure 29). The counts were taken above, below, and to the right and left of the fenestration. These measurements taken to the top, bottom, left, and right of both fenestrations were averaged to obtain a mean warp and weft value. The logic behind this was that the fenestrations performed on each side of the stent graft were done using the same conditions and fatigued under the same conditions. A warp and weft count were also taken on unfenestrated areas of the fatigued specimens, as well as on the control samples for comparison purposes.

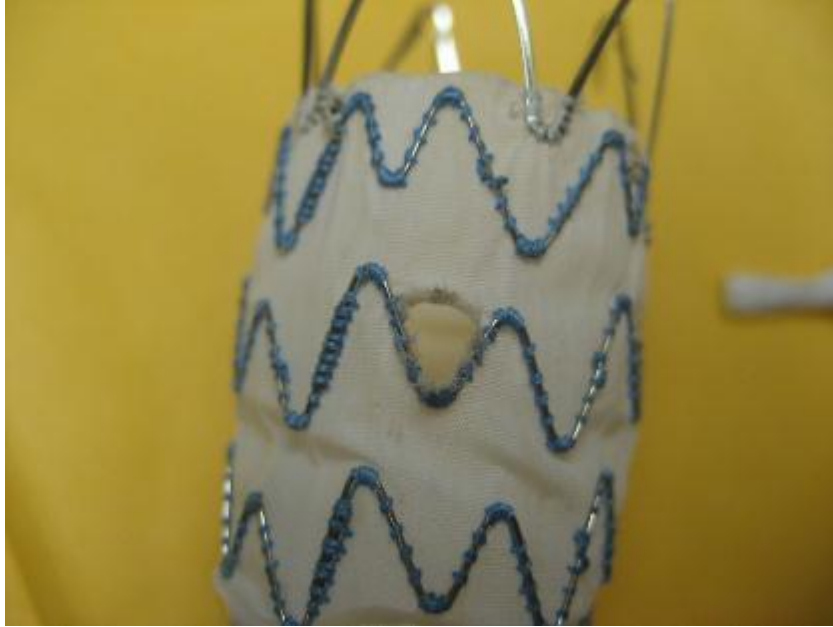
Figure 36: Showing the location of the right renal fenestration at the bottom of a 'V' stent

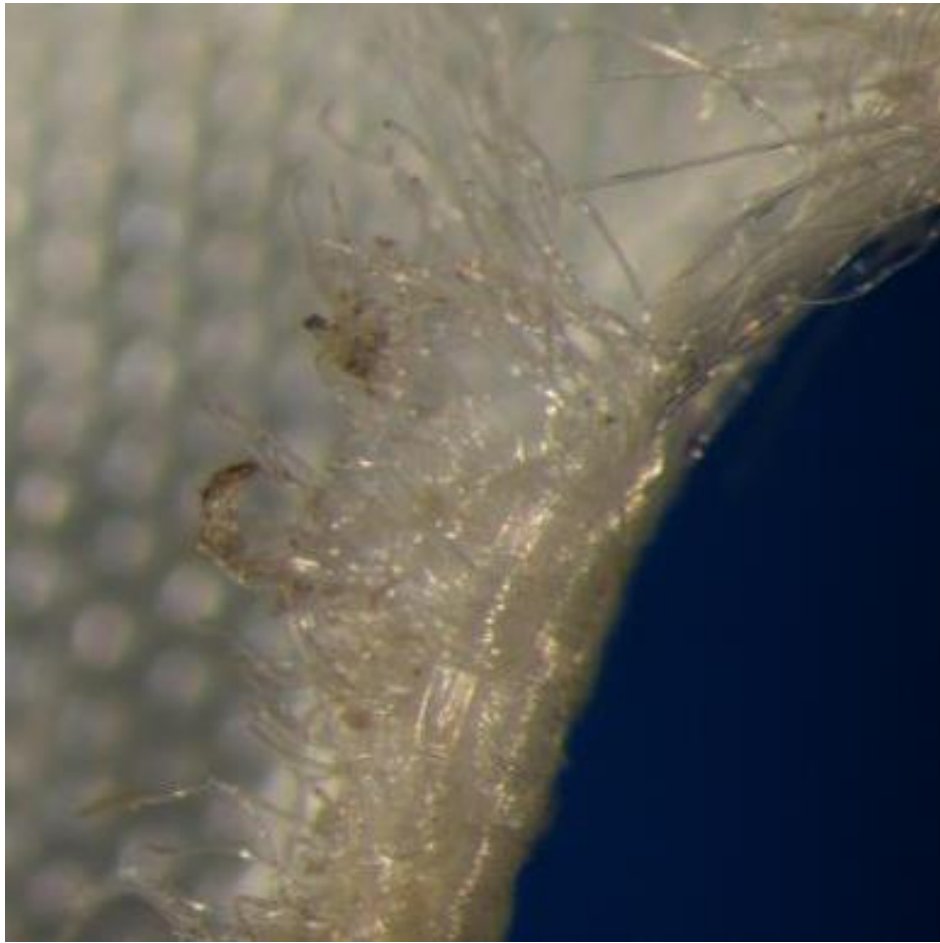
Figure 37: Evidence of fraying at the edge of the fenestration, as well as some melted and fused fibers. 40x zoom.

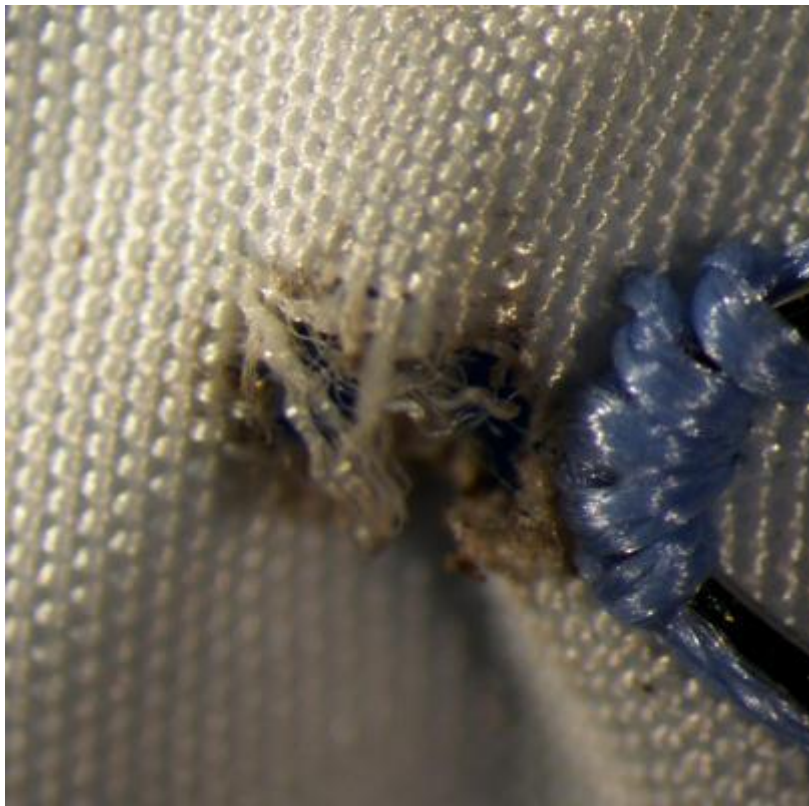
Figure 40: Hole underneath stent viewed from the top under 20x Zoom.

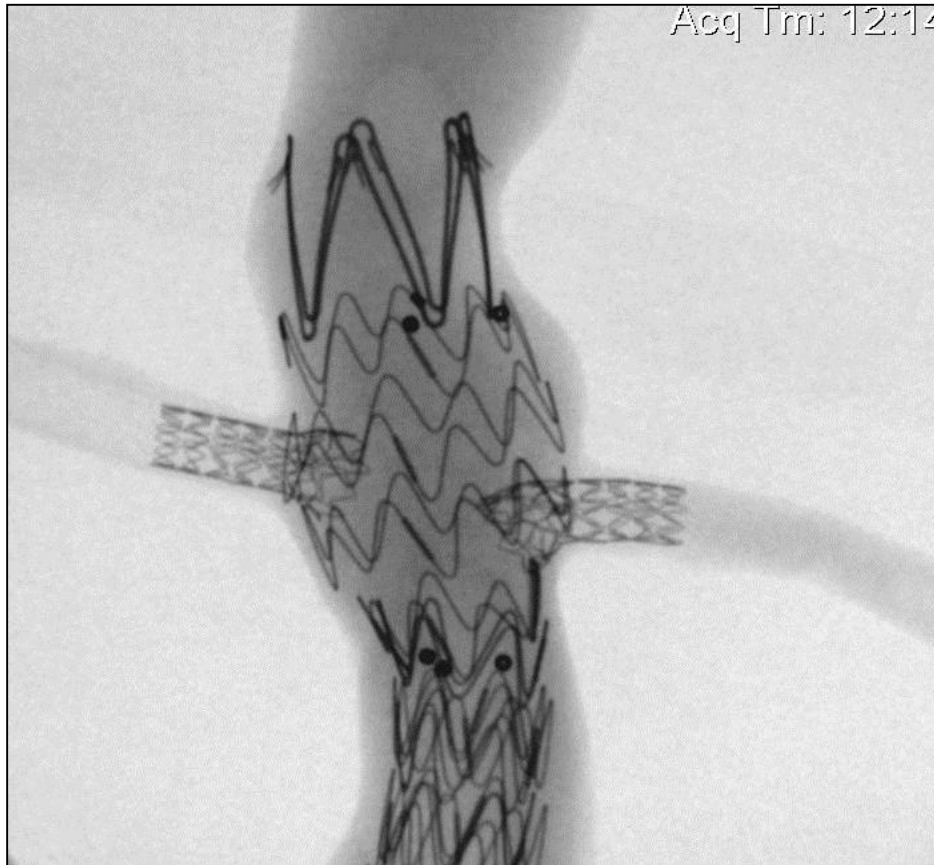
Figure 41: Fluoroscopic image of GC2 device showing both renal extensions without waist

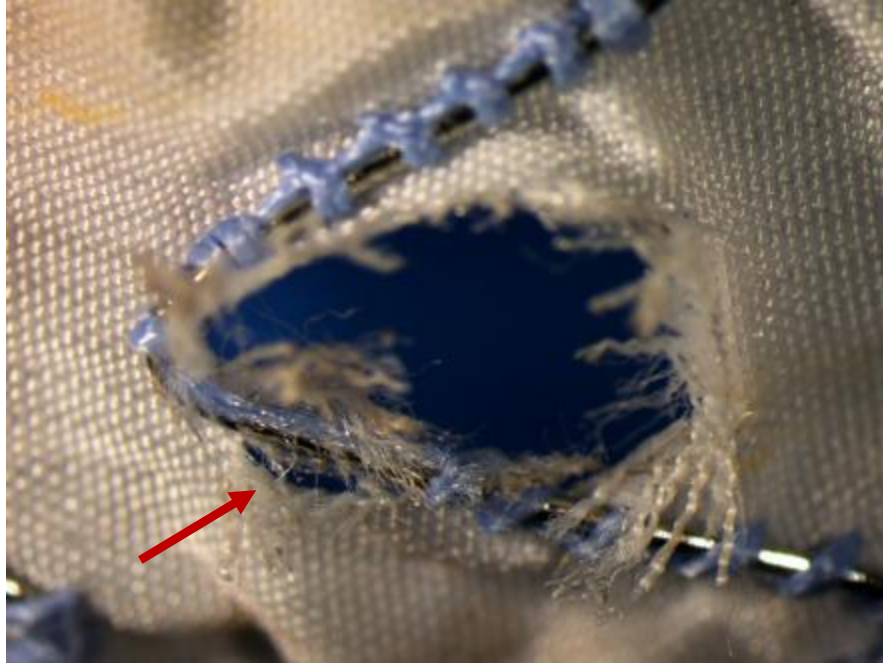
Figure 42: Right renal fenestration continuing under stent

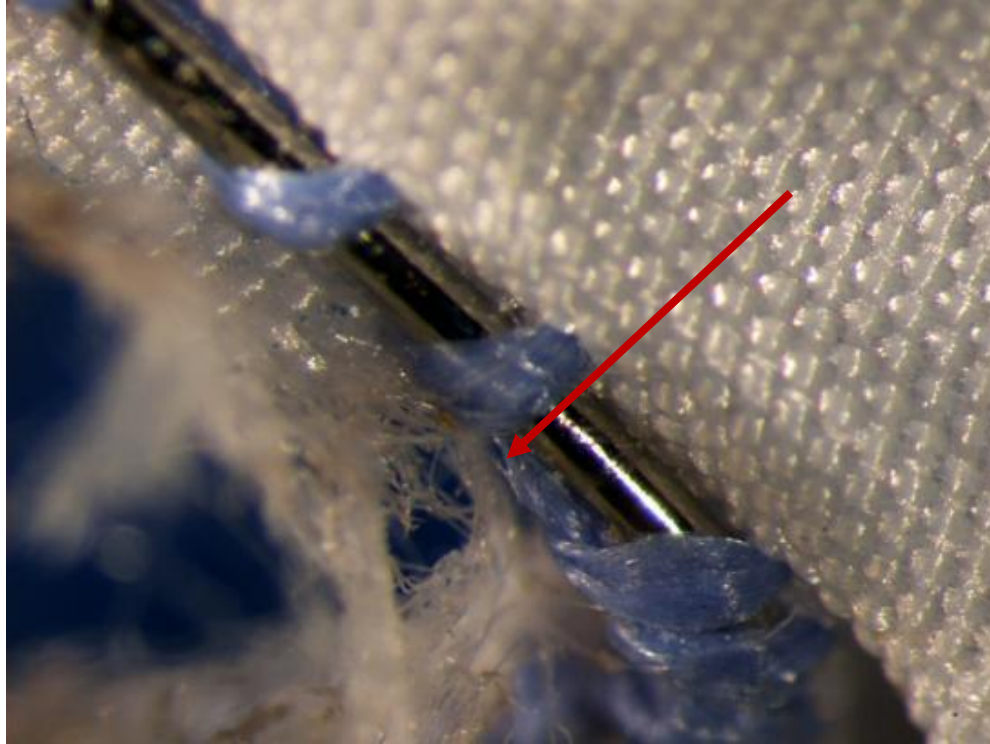
Figure 44: What could be a small raveled section on the GM2 device (30X magnification).

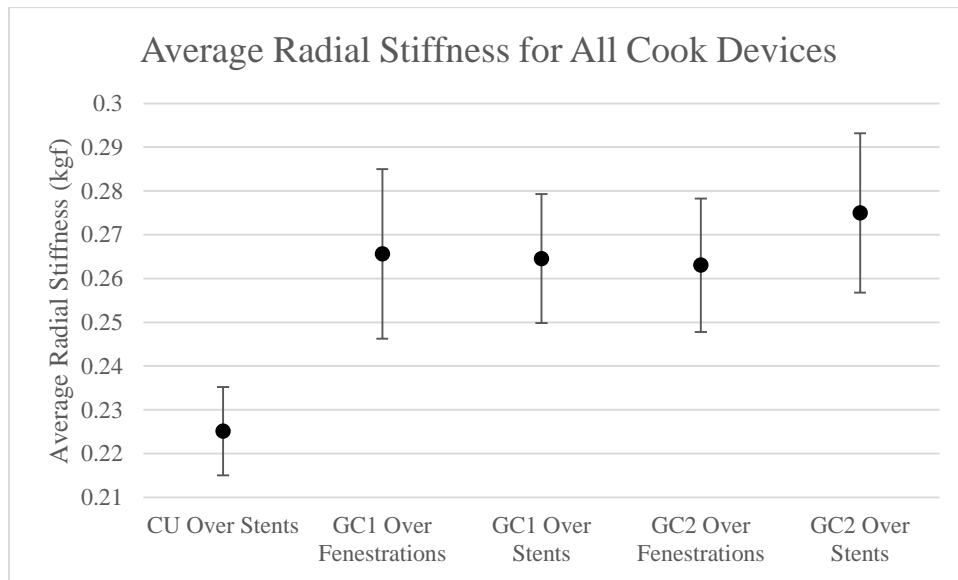
Figure 49: The Average Radial Stiffness of the Cook devices with Standard Error Bars

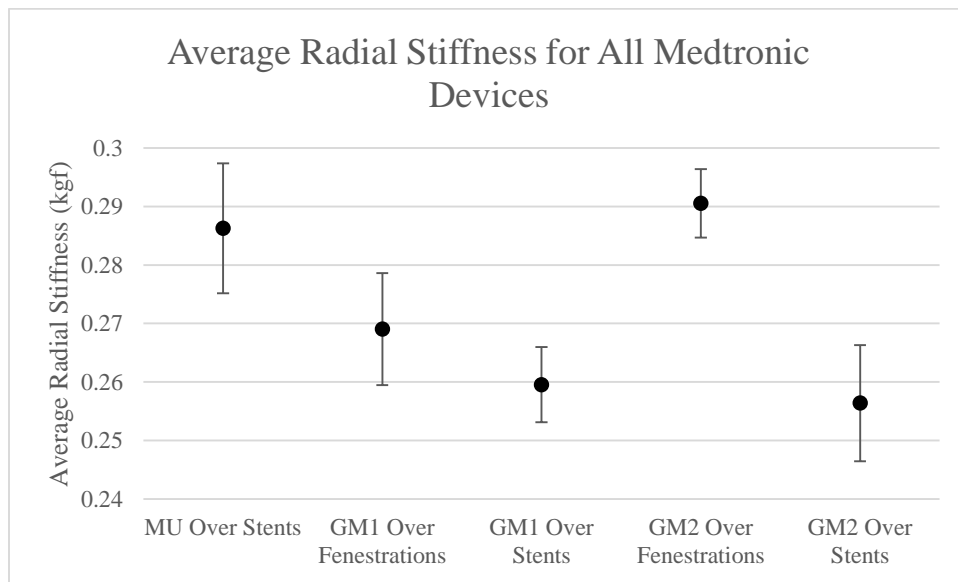
Figure 50: The Average Radial Stiffness for Medtronic Devices with Standard Error ($1.96 \cdot \text{StdErr}$) Bars
