# Qualification of Composite Liners and Pressure Tests at the Mock-up at Walldorf, Germany

## ABSTRACT

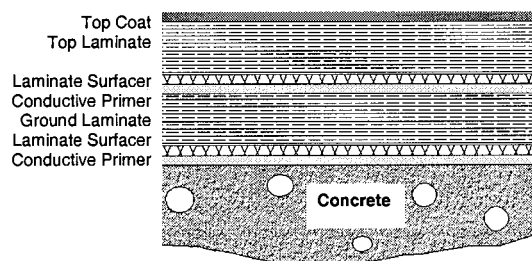
In context with the EPR project different composite liners were developed and tested with regard to the specific requirements as a leak tight barrier for a containment. Vinyl ester or epoxy resins combined with glass fibers have shown to be best suited for this purpose. The coating thickness ranges from approximately 3 to 8 mm depending on the liner design. A typical liner composition is presented below.

*Typical Liner Composition*

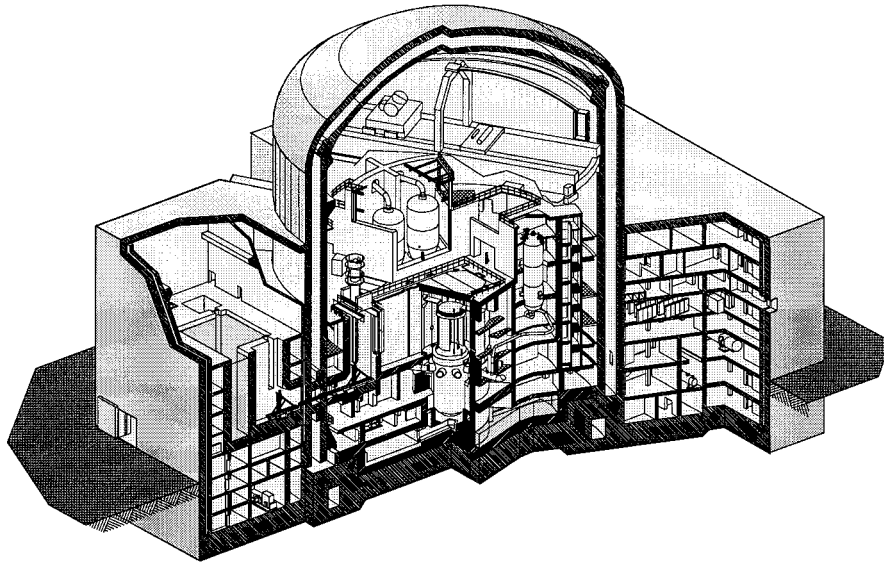
The following drawing gives an impression of the EPR – containment founded on a common raft with adjacent buildings of the nuclear island.

*EPR Double Containment*

The test and design pressure of the containment is 0,65 MPa, whereby the leak rate for a 24-hour period must be less than 1 percent by volume.

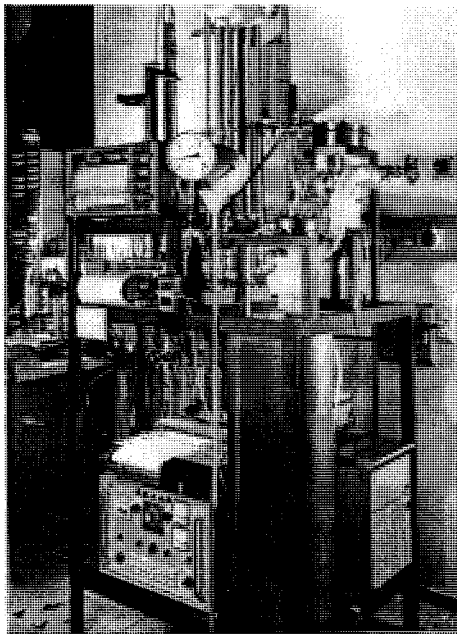
LOCA resistance means the liner systems have to be resistant against the consequences of a specified loss of cooling accident (LOCA) in terms of elevated pressure and temperature loading. Non total loss of adhesion is required after loading of the liner system with LOCA conditions. The LOCA tests were performed at Erlangen with an arrangement and under the conditions shown in the following figures. At 200°C a blow down was performed and the liner systems were loaded in accordance with the temperature loading curves shown below. The liner systems were checked on visual detectable changes and with a pull-off test according DIN EN 24 624 after a controlled cooling down. The adhesion value and the break behavior were evaluated.

*LOCA Test Installation*

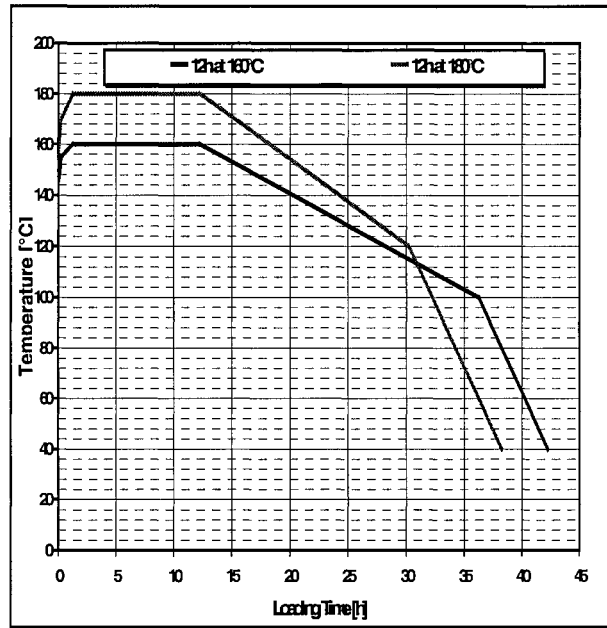
*Temperature Loading Curve*

No total loss of adhesion could be determined. The adhesion decreased for the epoxy liner system to a range of  $> 1$  MPa. Different loading times and/or loading temperatures did not significantly influence the adhesion. Only small cracks in the top coat layer could be detected after the loading. These cracks stop at the borderline between top laminate and top coat.

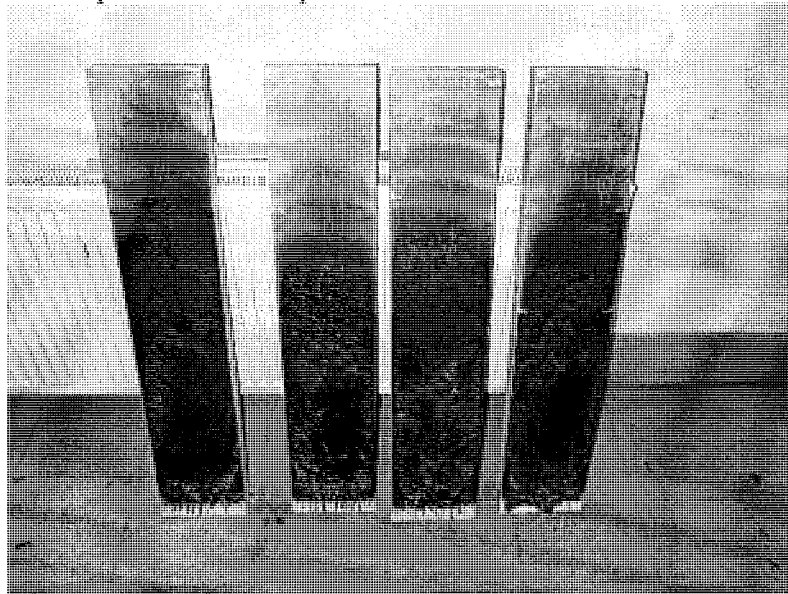
The epoxy liner was tested with respect to its fire resistance in accordance with DIN 4102 Teil1. The test specimen were placed in an oven and then the flame device was started. The duration of the flame treatment was 10 min with a flame temperature of 500 to 600°C. The epoxy liner system fulfils the requirements for a class B1 classification. The requirements are given below together with a photo of four test specimen taken after the flame resistance test has been performed:

***Test Specimen after Fire Resistance Test***  
length of non affected surface > 15 cm  
max. flue-gas temperature < 200°C

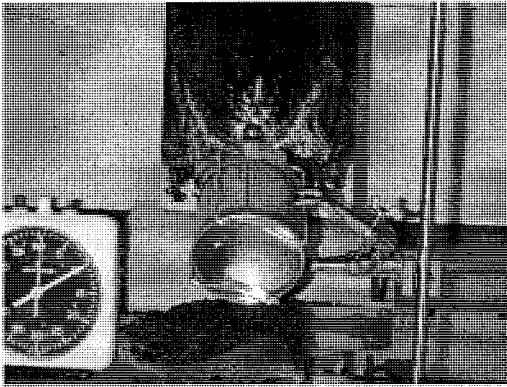
In addition further flame resistance tests were performed. The areas loaded during the flame resistance tests were directly loaded with the flame of gas burner for again 10 min (flame temperature >800°C). No flame propagation on the top coat or other degradation effects could be observed.

*Direct Flame for 10 min at 800 °C*

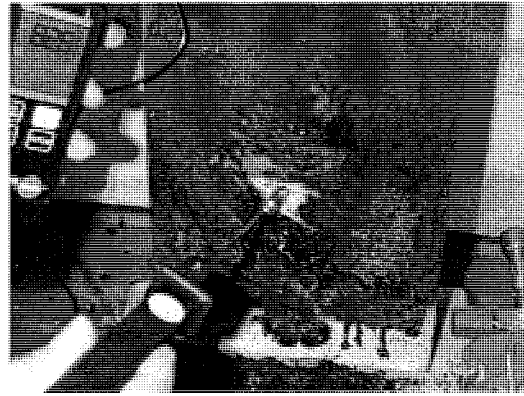
*Intact Resin under Carbonized Top Coat*

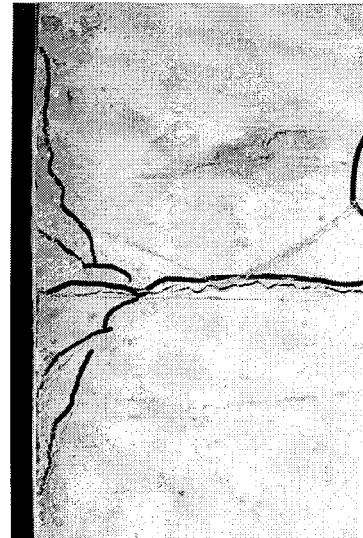
A variety of different tests to check the crack bridging behavior had been performed at the universities of Karlsruhe and Kaiserslautern in Germany and at the Hochtief laboratories. An impression of the tests and the capability of the liner to branch large cracks (within the concrete) like a crack distributing reinforcement into several single cracks (at the surface) give the photos below:

*Branching of a Crack by the Liner*

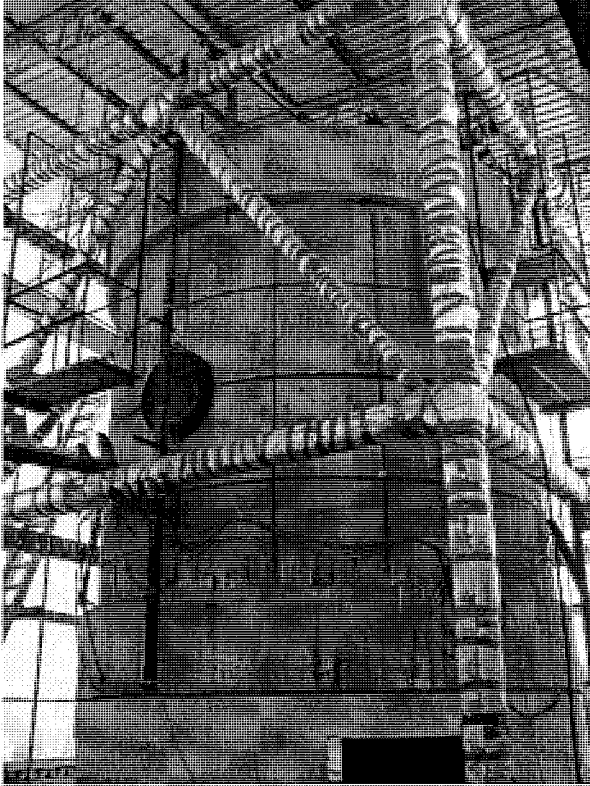
The photograph below gives an impression of the dimensions of the containment mock-up at Walldorf. It was taken on March 9, 2000, on reaching the planned limit pressure of 1,6 MPa. The internal pressure was applied by means of a water fill for safety reasons and ease of handling and leakage detection.

**Mock-up at 1.6 MPa without Leakage  
(2.7 times Design Pressure)**

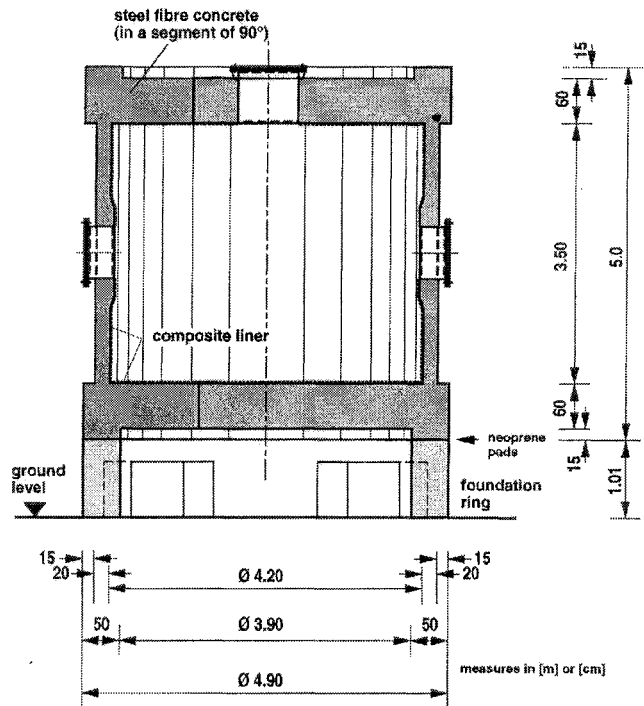
The mock-up was designed in such a way that the radial and tangential expansions arising under pressure loading are similar to those that would occur at the planned EPR containment at the same load. One segment of the containment was poured with steel fiber concrete to check its improved performance due to a better crack distribution as compared to normal concrete and with respect to interaction with the composite liner. The reinforcement of the mock-up was selected in such a way that the occurrence of large crack widths in the concrete was pre-programmed. Furthermore special measures were taken locally to provoke cracking and concentrate deformations. This enabled testing of the liner systems under extreme conditions.

**Cross Section of the Mock-up**

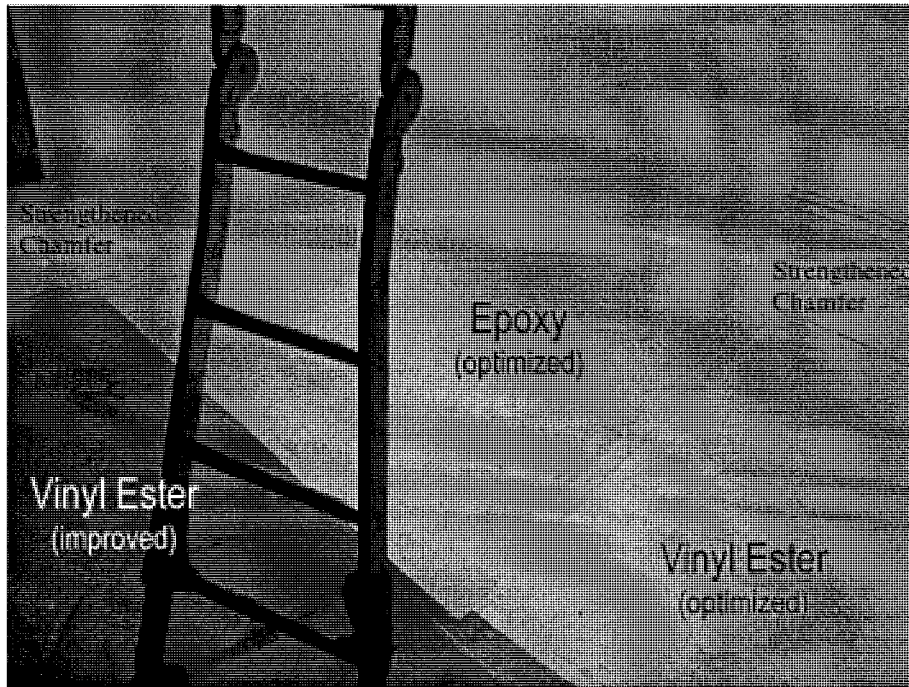
The tests were originally scheduled for completion in the fall of 1998. In the summer of that year, the preliminary liner was removed, and half of the containment mock-up re-coated with the improved liner system. Coating work on the second half had just begun when the vinyl ester liner at Civaux failed as a result of the alkali reaction described in [1]. As a result, it was decided to interrupt the Walldorf tests to enable the development of alkali-resistant systems. Two new optimized systems, one system on epoxy resin base and one system on base vinyl ester were applied to the remaining half of the mock-up. The arrangement of the liner systems in the containment floor/cylindrical section area is shown in below.

*Arrangement of the Liners with Strengthened Chamfers*

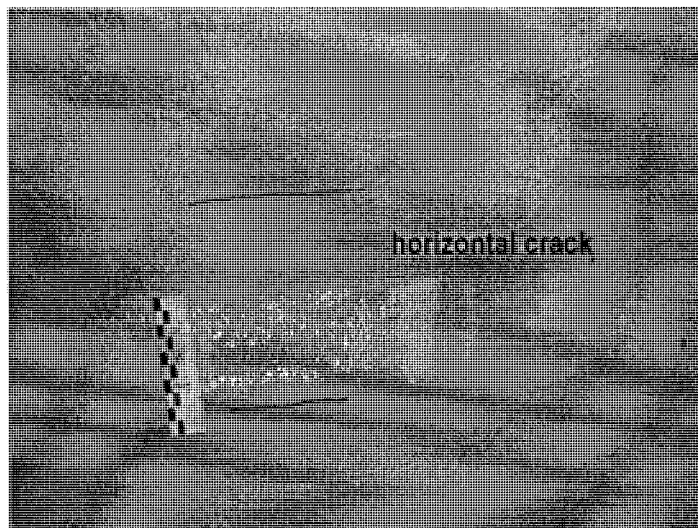
- On 21<sup>st</sup> December, 1999 at a pressure of 1.4 MPa a leakage occurred. Wet spots and water from cracks at the junction between the bottom slab and the cylindrical wall around the total circumferencial area could be observed. The pressure dropped to 1.1 MPa after an hour and to nearly 0 the next day. The inspection of the liner gave the following observations. The liner showed no visual degradation. After a more thorough look at the liner a thin horizontal crack of around about 30 cm length was observed on the section of the optimized vinyl ester liner system at the chamfer connecting the bottom slab and the cylindrical wall (see picture hereafter).

*Crack at the Optimized Vinyl Ester Liner after 1.4 MPa (2.4 times Design Pressure)*

After the first two tests (0.65 MPa and 1.1 MPa) this area had already been identified as a potential weak point where local detachment from the concrete surface was identified. This previous detachment was obviously the reason that the

leakage was distributed behind the chamfer and occurred simultaneously around the 360 ° of the mock-up. The vinyl ester resin is much stiffer than the epoxy resin and this explains that at the chamfers (which are areas of stress concentration) the risk of cracks at the vinyl ester liner is higher than at the epoxy liner.

It was decided to repair the crack and to improve all the chamfers at the bottom and top areas of the vinyl ester liners. The epoxy liner was not upgraded.

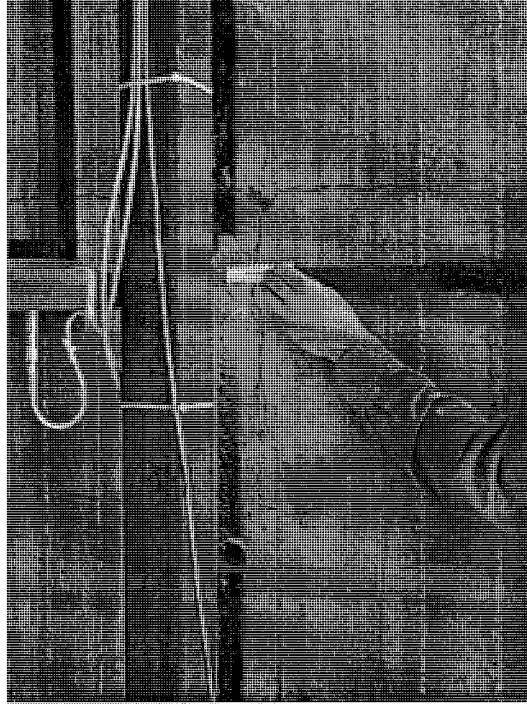
*Large Cracks at the Cylindrical Wall at 1.6 MPa*

As expected, at this level of pressure the reinforcement of the mock-up was already in the non-linear range with measured strains of up to 6.6 %.

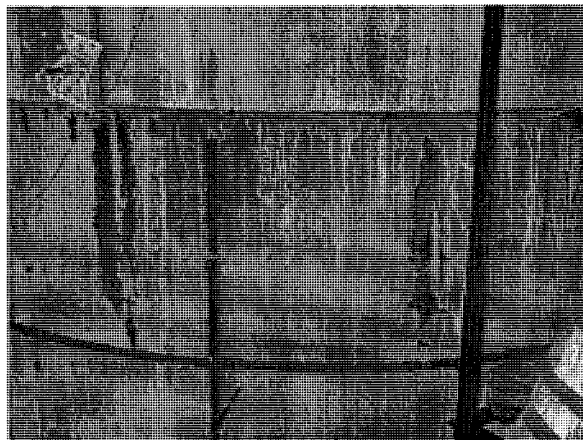
As the mock-up was obviously able to carry this extreme loading it was decided to go further on with the pressurization. At a pressure of 1.7 MPa (corresponding to 2.9 times the design pressure) the first leaks started gradually at the connection between the cylindrical wall and the top slab and at the top penetration. An impression of the leaks and the large deformation of the reinforced concrete with cracks up to several millimeters wide are represented in the following photos, taken when the mock-up was fully pressurized .

*Slowly Starting Leakage at the Top of the Cylindrical Wall at 1.7 MPa*

Again, the inspection of the liner showed no visual degradation. The identification of the areas where the leakage occurred was only possible via the electric brush procedure. At the upper chamfer of the improved vinyl ester five small cracks were clearly identified as the reason for leakage.

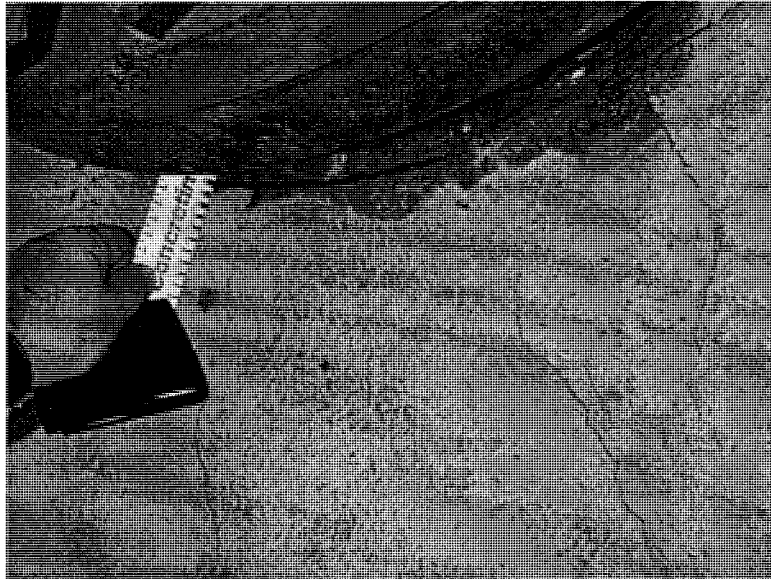
*Large Cracks and Starting Leakage at the Penetration at the Top Slab*
