SEISMIC SHAKE TABLE TESTS ON A GRAVITY LOAD DESIGNED FRAME STRUCTURE – LINEAR TO NONLINEAR TESTING

Akanshu Sharma¹, G.R. Reddy¹, R.R. Babu², K.K. Vaze¹

¹Reactor Safety Division, Bhabha Atomic Research Centre, Mumbai, INDIA-400085

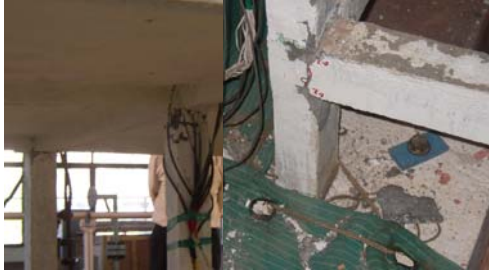
Fig 10 Damage patterns observed at PGA = 0.5g

Fig 10 shows the damage patterns observed for the base excitation with a PGA level of 0.5g. It was observed that many new cracks were formed in the beams and columns and the old cracks opened widely and led to spalling of concrete. The major damages were observed for the columns of 1st and 2nd storey levels. However, the cracks formed at the very base of the columns at the PGA of 0.2g (Fig 11 (a)) neither grew any further nor opened significantly. It was observed that the newer cracks that were formed at the plinth beam level (Fig 10) became

significant. This suggests that plinth beam definitely has beneficial effects as it prevents the structure to form a soft story type of mechanism.

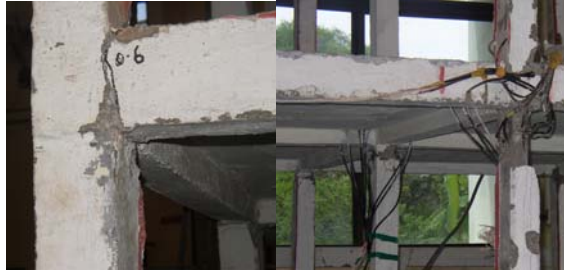
Fig 11 Damage patterns observed at PGA = 0.6g and 0.7g

After the PGA of 0.5g, the spalling was significant and the already formed cracks were seen to open up widely. Fig 11 shows the damage patterns observed at the PGA of 0.6g and 0.7g, which was the maximum base acceleration level applied. The bottom beam bars became visible and the interior column just below the first storey level has lost almost all of the concrete forming a total hinge. Not only the cover concrete has spalled off but even the core concrete within the reinforcement is lost. This shows the effect of lack of proper confinement with ties in the critical zones. However, the failure is essentially a flexural failure that may be attributed to large span to depth ratio for the columns, but the plastic hinge length is quite large in this case.

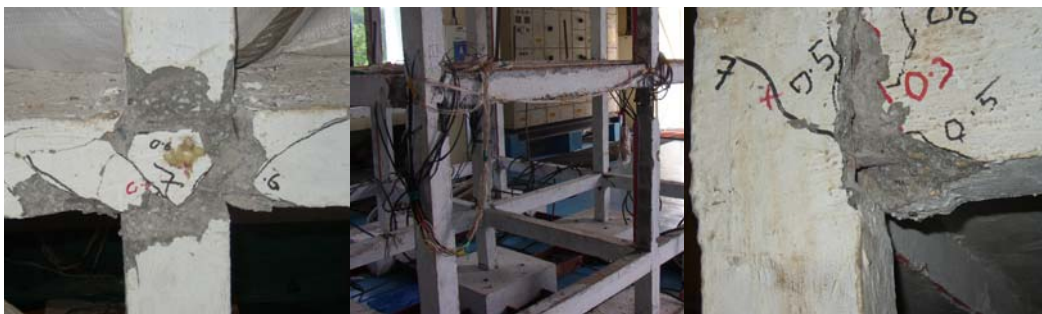
Fig 12 Damage patterns in Joints

Fig 12 shows the damages in the joints. However, in this case it is not a pure joint shear (JS) failure but more of a so-called BJ failure mode where the members framing into the joint yield first and the shear failure of the joint occurs later. Similarly joint shear cracks can be seen propagating in the exterior joint. These pictures indicate that the joints could not remain essentially elastic, which is mainly due to the lack of shear reinforcement in the joint core, but in this case, the joint failure was not so critical since the members of the structures failed first and then the cracks in the joints were induced.
