1,4-DIOXANE AND THE APPLICATION OF PHYTOREMEDIATION AT
NORTH CAROLINA HAZARDOUS WASTE GROUNDWATER CONTAMINATED SITES

Master of Environmental Assessment

2013

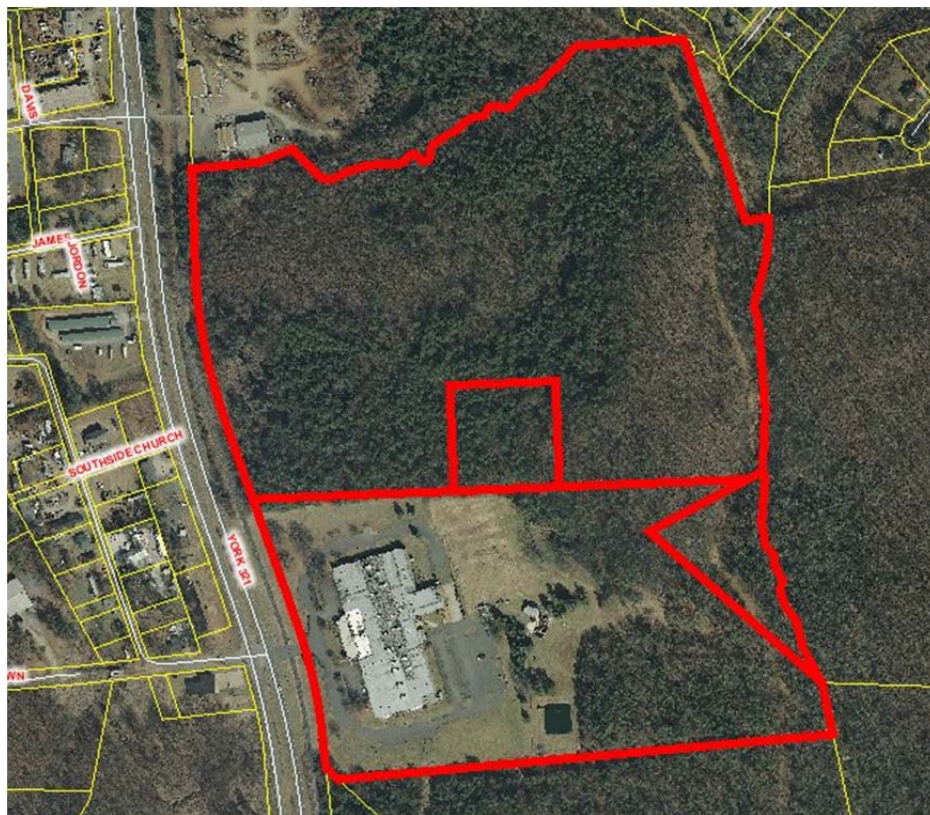
Figure 3: Aerial of A.B. Carter (54).

The 1,4-dioxane contamination plume highest concentrations are found near the excavated sludge beds located east of the main building. The plume is reportedly migrating towards a stream that is located along the eastern side of the property and less than 200 feet from MW-23 that had a concentration level of 17µg/L of 1,4-dioxane. Groundwater depths were between 19.5 feet and 44.7 feet below land surface, as measured in monitoring wells during the August 2012 monitoring event (47). Groundwater flows in an east-southeastern direction as a result of site topography. Site groundwater has a horizontal hydraulic gradient of approximately 0.024 feet/foot and an average groundwater flow velocity of 124 feet per year (47).

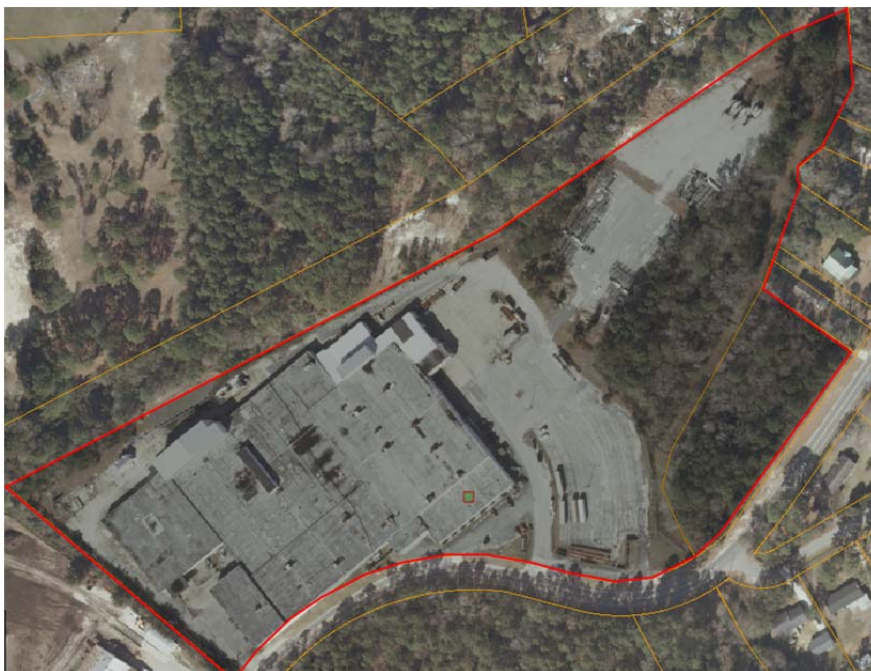
Figure 6: Aerial of Former Heatcraft Remediation Site (66).

Water table depth at the Former Heatcraft Remediation Site is between four and ten feet below land surface (50). Site groundwater discharges to North Creek, which acts as a discharge boundary for the water table aquifer (50). Groundwater flows to the southwest towards the creek on the eastern side of North Creek (50). There are two groundwater systems present: a surficial aquifer that flows towards the southeast towards an unnamed tributary and a deep Peedee Aquifer that flows to the southwest towards the Cape Fear River (65). 1,4-Dioxane contamination has been identified in both aquifer systems (65).

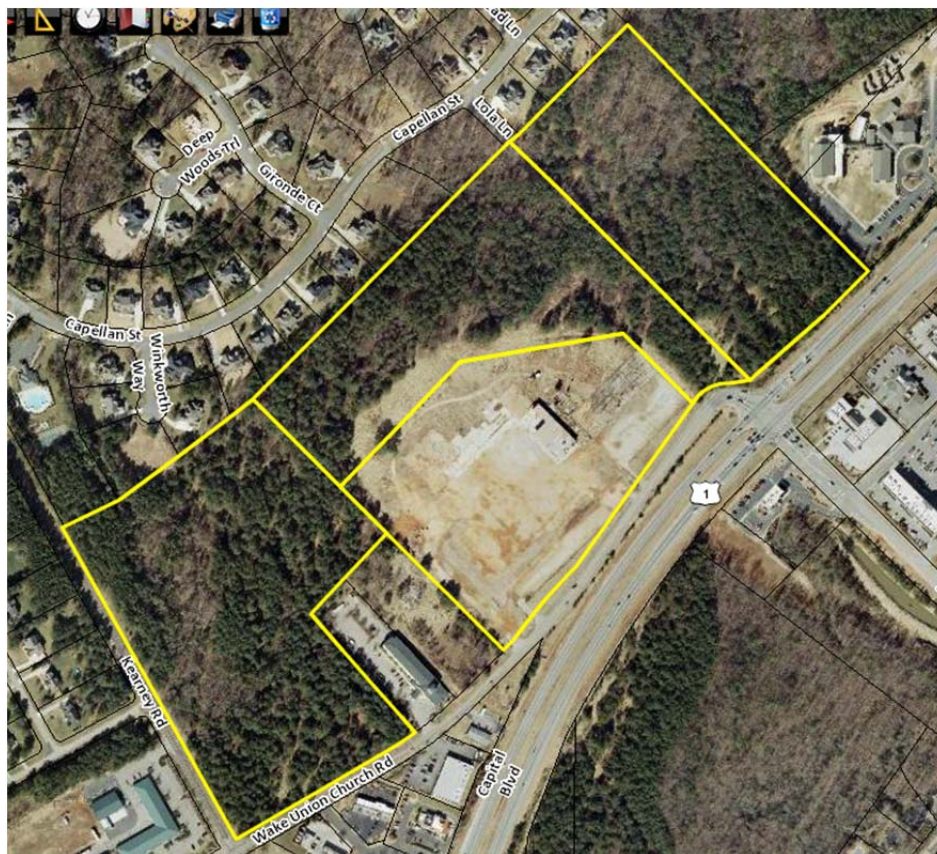
Figure 7: Aerial of Parker Hannifin Corporation (36).

The groundwater table depth across the monitored area varies between 5.4 feet below land surface and 41.0 feet below land surface (51). Groundwater flows towards the three extraction wells and north-northwest towards surface water (51). Water table depth in the wells with detected 1,4-dioxane is between 37.8 and 41.8 feet below land surface.

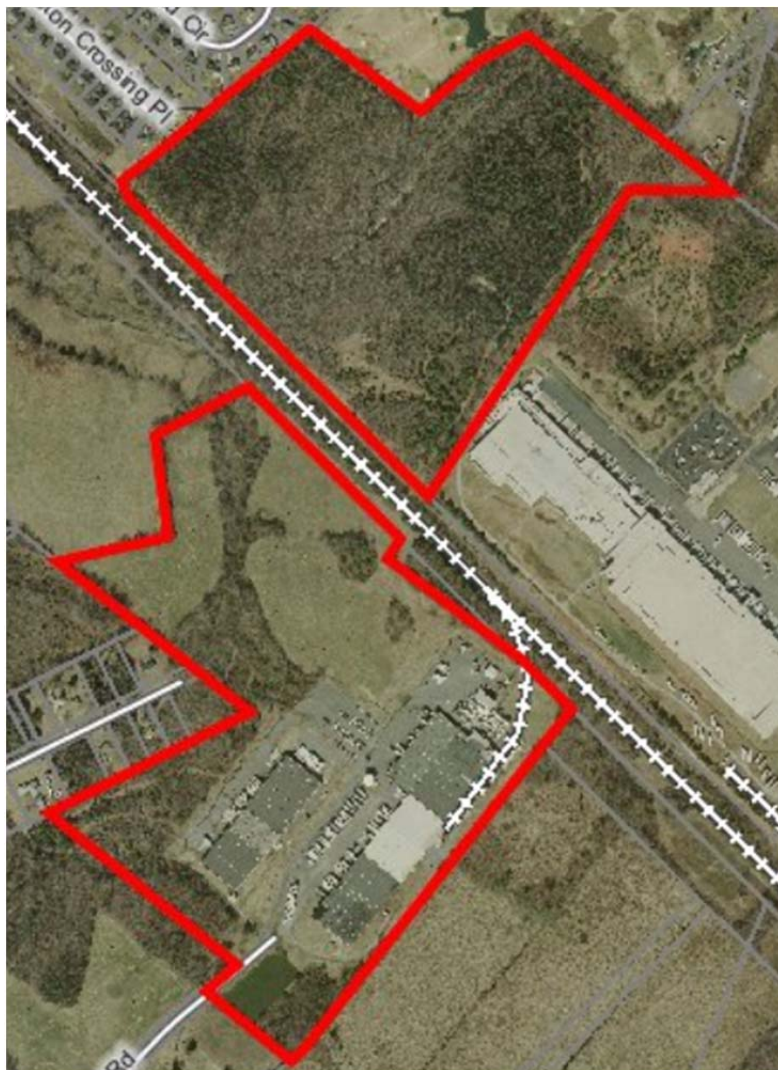
Figure 8: Aerial of Radiator Specialty Co. (69).

Groundwater table levels located on-site were measured between 8.5 feet and 77.0 feet below land surface (52). Surface water generated on the southwest side of the facility discharges through intermittent streams to Price Mill Creek while surface water generated on the northeast side of the facility discharges into intermittent streams draining to the South Fork Crooked Creek (67). Likewise, there is a groundwater divide in the area of the RCRA regulated units, where the groundwater flows to the northwest (67).
