FRACTURE STUDIES OF MODEL PRESSURE VESSELS MADE OF NUCLEAR GRADE STEEL *

R.W. DERBY,

Oak Ridge National Laboratory, Oak Ridge, Tennessee, U.S.A.

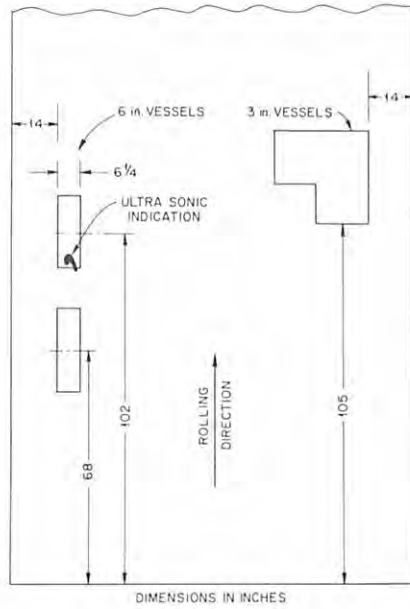
The models were made from blocks of A533 grade B, class 1 steel which were cut out of a large, 12-in.-thick plate. The locations of these blocks relative to the plate are shown in Fig. 1. Note that all three blocks were taken from a location slightly greater than one thickness away from the edge of the plate. The bottom of the figure corresponds to the bottom of the ingot. The arrow points in the rolling direction. Also of considerable interest is the ultrasonic indication which was accidentally captured in one of the blocks.

Fig. 1. Location of Vessel Material Relative to Plate.

From the blocks shown in Fig. 1 a number of cylinders were cut as shown in Fig. 2. Note that the long axis of the cylinder corresponds to the thickness direction of the plate. The reason for selecting this orientation was that any laminations which might have occurred in the plate would not be perpendicular to the direction of largest principal stress. In a full size reactor vessel this relationship is inherent although it is arrived at in a different manner. An additional reason was that the cutting plan shown in Fig. 2 results in relatively uniform properties along any circumference because the temperature history during heat treatment depends primarily on distance from a free surface.

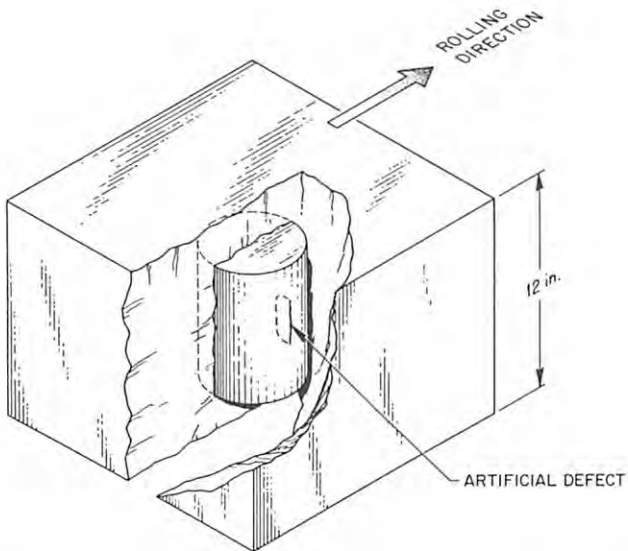
The artificial flaw shown in Fig. 2 was made so that the plane of the flaw would be perpendicular to the rolling direction of the plate. This orientation was selected to correspond to that which would be the most serious in a vessel made from a plate.

Fig. 2. Orientation of Cylindrical Sections Relative to Plate.

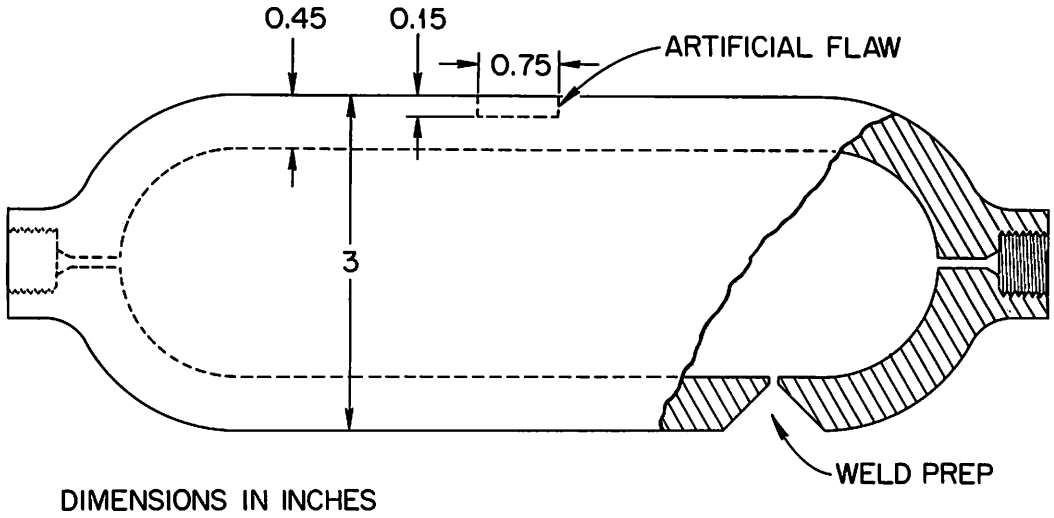
A sketch of the smaller vessels is shown in Fig. 3. Note that the flaw is one third of the wall thickness deep and is five times as long as deep. These flaws were placed in the vessel by using a process developed by Canonico and Hudson at Oak Ridge National Laboratory [7]. Basically, the method consists of hydrogen charging an electron beam weld. The result is a true crack which often cannot even be seen with the naked eye.

Fig. 3. Sketch of 3-in.-Diameter Vessels.

by equating the code allowable primary membrane stress intensity, 26,700 psi to a formula for stress intensity as a function of pressure and then solving for pressure. From Fig. 3 the average tangential stress across the section as a function of the pressure, P is

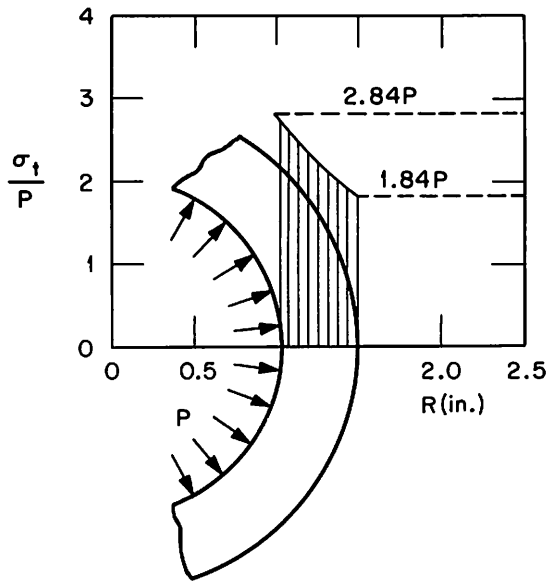
The stress distribution in the wall of the vessel as calculated by Lamé's equation is shown in Fig. 4. The point of the illustration is to emphasize that the models have a much smaller ratio of radius to wall thickness than a real reactor vessel. The reason that the models are not geometrically similar to a reactor vessel is that we were interested in getting as much thickness with as little mass as possible.

Fig. 4. Application of Lamé's Equation to Vessel.

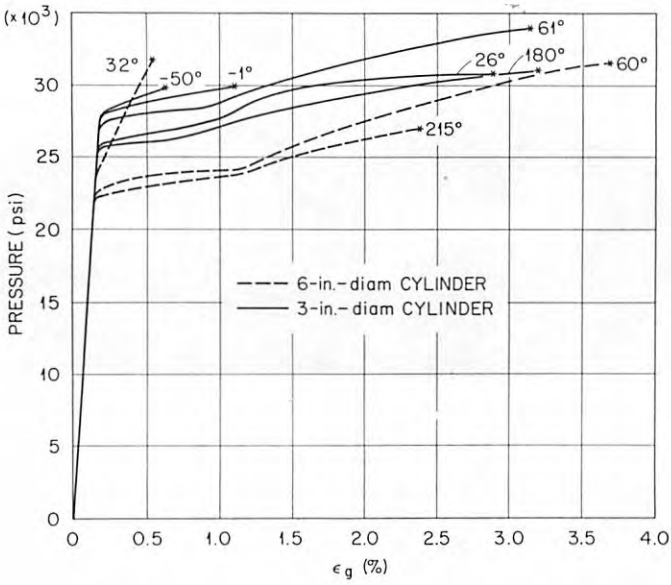
3.2 Post Yield Behavior. The load-strain curves for a variety of conditions are shown in Fig. 5. The solid lines are for 3-in.-diameter vessels and the dotted lines are for 6-in.-diameter vessels. The stars mark the conditions at failure.

It is apparent that the gross strains at failure fall into two distinct categories, those around 3 per cent and those around 0.8 per cent. Over a rather narrow temperature range there is a distinct change both in the gross strain at failure and in the mode of failure. For example, for -1°F and -50°F the failure was flat with low strain tolerance (see Fig. 6) and at 26°F the strain has tripled. Both vessels failed at the same pressure, 30,000 psi although the vessel at -1°F experienced almost twice the strain, 1 per cent as opposed to 0.64 per cent.

Fig. 5. Pressure-Strain Curves.

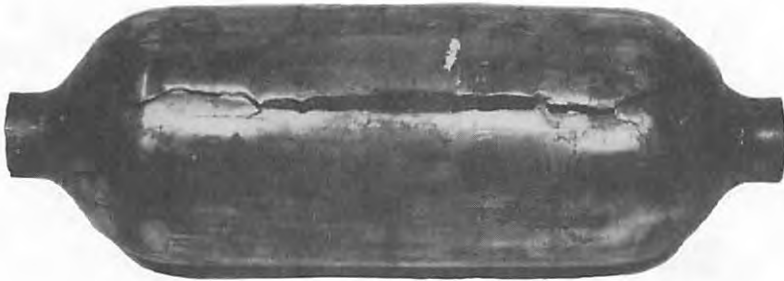
**3" VESSEL NO.5
30,000 PSIG
150MIL FLAW
2-1-71 -50F**

Fig. 6. 3-in. Vessel Tested at -50°F .

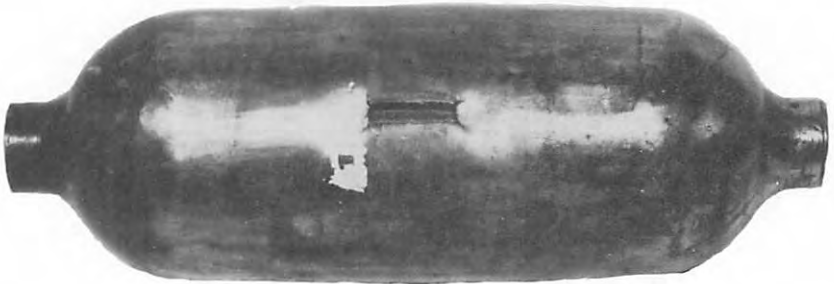
3.2.1 The 3-in.-Diameter Vessels. The 3-in.-diameter vessels which were tested hydraulically at 26°F or higher all leaked at failure. The mode of failure is shown in Figs. 7 and 8. Note the little dimples at the end of the flaw in Fig. 7. The failure in the room temperature test (61°F) was particularly interesting. At 34,000 psi the vessel sprang a leak and the pressure dropped to 21,000 and held. When we tried to increase the pressure we could observe a spray such as that shown in Fig. 8.

3" VESSEL NO. 6
34,000 PSIG
150 MIL FLAW
1-29-71 61°F

Fig. 7. 3-in. Vessel Tested at 61°F.

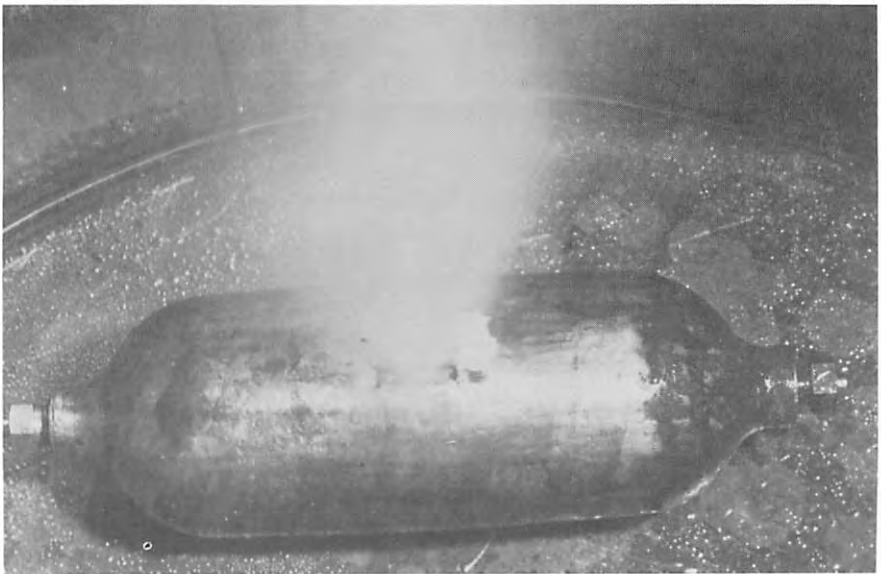
Fig. 8. 3-in. Vessel Leaking Under Pressure.

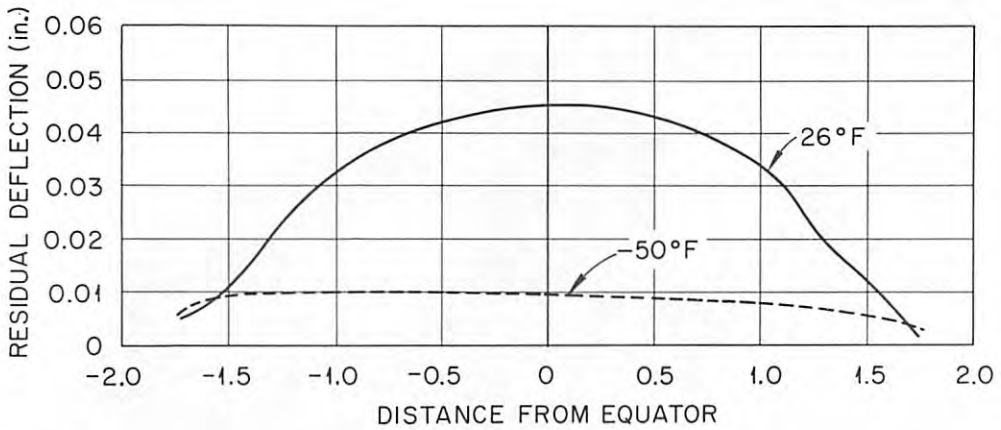
An additional difference between the two types of failure is shown in Fig. 9. Here the radial deflection after failure is plotted as a function of distance from the equatorial plane. The vessels which failed above the transition temperature all exhibited pronounced barreling whereas those which failed below the transition did not.

Fig. 9. Comparison Between Barreling at Two Temperatures.

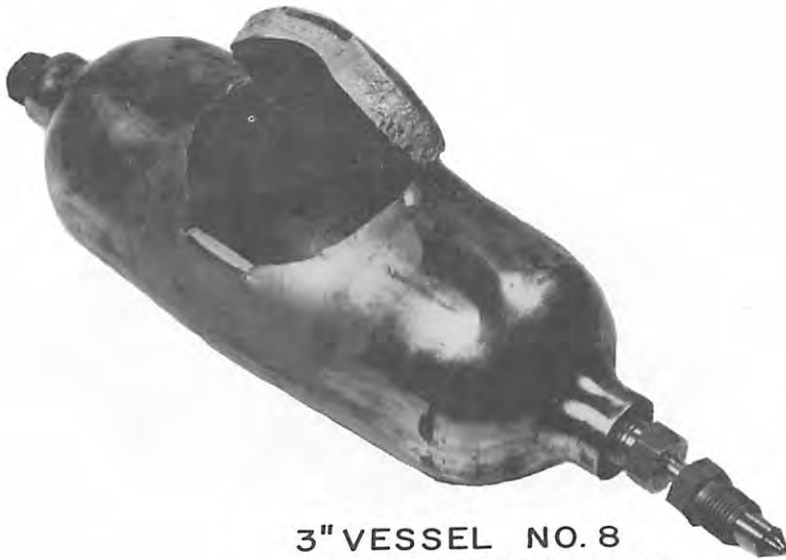
Some of the vessels were tested pneumatically. Results from such a test are shown in Fig. 10. The pressure at failure was 34,000 psi. Although this vessel did not have strain gages on it the reader can probably observe the bulge which took place around the equator before failure. Ostensibly the test took place at room temperature but the failed specimen was warmer due both to the heat of compression of the gas and plastic work in the metal. Although it was difficult to draw much comfort from the large door which opened in the specimen there was no fragmentation. Several more tests near the upper shelf temperature of the A533 B steel seemed in order. The result of one of them is shown in Fig. 11. Here the temperature was 180°F but the flaw turned out to be slightly small, 0.13 in. instead of 0.15 in. Note that the burst pressure was actually slightly lower than that of the other pneumatic test, 32,000 instead of 34,000 psi.

**3" VESSEL NO. 8
33,800 PNEUMATIC
150 MIL FLAW
2-4-71 ROOM TEMP**

Fig. 10. Result of First Pneumatic Test.

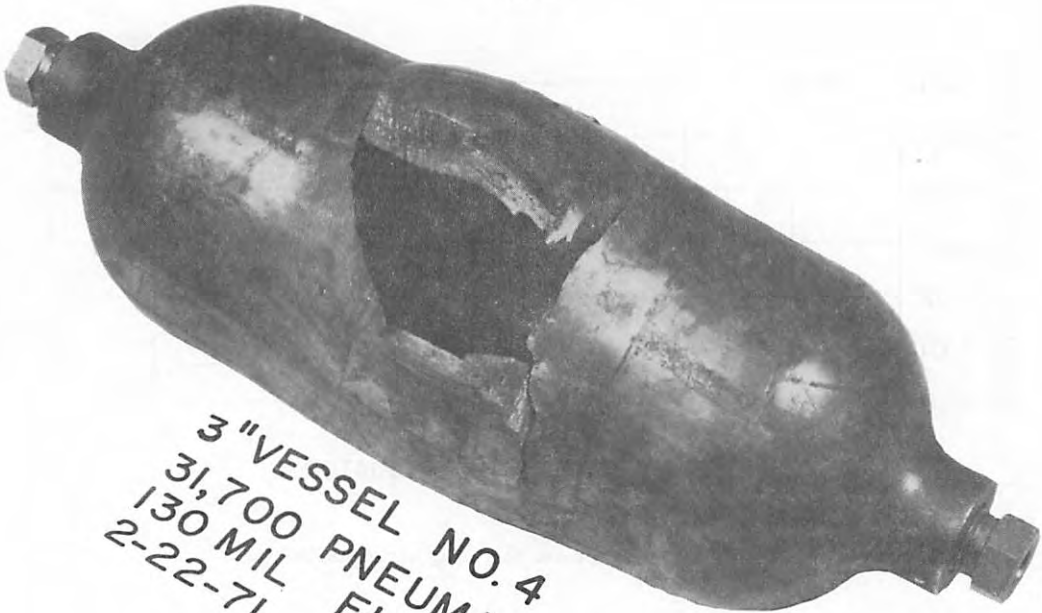
3" VESSEL NO. 4
31,700 PNEUMATIC
130 MIL FLAW
2-22-71 180°F

Fig. 11. Result of Second Pneumatic Test.

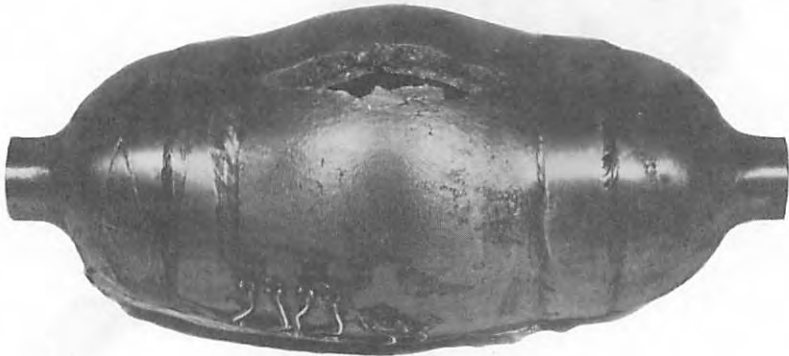
Finally, the behavior of an unflawed vessel is shown in Fig. 12. The results of the 3-in. series are summarized in Table IV.

3" VESSEL NO. 1
38,000 PSIG
NO FLAW
1-29-71 61°F

Fig. 12. Failure of Vessel Without Flaw.

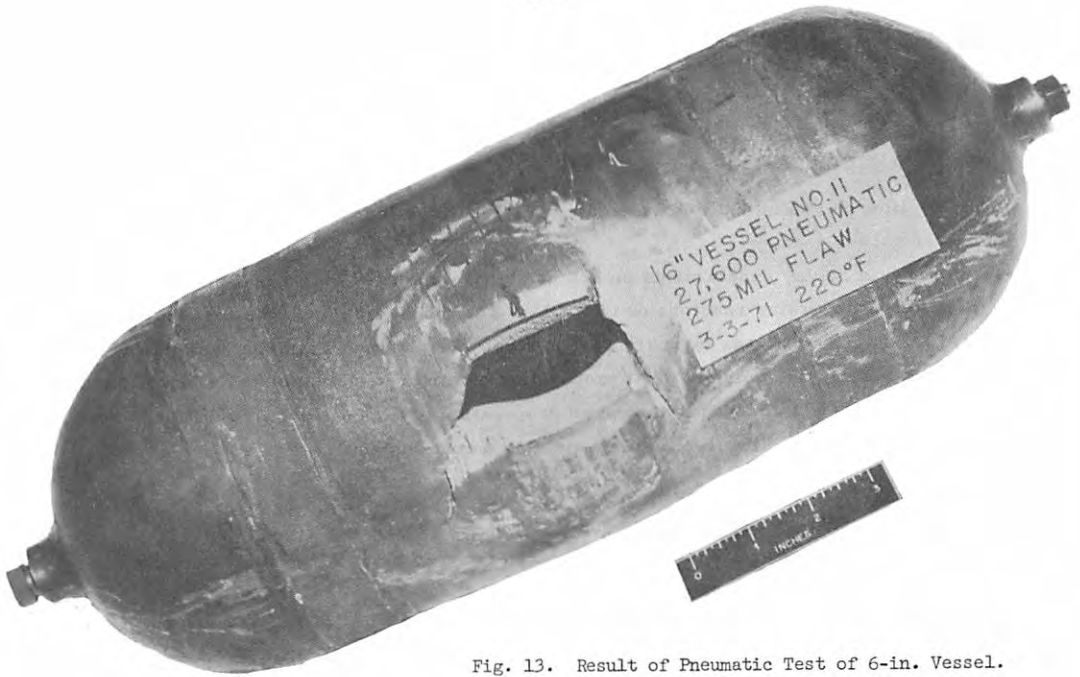
3.2.2 The 6-in.-Diameter Vessels. The first of the 6-in. series was tested at 215°F. The failure was at a lower pressure than any previous test. The strain was also lower than expected, 2.4 per cent. The opening which formed in the vessel was not particularly large although some had anticipated that with increasing size the chance of fragmentation would

be increased. (It is worth remarking that the energy stored in this vessel was equivalent to about 2 lbs of TNT.) See Fig. 13.

Fig. 13. Result of Pneumatic Test of 6-in. Vessel.

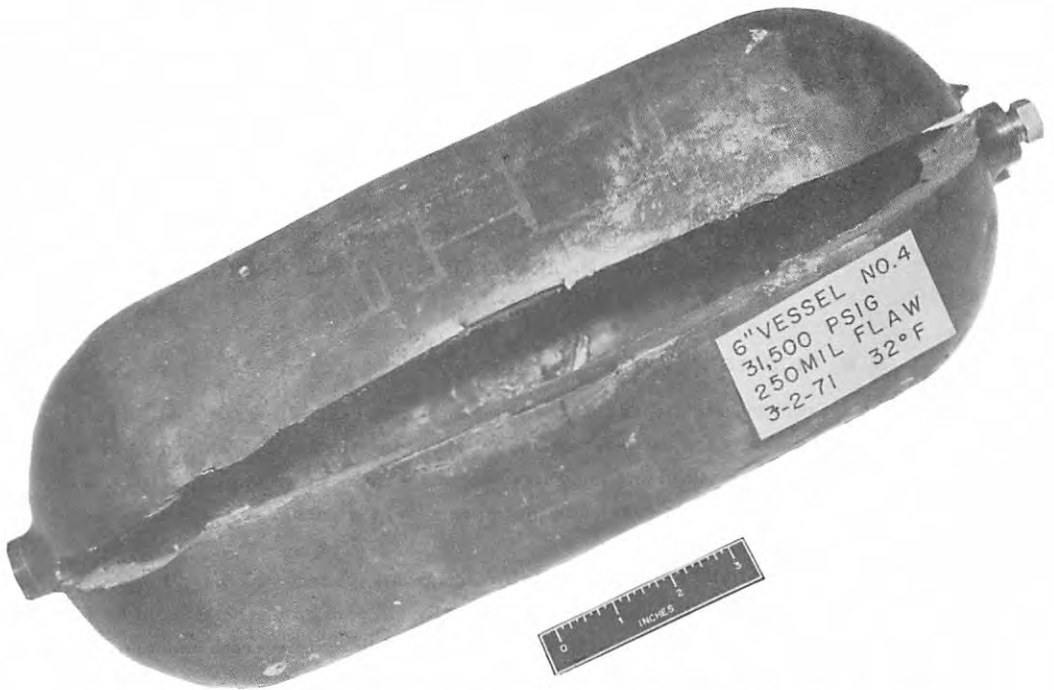
The brittle failure of the 6-in.-diameter vessel tested in an ice bath was equally interesting if not surprising. A large natural flaw was accidentally captured on the mid-plane of the cylindrical section. Although the exact nature of this flaw is, as yet, unknown it is believed to be similar to those analyzed earlier by Klindt and Canonico [8]. (We plan at a future date to dissect the wall of the vessel.) Both the inside and outside gave strong indications when examined with dye penetrants. In fact, the cylindrical section had so many indications that we doubted that it would be able to hold pressure. From inside the vessel the flaw looked like a depression in the wall 1/2 in. across and several millimeters deep. Hence the section was given a copper cladding several thousands of an inch thick. Unfortunately the cladding did not close or cover the cracks around the large flaw. In the end a gob of silver solder was put on top of the flaw. After the vessel was welded closed and given a post-weld heat treatment it had an artificial flaw of the kind previously described placed in it. In spite of the flaws the vessel achieved 31,500 psi before failing in a brittle manner. See Fig. 14.

Fig. 14. Result of Hydraulic Test of 6-in. Vessel in Ice Bath.
