**MONITORING STUDY OF THE PERFORMANCE OF STORMWATER BEST
MANAGEMENT PRACTICES IN THE CITY OF CHARLOTTE**

By
Jonathan T. Smith PE and William F. Hunt PE, PhD

Department of Biological and Agricultural Engineering
North Carolina State University
Raleigh, North Carolina

January 2006

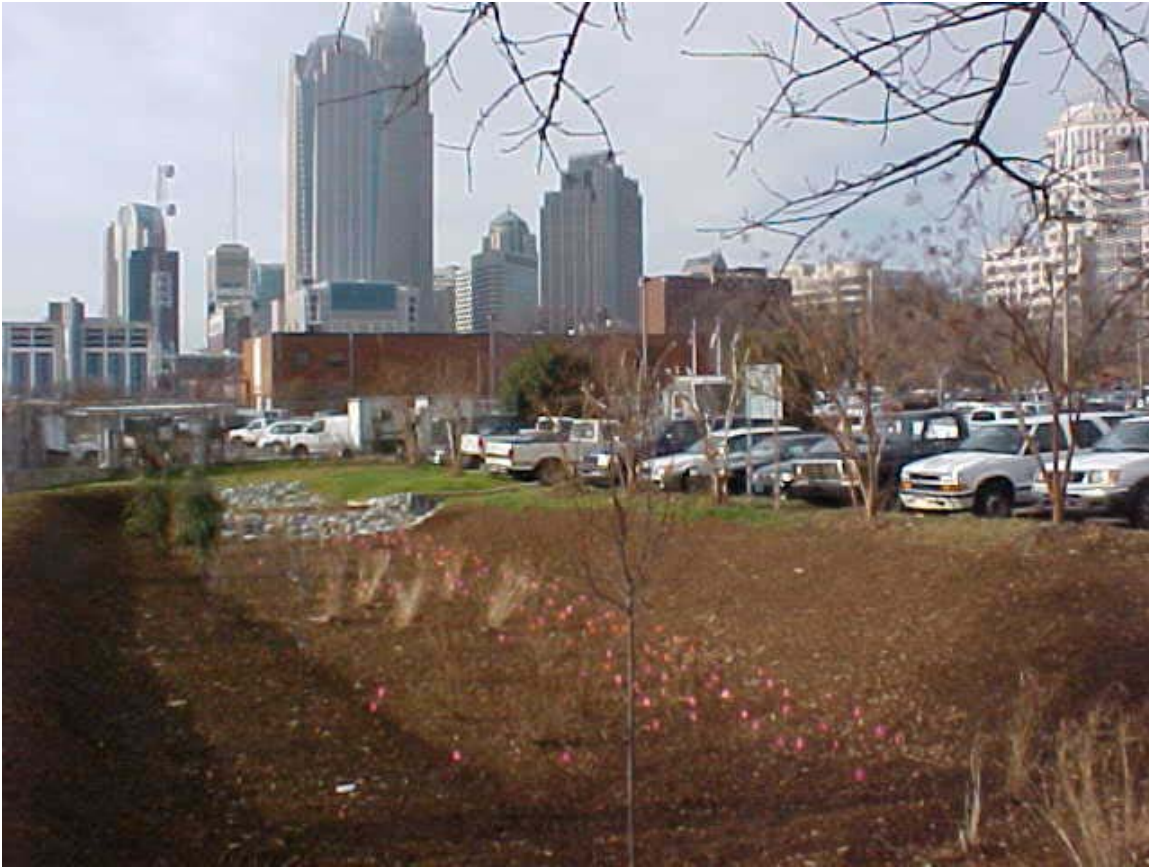
Hal Marshal Parking Lot Bioretention Area

Hal Marshal Bioretention area is a retrofit bioretention area providing stormwater runoff treatment for an asphalt parking area adjacent to the Hal Marshall Municipal Services Building. The Hal Marshal Building houses the offices for the Mecklenburg County Land use and Environmental Services (MCLES). As a result, the location of the bioretention area is ideal for water quality monitoring activities.

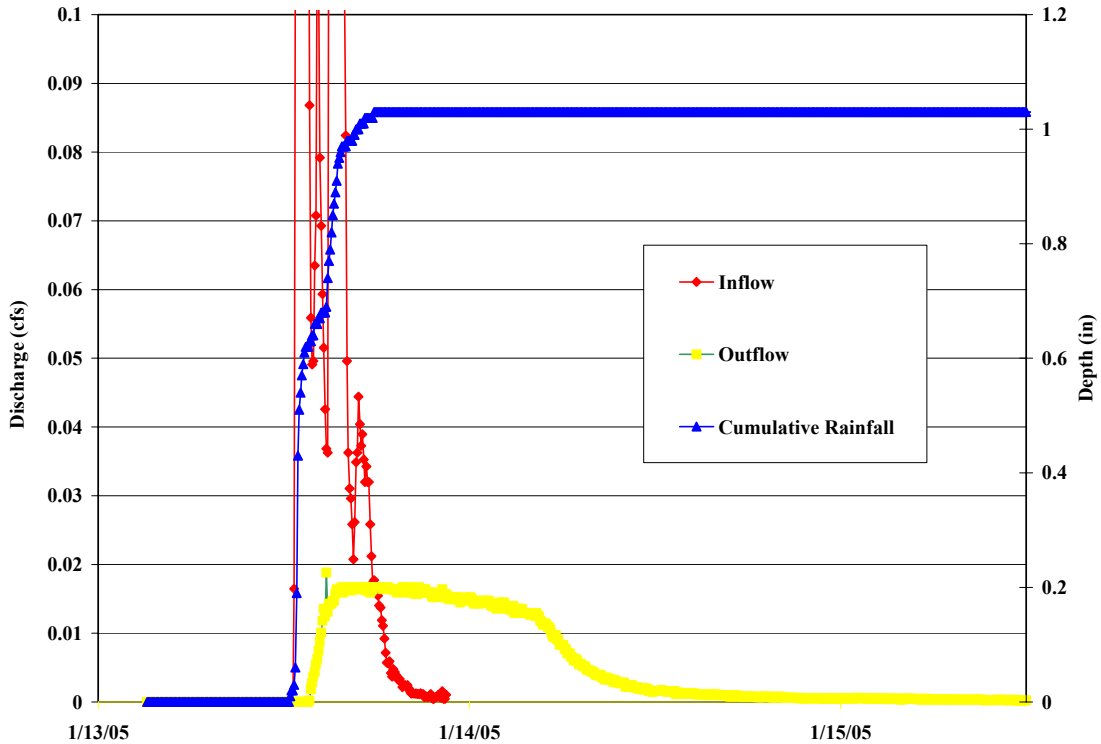
Figure 1 Rainfall and Hydrograph from Typical Storm

Figure 1. Total rainfall for the event shown was just over 1.04 inches in depth. The event can be considered to be near, but less than the “capacity” event for the device. Flow rate at the outlet was not observed to exceed 0.2 cfs for any of the storm events monitored and may be considered the maximum underdrain outflow of the BMP. Additionally, outflow was observed to decrease considerably 12 hours after precipitation ceased and approached zero at 24 hours after the end of the rainfall event. This drawdown pattern was observed for all events sampled. As a result, the drawdown period for the BMP is considered to be 12- 36 hours for most events.

Recording stage at the V- notch weirs at the inflow and outflow locations allowed direct measurement of flow rates during storm events. A typical hydrograph is shown in

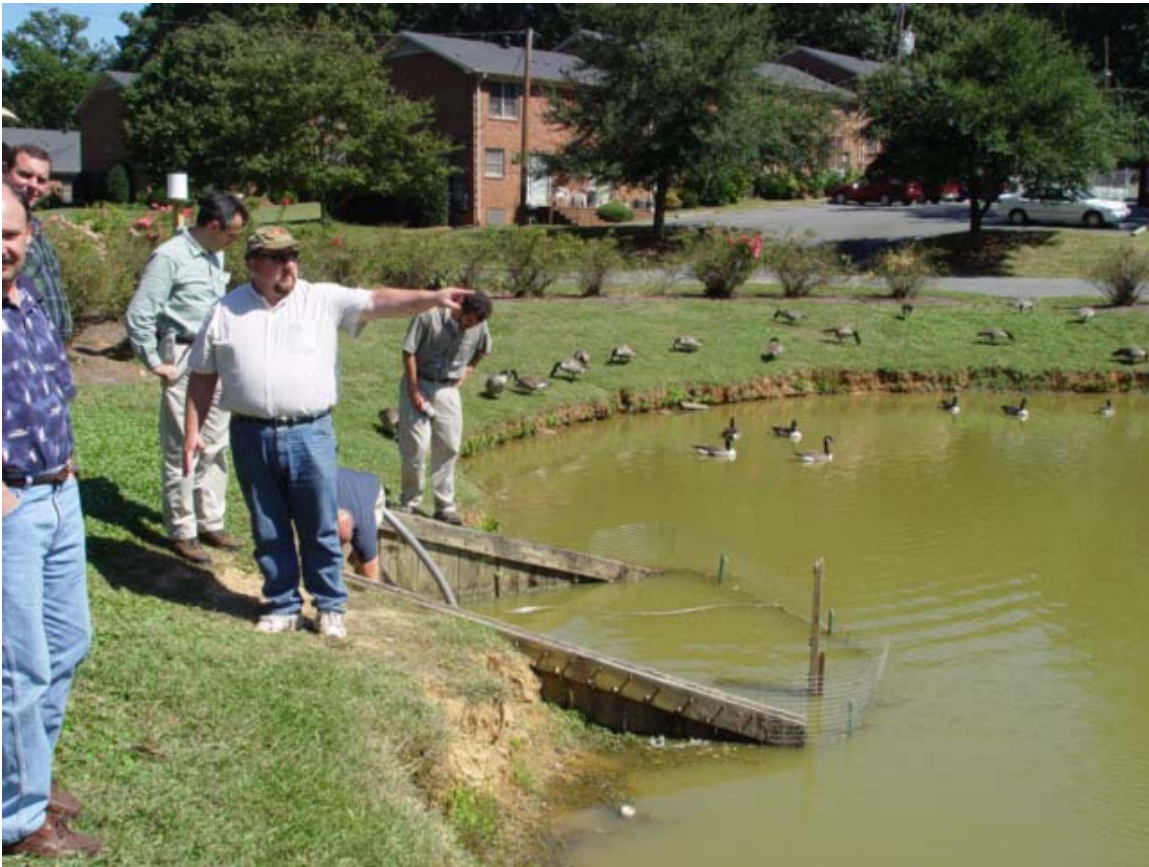
Shade Valley Pond

An aging urban pond in Charlotte, North Carolina was monitored for a period of one year prior to a water quality enhancement project for the pond and nearby drainage network. The 11 ha (27 ac) watershed for the 0.24 (ha (0.6 ac) pond consisted of mixed residential and commercial uses. Inflow and outflow composite samples were collected from August 2003 through July 2004. Samples from 17 storms were analyzed for a suite of pollutants and event mean concentrations (EMC's) were determined for each storm. The pond was enhanced by the addition of a forebay, a detention component and a littoral shelf around its edge. In addition, a number of drainage improvements were made within the watershed to remove failing conveyances. The detention component of the pond was designed to store and hold the runoff associated with a rainfall of 2.54 cm (1 in) for a period of up to 24 hours. Water Quality results for the post construction period were not available at the time of this writing.

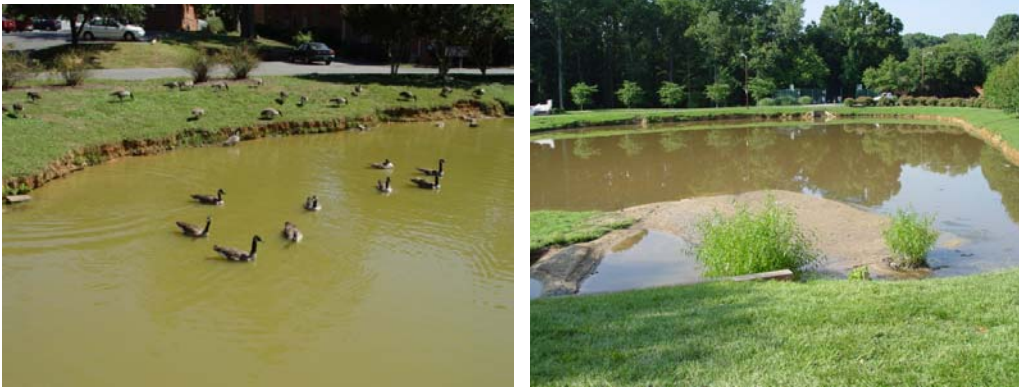
Figure 3. a and 3.b Condition of Pond during Pre- Construction Monitoring Period

the pond were rapidly eroding. Conveyance structures at the pond edge had collapsed resulting in erosion of the adjacent areas. Sediment deposition at the main inlet of the pond had created an exposed sand bar which nearly encircled the inlet. Fecal matter and feathers were prevalent on the banks of the pond and in the pond itself. Conditions during this time are shown in Figure 3a and 3b

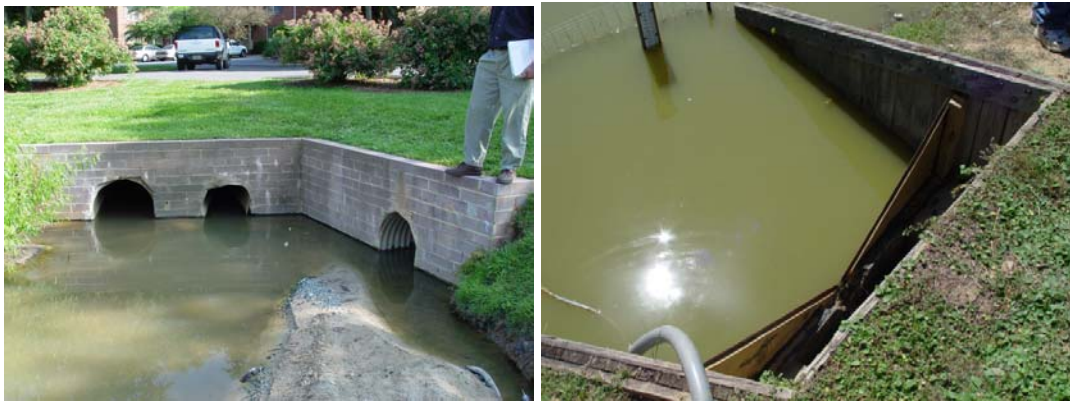
Figure 4.a and 4.b Locations of Inlet and Outlet Sample Collection

Any detention which occurred within the pond during storm events was determined to be minor compared to the overall runoff from the event. Inlet and outlet sampling locations were outfitted with ISCO 6712 samplers for flow monitoring and sample collection. Location of inlet and outlet sample collection is shown in **Error! Reference source not found.5**. An ISCO model 750 bubbler module was outfitted to the outlet sampler for flow monitoring purposes. In addition, an ISCO tipping bucket rain gage was installed on the outlet sampler to provide continuous measurement of rainfall depth and intensity during sampling events.

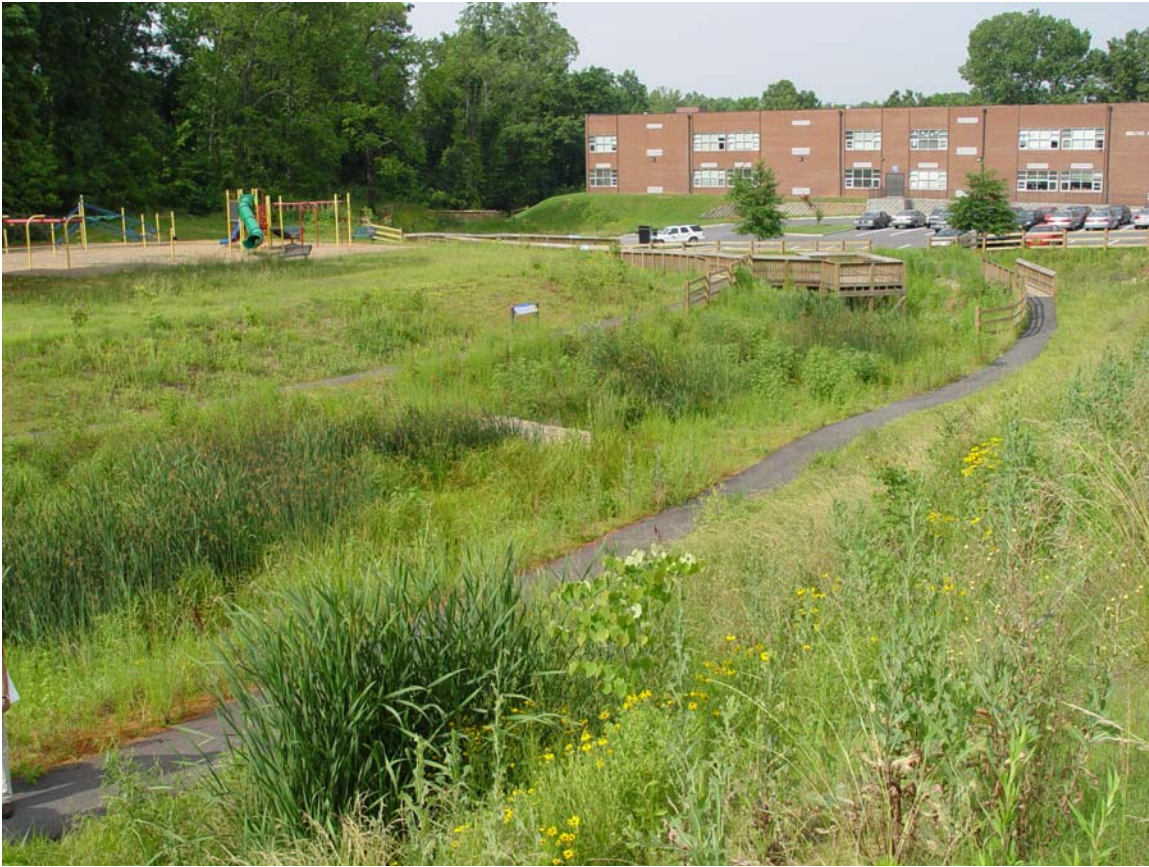
The Bruns Avenue Stormwater Wetland is a retrofit wetland adjacent to the Bruns Avenue Elementary School. The 15.8 acre watershed draining to the wetland consists of a residential development and school property. Monitoring activities were begun in September 2004 and have continued to the present. However, only analysis thru April 2005 are included in this report due to results not being complete for the summer of 2005 and the subsequent drought of the fall of 2005. Composite and grab samples were taken at two inlets and the single outlet of the wetland. The inlet concentrations were flow-weighted to determine the overall inlet concentrations. Samples from nine storms were analyzed for a variety of pollutants and event mean concentrations (EMC's) were determined for each storm.

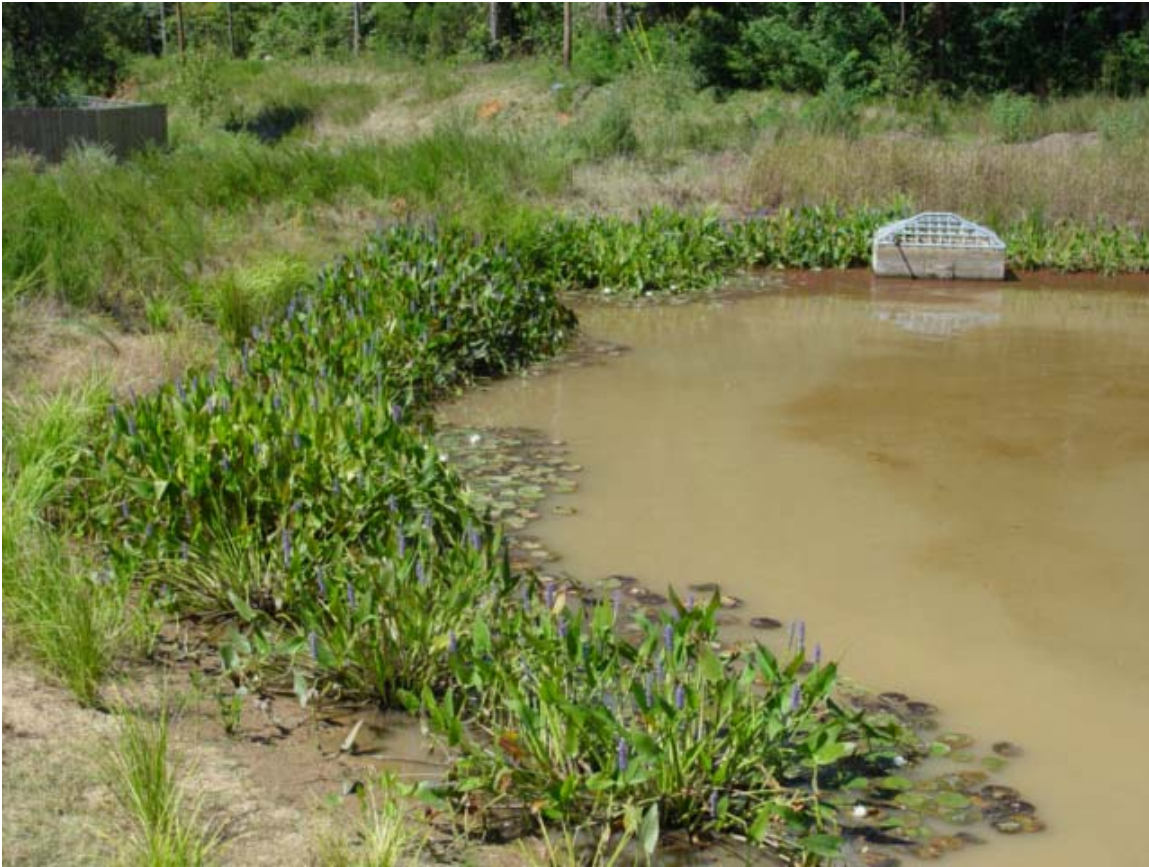
Edwards Branch Stormwater Practice

Edwards Branch Wetland is an offline stormwater wetland installed in the Edwards Branch watershed. The wetland was constructed in 2001 in conjunction with a natural channel stream restoration of Edwards Branch. An elevated walkway over the wetland provides citizen access to Sheffield Park which is adjacent. Nestled between the restored stream reach and the park, the wetland is approximately ½ acre in size with average depth of approximately 1.5 ft (18 in). Although the topography of the wetland is typical of such BMPs the vegetation level is more representative of an innovative wetpond. The watershed, consisting of primarily single family residences on ¼ to ½ acre lots, is located on the opposite side of Edwards Branch from the wetland. Sizing and features of the wetland were selected to comply with state guidelines for wetland design (NCDENR, 1996).

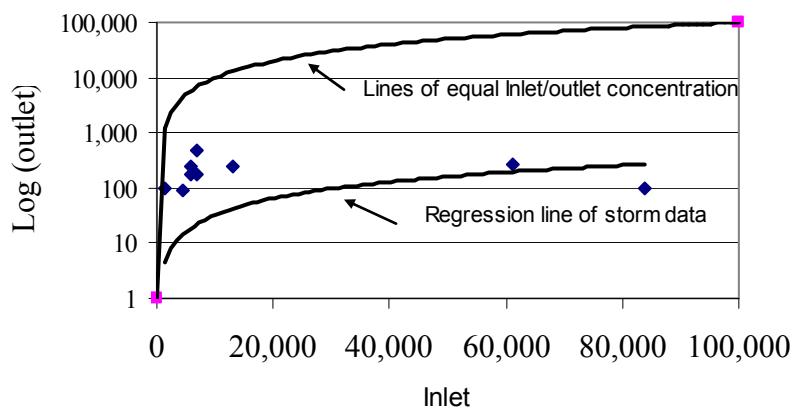
Figure 10 Outlet vs Inlet Fecal Coliform Edwards Branch Wetland

Computed removal efficiency for Fecal coliform was very high (99%) for the 9 storms in which grab samples were collected. This reduction serves as a good indicator but more storm data is needed for a confident assessment of the degree of removal (Figure 11).

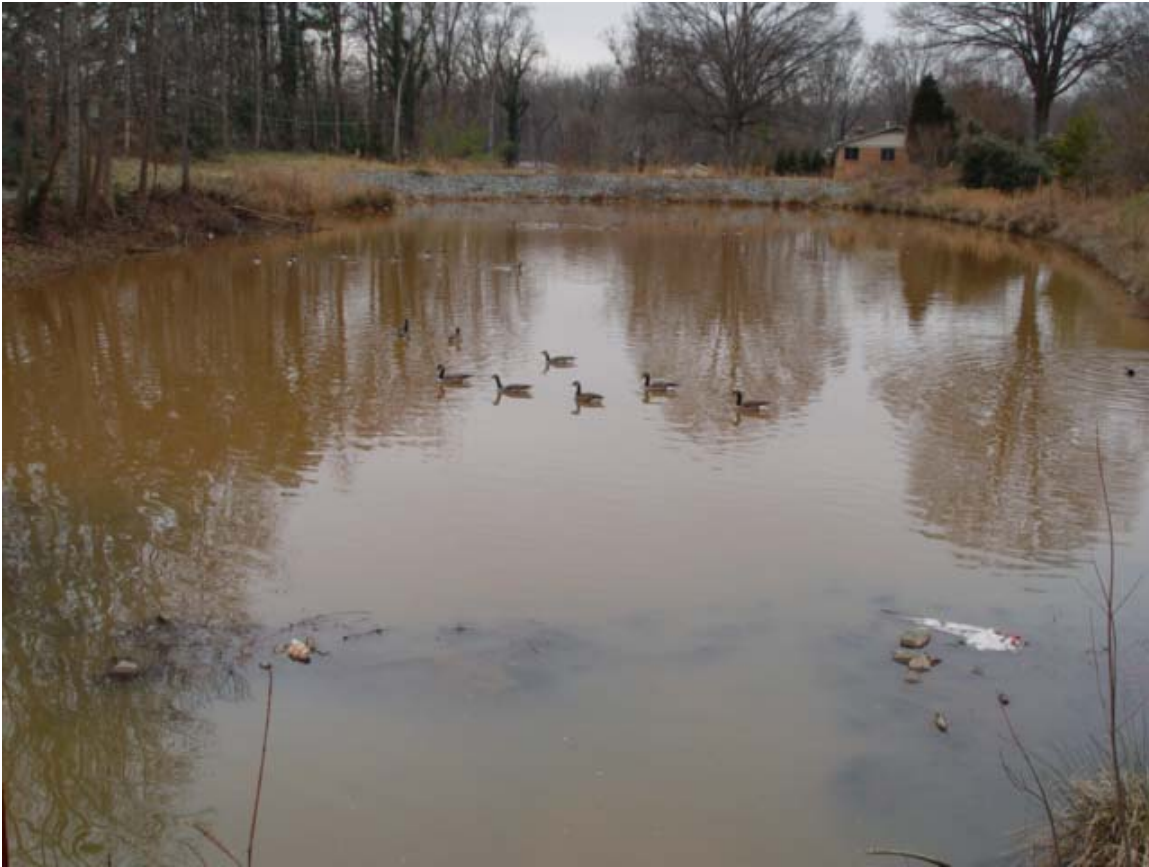
Pierson Pond is an urban pond of unknown age in a neighborhood of single family residences. The original purpose of the pond is unknown, but likely it was constructed for either agricultural purposes, recreation, or aesthetic reasons. The pond is fed by a small blue line stream exhibiting typical characteristics of urban impacted streams. The watershed draining into Pierson Pond is approximately 120 acres of mixed commercial and residential development with the majority of the watershed being single family residences on approximately $\frac{1}{4}$ to $\frac{1}{2}$ acre lots.

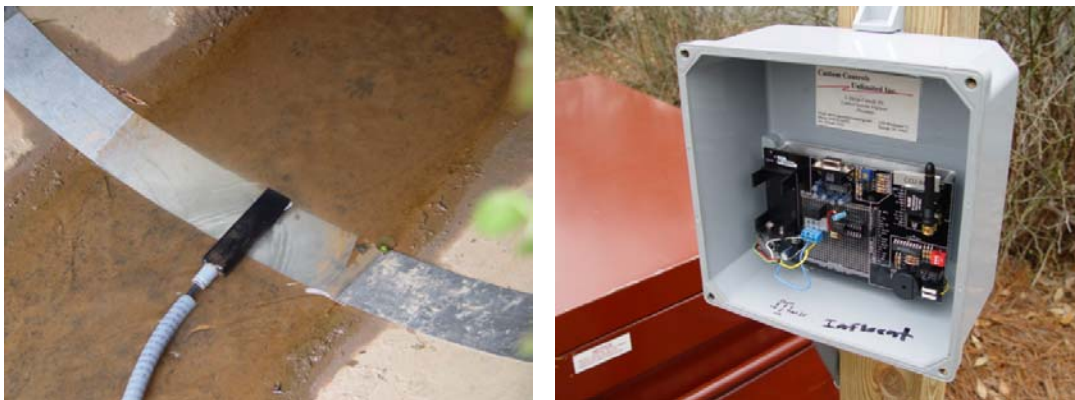
Figure 11 a and b Low profile Area-Velocity probe at Outlet and Wireless Sampler Triggering Device at Pierson Pond.

An ISCO low profile area velocity meter module was utilized in union with an ISCO Avalanche portable refrigerated sampler to collect flow weighted composite samples at the outflow point. An ISCO tipping bucket rain gage was installed near the pond outlet to provide rainfall records for all monitoring events. As a result of the flow-through nature of the pond (no detention component of the riser system), the inflow rate can be assumed nearly equivalent to the outflow rate. In order to utilize automatic sampling techniques at the inlet sampling location a wireless communication system (developed by CCU, Inc.) was utilized which would signal the inlet sampler each time the outlet sampler collected an outflow sample aliquot. Once this signal was received the inlet sampler would collect an inflow sample aliquot and await further signals from the wireless device (Figure 12). In this manner equivalent inflow and outflow flow paced composite samples were collected.

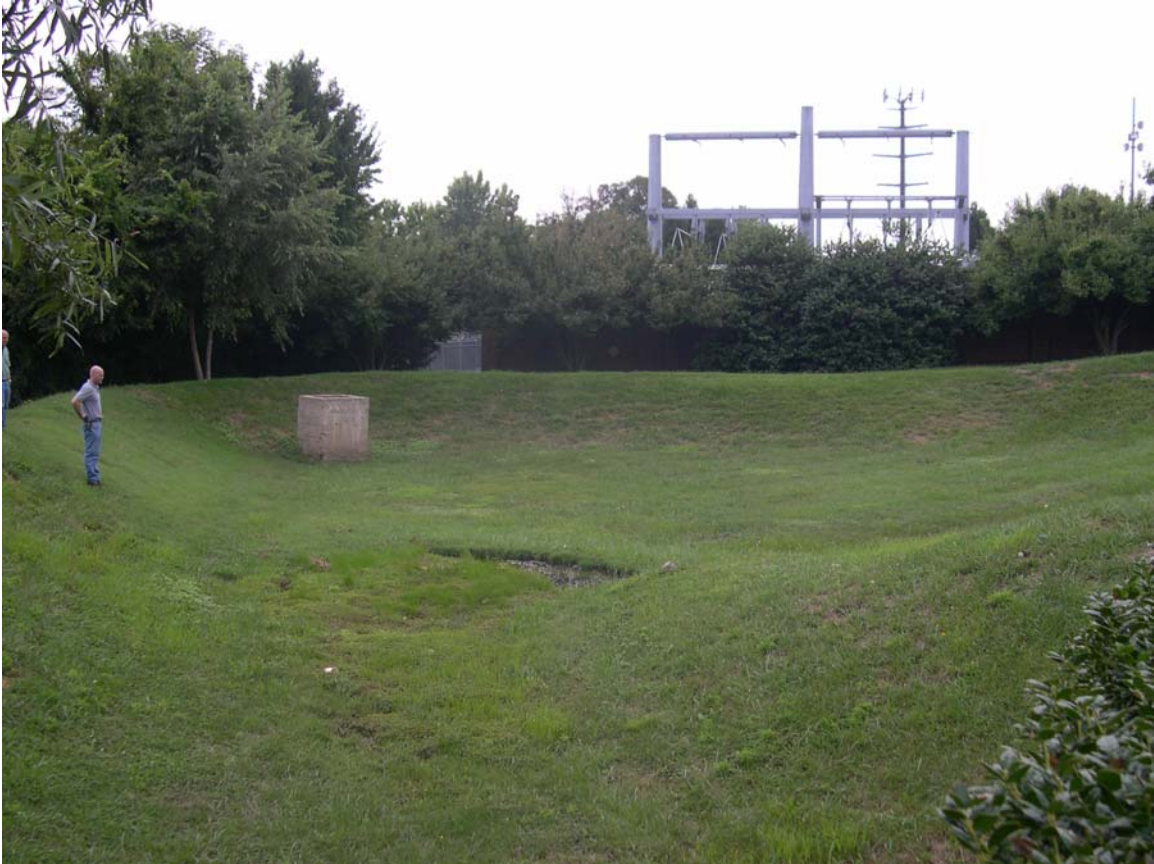
The Morehead Dry Detention basin treats a commercial office park and associated parking areas as well as some landscaped areas. The detention basin is fully vegetated with grass which appears to be well maintained and frequently mowed. Some erosion as well as sediment deposition has occurred within the detention bottom. The age of the basin is unknown at this time, but appears to be 15 to 20 years old. The outlet utilized a 4 inch rectangular hole to allow drawdown of stormwater. The orifice is on the side of a fabricated masonry riser approximately 4 feet high. The top of the riser serves as the emergency overflow.

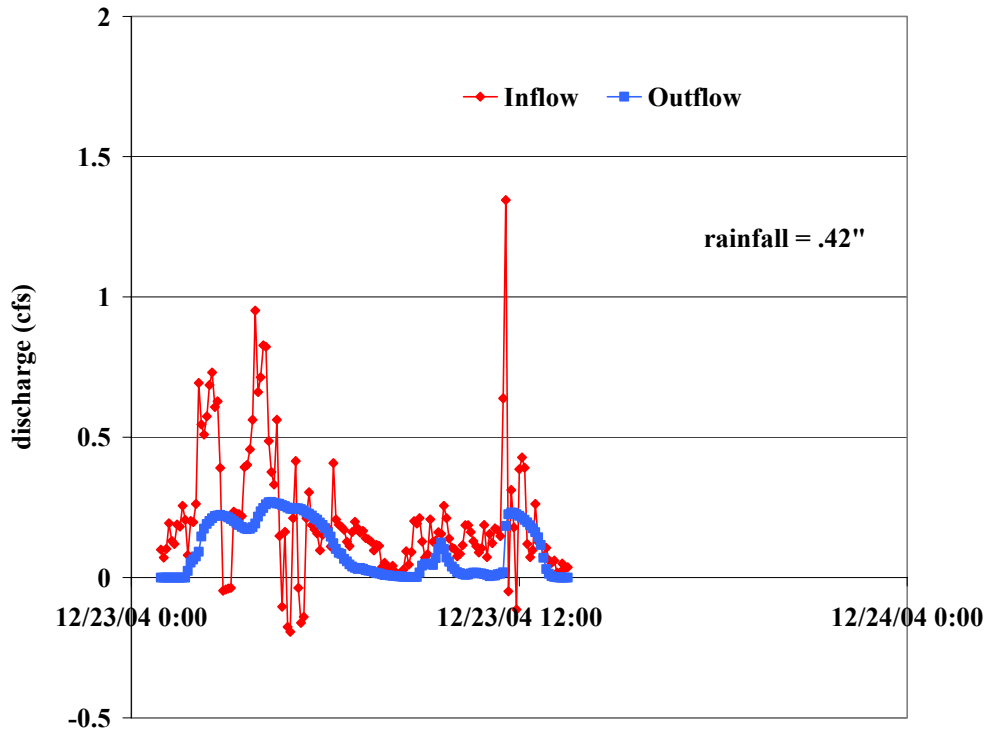
Figure 12 Morehead Dry Detention Inflow and Outflow Hydrographs for Small Storm of 12/22/2004

An example of this is shown in Figure 12 for a 0.42 in. storm of 12/23/05. The outflow hydrograph follows the same general shape of the inflow hydrograph, this would be expected for small storms in which the detention function of the basin is not utilized. Inaccuracies in the flow measurement system at the inflow cause spikes and negative values in the flow data which are obvious errors. Although the severity of these errors make total flow volume determination and precise peak flow calculations difficult, they are not substantial enough to affect the ability of the flow meter/sampler combination to collect acceptable flow weighted samples for water quality analysis. It is recommended that future monitoring activities include frequent cleaning of the sensor surface of area – velocity meters

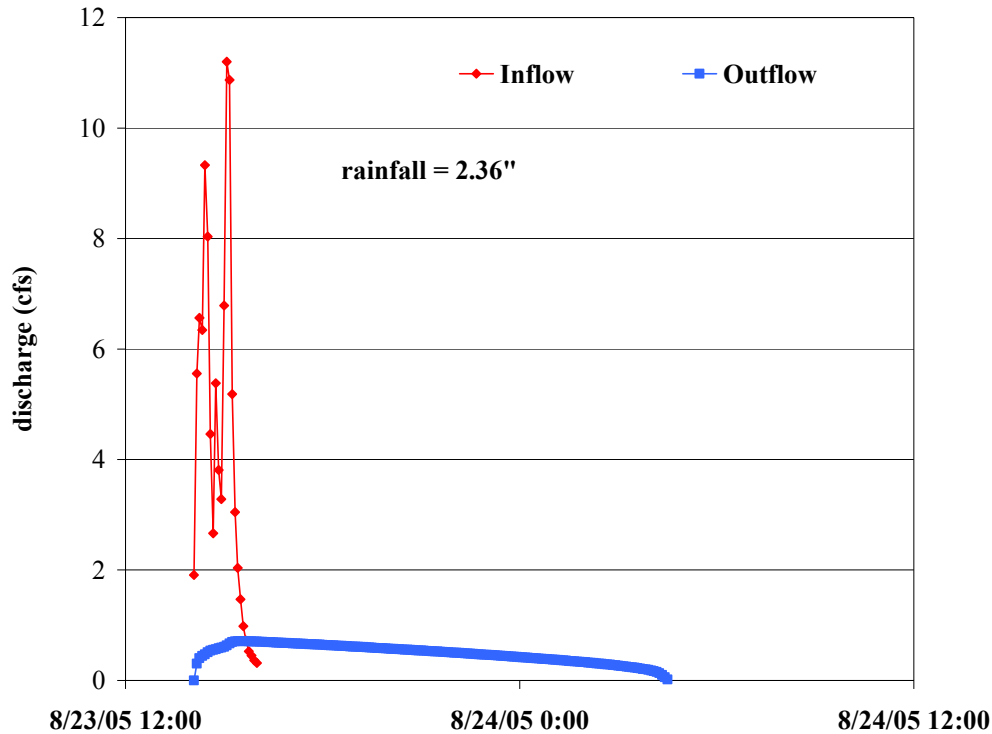
Figure 13 Morehead Dry Detention Facility Inflow and Outflow Hydrographs for Storm Event of 8-23-2005

For larger storms, the detention feature of the BMP was evident in the resulting hydrographs. Figure 13 shows the impact of the BMP on the outflow hydrograph from a 2.36 in. storm event. Similar reductions in peak discharge were observed in other storms of similar size. This reduction is expected for storm intensities exceeding the design storm intensity for the 2- yr 24 hr storm. Both composite and grab samples were collected for analysis. A summary of the results of these 8 storms is provided in Table 10.

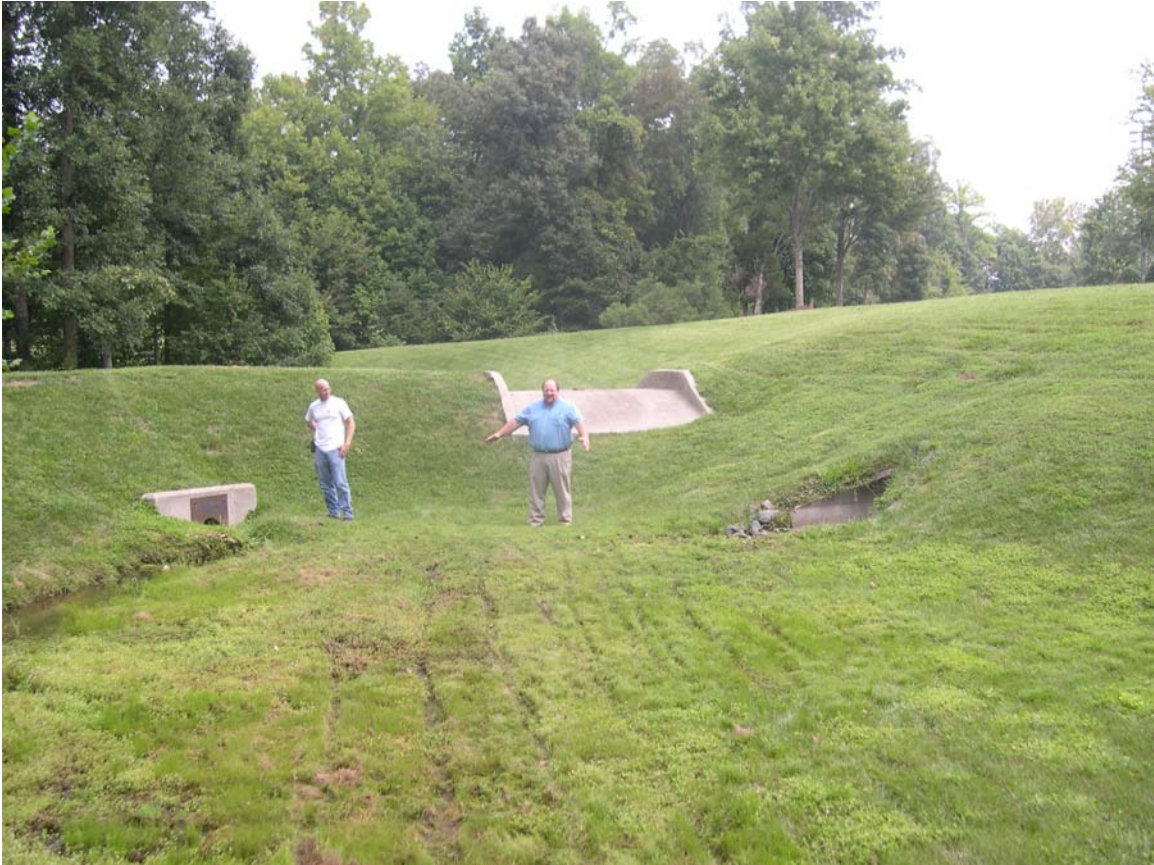
University Park Dry Detention

The University Executive Park Dry Detention is an extended dry detention basin treating a commercial office park and associated parking areas as well as some landscaped area. The watershed draining to the detention area is approximately 5.9 acres with approximately 70% of the watershed being impervious surfaces. The detention basin is fully vegetated with grass which appears to be well maintained and frequently mowed. Some erosion as well as sediment deposition has occurred within the detention bottom. The age of the basin is unknown at this time. Although the inlet to the detention basin is near the outlet, topography of the detention bottom causes low flows to follow a circuitous flow path such that contact time within the basin is not short circuited. A 24 in. RCP with a flared section acts as the dry detention inlet. The invert of the inlet pipe is approximately 6 in. higher than the average elevation of the detention bottom. The outlet utilizes a 14 in. circular orifice to allow for drawdown of stormwater detained within. The orifice is on the side of a fabricated concrete headwall attached to a 15 in. RCP. A cast in place concrete emergency spillway is installed over the detention berm. It is unlikely that the emergency spillway was utilized during any monitoring events.

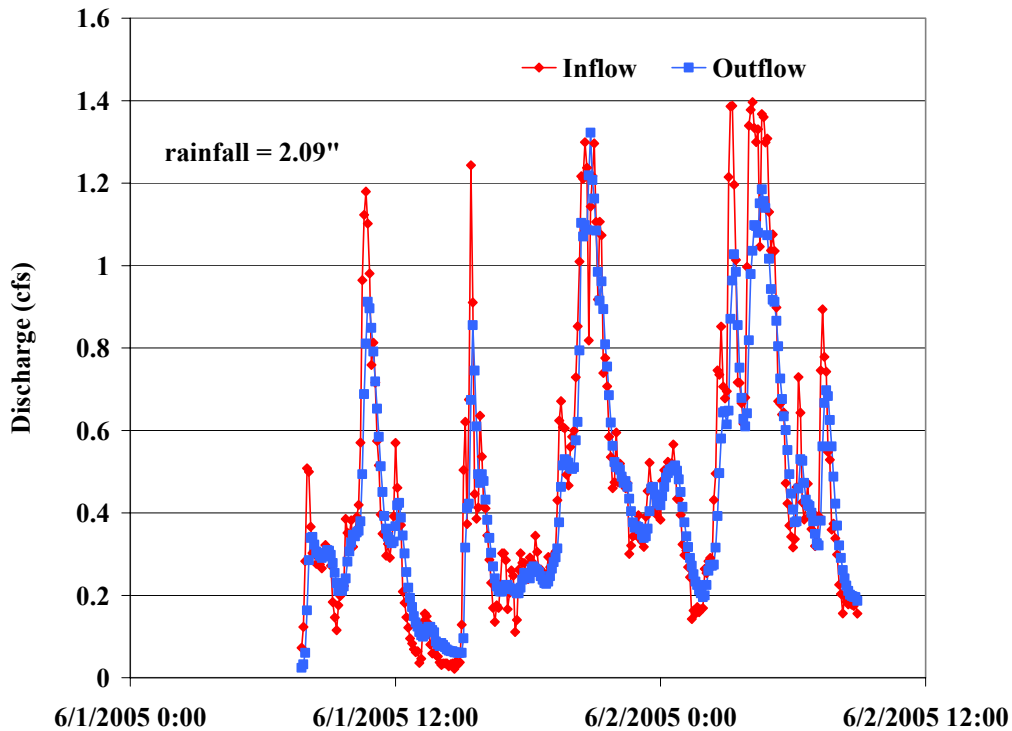
Figure 15 University Dry Detention Inflow and Outflow Hydrographs for 6/1/2005 Storm Event

Results for 6 storms monitored during the study period were available for analysis at the time of this writing. Although such a small number of sample events can not be reliably used for conclusions, some general observations can be made. Hydrologic results from the University Dry Detention basin were generally similar to results from the Morehead Dry Detention. Submerged conditions at the inlet were believed to have caused inaccuracies with the flow measuring capabilities of the area velocity meters at those locations. This effect was observed for several storms during the monitoring period. Two storms monitored during the study period consisted of rainfall events of larger than 1 in. Results from a large storm (2.09 in.) are shown in Figure 15. As can be seen, no significant reduction in peak discharges for this storm were observed. This is in contrast with the storm shown in Figure 13 in which a reduction of peak discharge was observed for a storm of similar size at the Morehead Dry Detention. No peak reduction in flows was observed during either of the large events which occurred during the monitoring period. The cause for this observed difference in hydrologic function is not known. It may be that the outlet of one of the basins is incorrectly designed or constructed or it may be a result of differences in the rainfall intensities of the monitored events.

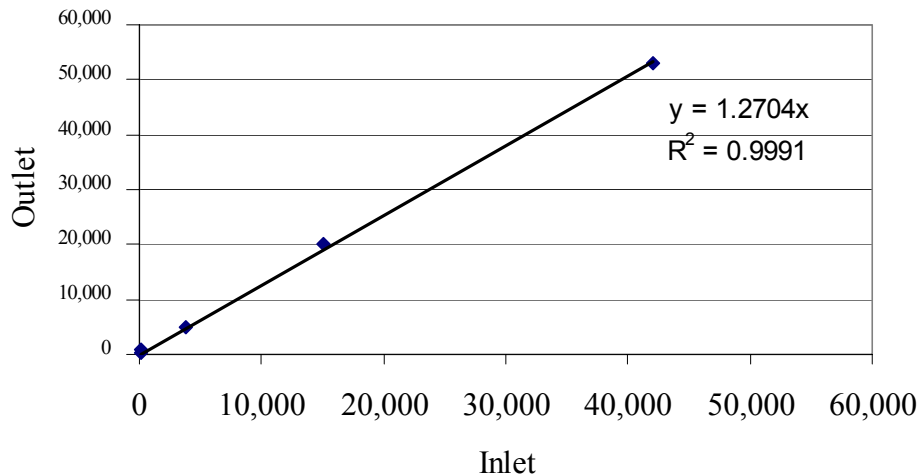
Figure 16 Fecal Coliform Concentrations at University Dry Detention

One specifically interesting trend observed is the slight increase in fecal coliform concentrations in the outlet grab sample. At this time it is unknown whether this increase is a result of normal data scatter or growth of fecal colonies within the basin during storm events. However as can be see in Figure 16 the relationship between inlet and outlet concentrations is quiet striking and shows a slight increase. Given the very low numbers of data points for analysis and short period of record, little conclusions can be drawn from these observations at this time.
