An International Round-Robin Test of NDE Reliability for PWSCC

George J. Schuster¹⁾, Stephen E. Cumblidge¹⁾, Steven R. Doctor¹⁾ and Carol E. Moyer²⁾

1) Pacific Northwest National Laboratory^a, Richland, WA

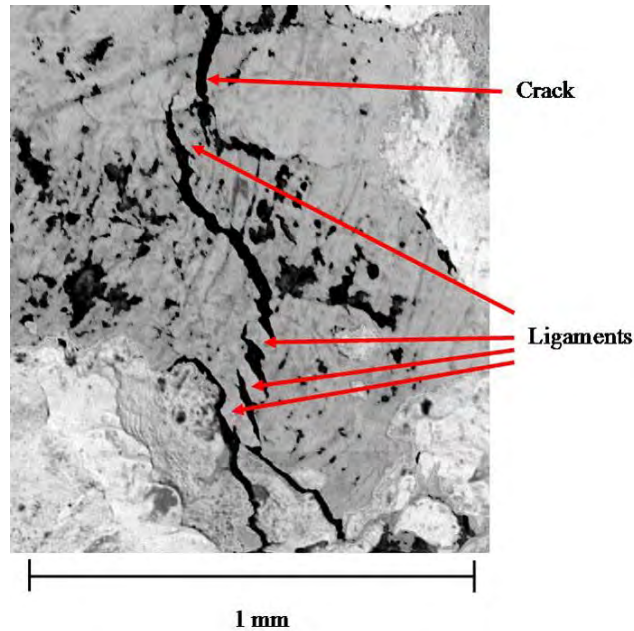
SEM of the wetted surface shows, in Fig. 1, that the crack has a discontinuous profile. Many separate, short (<1 mm) and very tight cracks were found on the weld surface. A 4-mm-long, 25-micron crack opening dimension (COD) discontinuous crack segment begins at the weld/butter boundary and extends at an angle into the buttering. A 2.5-mm-long and very tight (too tight for the SEM to measure in many places) tail extends further into the buttering towards the stainless steel cladding. One important feature of the crack at the surface is the discontinuous nature of the crack. Even along the 4-mm-long main segment there are several ligaments of metal crossing the crack.

Fig. 1 Electron Image of Portion of PWSCC on the Wetted Surface Examined for a Leakage Path in North Anna 2 CRDM Nozzle 31

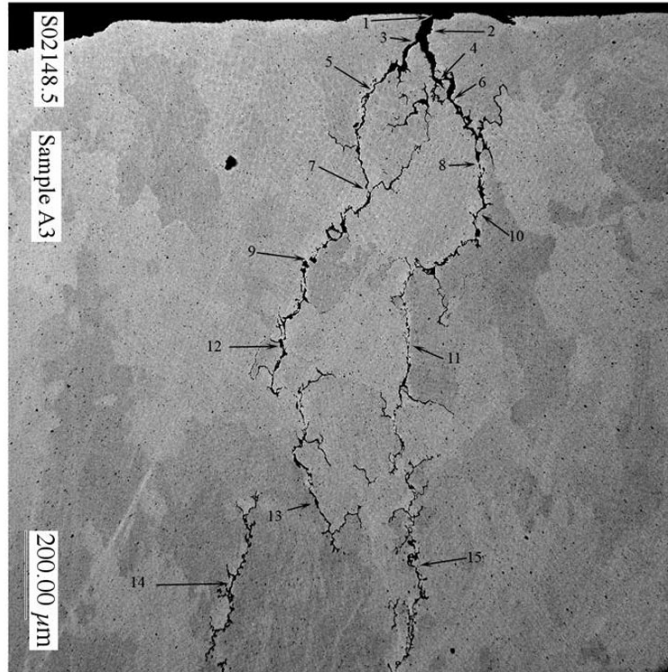
After the surface examinations were completed, the sample was sectioned into thin slices perpendicular to the crack. These slices were then polished and examined in an SEM. Of interest is a detailed look at the crack COD at various points along the crack. Fig. 2 shows the first 1.5 mm of the through-wall crack. Looking close to the surface, one finds several choke points very close to the surface of the crack. Points 3 and 4 are much tighter than the crack path above and below these points, which would reduce the effectiveness of dye penetrant testing (PT), and they are less than a tenth of a millimeter below the welded surface.

Location	COD (μm)
1	10
2	29
3	6
4	2
5	6
6	6
7	2
8	Closed
9	Closed
10	4
11	2
12	9
13	7
14	3
15	2

Fig. 2 PWSCC Width (COD) at Several Points Close to the Wetted Surface of North Anna 2 CRDM Nozzle 31

The crack characteristics determined via destructive examination correlate well to the NDE responses. The crack is reasonably tight and on a difficult surface for visual inspection, and was thus missed by direct visual testing (VT) and replica testing. The crack closes down to less than 10-microns wide very close to the surface, making it difficult to find using PT. The crack is oriented at a poor angle for detection with volumetric ultrasonic testing (UT) applied from inside the penetration tube. The discontinuous nature of the crack, both along the surface and through the first 3 mm of depth, reduces the amplitude of the eddy current response.

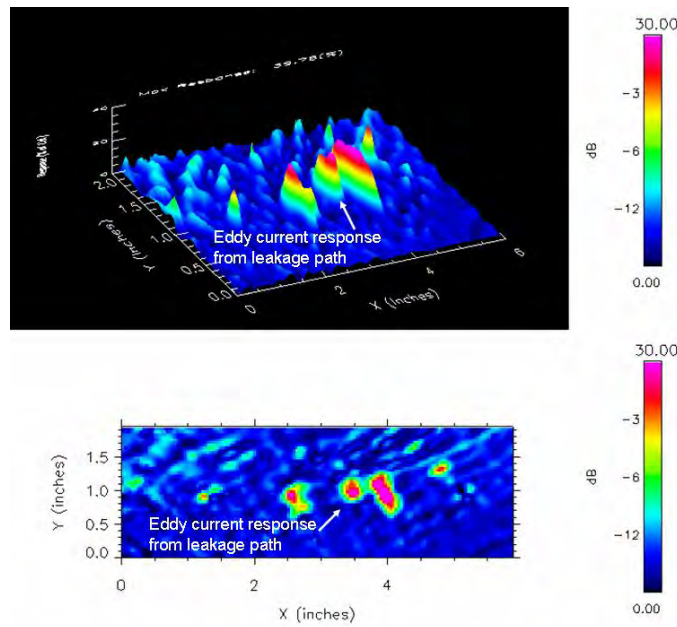
This section describes the eddy current apparatus and shows the eddy current images that were collected from the surface of North Anna 2 CRDM nozzle weldment number 31. Eddy current testing found the surface degradation associated with the PWSCC initiation site for the leakage path, and other confirmed PWSCC initiation sites. Fig. 3 shows the eddy current responses from the wetted surface area on a leakage path caused by PWSCC in nozzle 31.

Fig. 3 Eddy Current Responses from Crack Indication on a Leakage Path in North Anna 2 CRDM Nozzle 31

The eddy current probe used was a differential plus-point type of probe, manufactured by Zetec, model PP11A (+Point[®]) with part number Z0000857-1. This particular style of probe was used by Westinghouse (WesDyne) in the inspection of the V.C. Summer Unit 1 nozzle-to-pipe welds [9] and by PNNL in an earlier study on crack detection in cast stainless steel [10]. It consists of two coils at right angles to each other, making a plus or cross on the probe face. The coil widths are 3-mm

(0.120-in.) and the probe has a 12.5-mm (0.5-in.) spot size with a nylon wear face. The frequency range of this probe is approximately 100-800 kHz. The advantage of a differential coil is that material conditions, including lift-off, that affect both coils simultaneously are minimized. Conversely, conditions not common to both coils produce an imbalance in the electrical system and result in a larger recorded response. Thus, a plus-point probe performs better on rough surfaces than the traditional pancake-type probe that is adversely affected by variations in lift-off or coupling to the inspection surface.

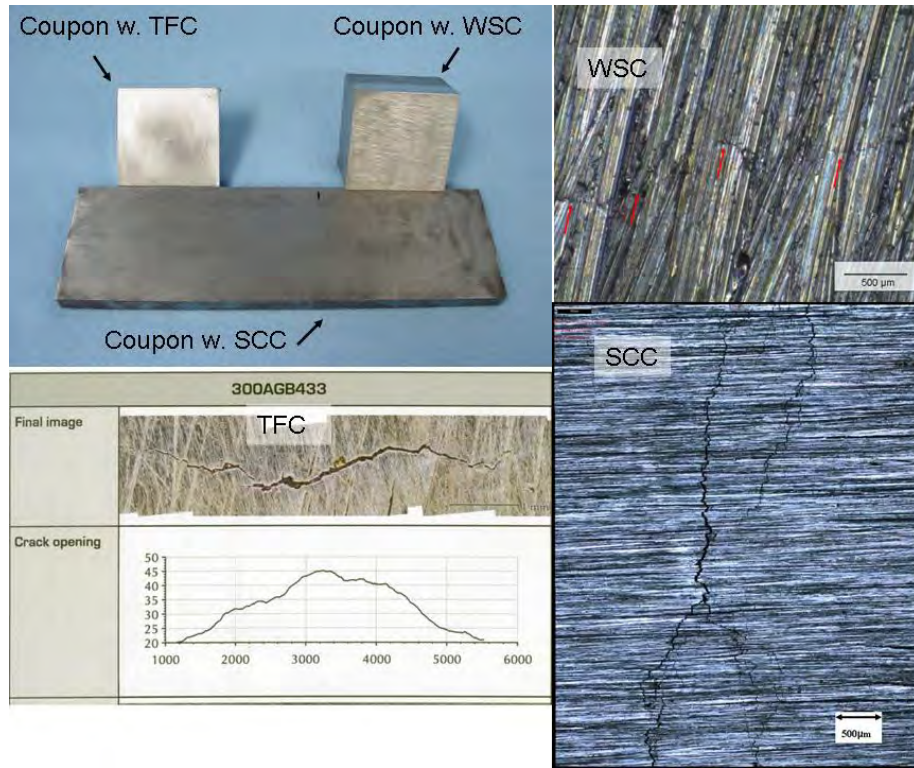
Fig. 4 shows the three cracked Alloy 182 weld metal coupons received at PNNL. The coupon on the left has a thermal fatigue crack that is 5.3-mm long and 2.3-mm deep. The thermal fatigue crack is introduced into the coupon with controlled thermal fatigue loading [11]. The coupon on the right in the figure has a weld solidification crack that is 10-mm long and 2-mm deep. Such a crack is introduced by performing a weld and adjusting the weld chemistry to produce a centerline crack that is bounded by the fused metal [12]. A laboratory-grown stress corrosion crack is in the coupon at the center of Fig. 4. The main crack is 28-mm long with a mean COD of 50 microns. The method for growing stress corrosion cracks is described in [13]. The method involves the manufacture of a test piece that is suitable for the application of tensile stress.

Fig. 4 Alloy 182/82 Weld Metal Coupons with Manufactured Cracks for Simulation PWSCC

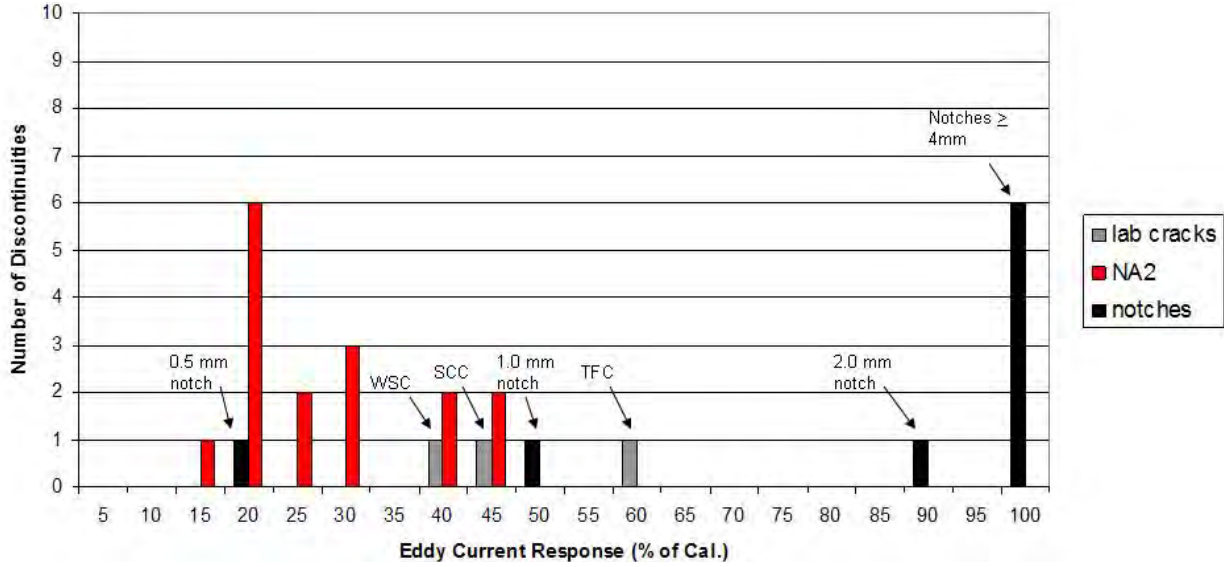
Fig. 5 is the summary chart of eddy current response distributions. The responses from 16 crack indications in NA2 nozzle 31, three manufactured cracks, and nine EDM notches are plotted. The 0.5-mm electrical-discharge machined (EDM) notch and 1.0-mm EDM notch approximately bracket the crack indication distribution. The responses from manufactured cracks are comparable to PWSCC crack indications producing the largest NDE responses.

Fig. 5 Eddy Current Response Distribution for Fabrication Flaws, PWSCC Indications, Manufactured Cracks, and Notches

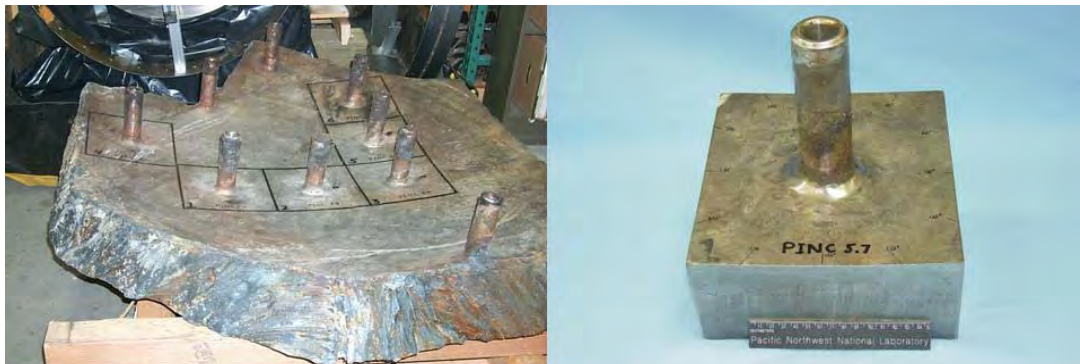
The most important missing product form in the open test blocks is Alloy 82/182 seal weld metal and buttering of CRDM and BMI assemblies. Fig. 6 shows a BMI nozzle penetration specimen from the cancelled Washington Nuclear Power Unit 1 (WNP-1). Six penetrations have been removed from the specimen. The six BMI nozzle penetrations are shown being prepared for separation using a band saw. Flame cutting was used as a first step to remove excess material in order to fit the specimen on the band saw. Machining of BMI nozzle penetrations from WNP-1 was completed and the penetration was prepared for NDE measurements. Fig. 6 also shows a picture of PINC BMI nozzle penetration seal weld test block 5.7. The test block is 175 mm on a side, 75-mm thick, and weighs 45 kg.

Fig. 6 Portion of Bottom Head from the Reactor Pressure Vessel of the Cancelled Nuclear Plant WNP-1 and a Test Block Removed from It

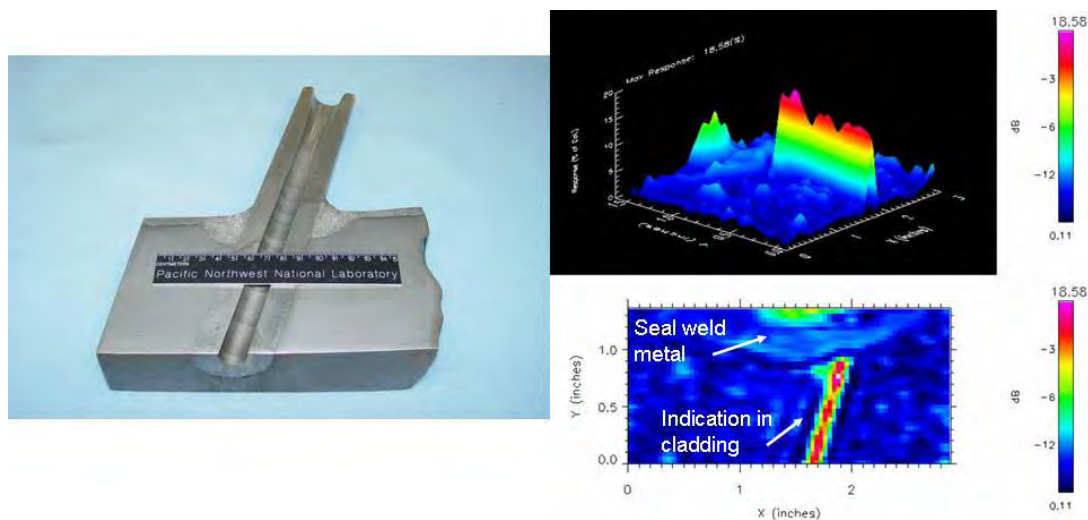
Fig. 7 shows a cross section and macro-etch of another BMI nozzle penetration seal weld specimen from WNP-1. The figure shows the tube geometry, the interference fit with the carbon steel on the bottom head, the seal weld metal, and the cladding of the bottom head inside surface. There is no buttering product form in the figure or in any of the WNP-1 BMI nozzle penetration weldments selected for the PINC mockup. Eddy current testing was performed on the six test blocks. Fig. 7 also shows an indication of a fabrication flaw in the cladding of one of the BMI test blocks. There are more than 10

such cladding flaws in the six test blocks. Their signal strength is high and similar to that from the crack indications in North Anna 2 nozzle 31, but location can be used with weldment design information to characterize these indications as fabrication flaws that should not present a problem for knowledgeable inspectors. Yet, they are interesting as a test of inspector expertise.

Fig. 7 Macro-etch of Seal Weld and Eddy Current Response from a Fabrication Flaw in the Cladding

The macro-etch on the left of Fig. 7 shows the weld profile. The eddy current images on the right were taken from the wetted surface of the seal weld.

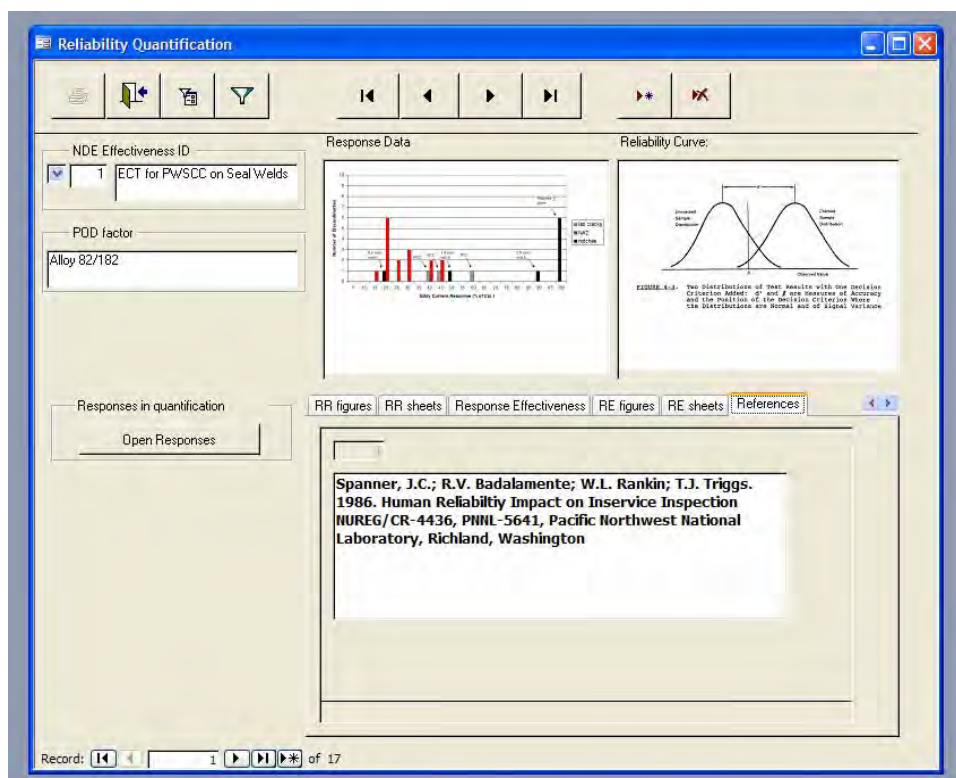
Most important for the database is quantification of NDE reliability. Fig. 8 shows the data viewing form for NDE effectiveness. NDE effectiveness in the in-service inspection of welds in light water reactors is typically measured by performance demonstration in a blind test of cracked and blank weld segments called grading units. Another method for quantifying NDE reliability is the parametric study, where the distributions of noise and signal responses are determined from the data, and the overlap of the two distributions is a measure of unreliability. The reference shown in Fig. 8 is the source for the reliability curve shown at the top right in this figure.

Fig. 8 Data Viewing Form for NDE Effectiveness Information in the PINC Atlas Database
