EXPERIMENT AND ANALYSIS ON THE CREEP-FATIGUE DAMAGE OF A 316SS NONLINEAR STRUCTURE IN LIQUID METAL REACTOR SUBJECTED TO A CYCLIC LOADING WITH 1HR HOLD TIME

J.B. Kim, H.Y. Lee, C.G. Park, and J.H. Lee
Korea Atomic Energy Research Institute, Korea
150 Dukjin-dong, Yuseong-gu, Daejeon 305-353, South Korea
E-mail: jbkim@kaeri.re.kr

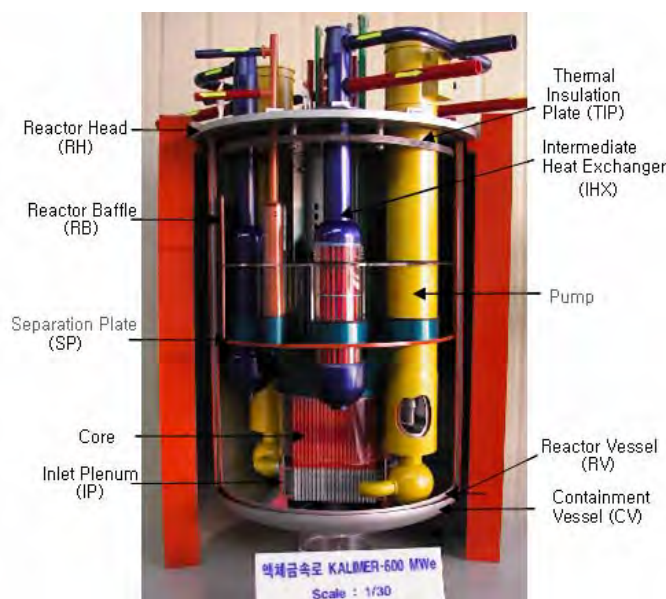
Fig. 1 KALIMER-600 Reactor Structures

The 600MWe Liquid Metal Reactor KALIMER-600[1] has been under development in Korea and the operating temperature is 545°C. Therefore the high temperature reactor structures may exhibit a highly nonlinear elastoplastic deformation behavior such as ratcheting and the time dependent creep deformation during the high temperature operation periods. This creep behavior of the structure induces difficulties in the assessment of a high temperature structural integrity. The creep-fatigue damage is one of the principal concerns to be dealt with for its structural integrity. Low cycle fatigue damage due to a thermal transient loading interacts with the creep damage during a high temperature hold time and this interaction reduces the life of the high temperature structures. The high temperature structure design guidelines such as BDS[2], RCC-MR[3], and ASME-NH[4] depend mainly upon the elastic approach with conservatism. Even though these guidelines allow one to use a detailed inelastic analysis method, they do not provide the proper inelastic constitutive equations. Thus a systematic analysis technology utilizing an inelastic analysis, accounting for both the time independent plasticity and the time dependent creep behaviors for a reliable structural safety assessment is necessary.

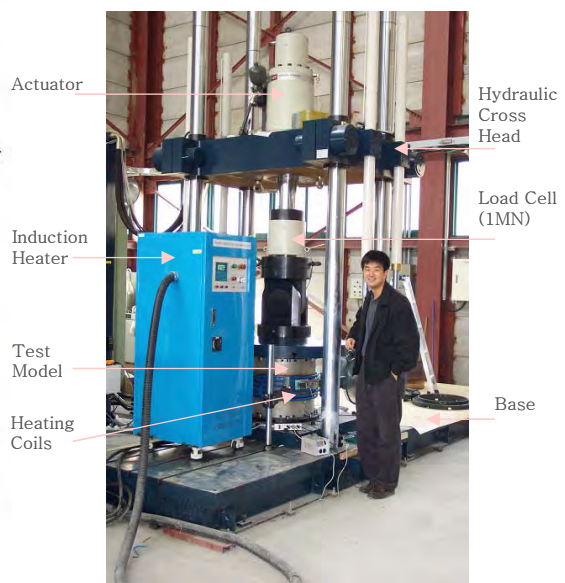
Fig.2 Creep-fatigue Test Facility

The creep-fatigue test facility is composed of a 1MN hydraulic actuator, load frame and an anchored base plate as shown in Fig.2. Heating unit applying the thermal load is a high frequency induction heater of which the capacity is 50kHz and 50kW. Fig.2 shows 6 turns of the copper heating coil surrounding the structural model used to apply the heat to the center zone of the test model.

Axial tensile load was applied by the IST 1MN hydraulic actuator by simulating the dead weight of the reactor structures and the thermal load was applied by a high frequency induction heater simulating the startup-hold-shutdown condition. The load and displacement data was collected continuously by a Labtronic-8800 controller. Vertical strain was measured by the high temperature extensometer (Instron Model 2632) and the radial displacement was measured by the LVDT(Schaevitz Model CA-121-200). The filament type high temperature strain gages developed by the Measurement Group (Model C-020708-D) were installed by a spot welding along both the longitudinal direction and the circumferential direction to measure the strains directly.

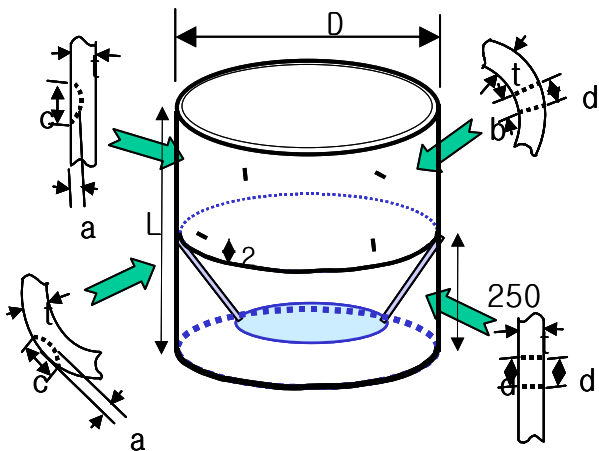
Fig. 3 Creep-fatigue Test Model

The creep-fatigue structural test model is a geometrically nonlinear structure of which the shape is a cylinder and a cone type skirt is attached to the inside surface of the cylinder at a center location by TIG welding as

shown in Fig. 3. The Type 316 stainless steel is used for the test model and the thickness, outer diameter, and height of the test model are 5mm, 600mm and 500mm, respectively. The thickness and length of the cone structure are 5mm and 200mm, respectively. And 4 defects were prepared by an electric discharge machining arranged at 90 degree intervals along the circumferential direction to obtain the accelerated damage development ahead of the defect front. Two of them are through wall defects, 20mm in length and 0.25mm in corner radius each, and arranged in the vertical direction and circumferential direction, respectively. Another two defects are elliptic shaped surface defects, 20mm in length and 1.25mm in depth, and arranged in the vertical direction and circumferential direction, respectively.

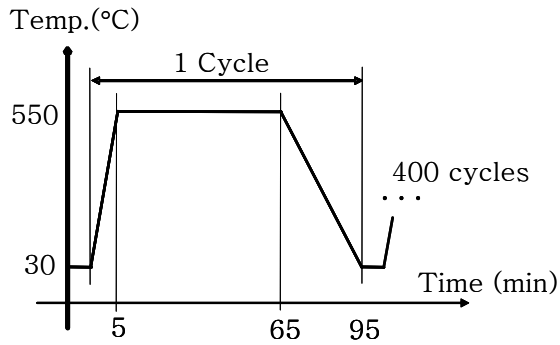
Fig.4 Creep-fatigue Temperature Loading

Tensile load was increased to 500kN for 10 seconds, maintained for 1 hour, and removed. Load control was accomplished by Labtronic 8800. At the same time, the thermal load was applied to the center region of the test model as shown in Fig.4 using a high frequency induction heater. . It took 5 minutes for the temperature of the test model to reach 550°C. Thermal load was controlled to maintain the temperature of the test model at 550°C for one hour and then removed. One cycle of loading took 95minutes and a total of 400 cycles of testing were carried out.

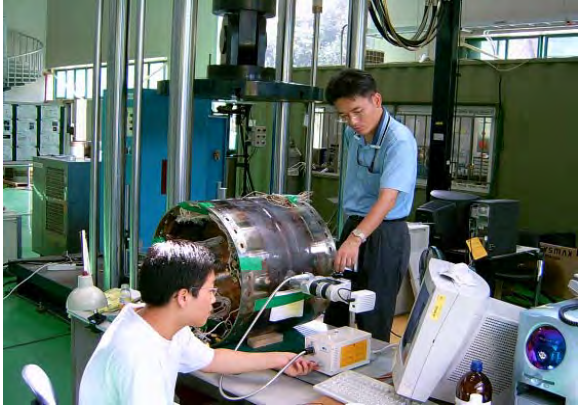
Fig. 5 Surface Examination (DZ2)

The interim field inspection was scheduled for every 100th cycle of the testing. A nondestructive metallurgical inspection was performed on the spot. A portable optical zoom microscope, shown in Fig.5, was used to investigate the creep-fatigue damage on the test model with the maximum magnification ratio of 3500 times. Several inspection points on the test model were ground, polished, and etched according to the standard procedure[15]. To supplement the optical observation results, a replica technique was utilized on the spot. After a surface treatment, several spots of interest were carefully replicated. The scanning electron microscope (SEM) was used to investigate the creep-fatigue damage evolution as shown in Fig.6.

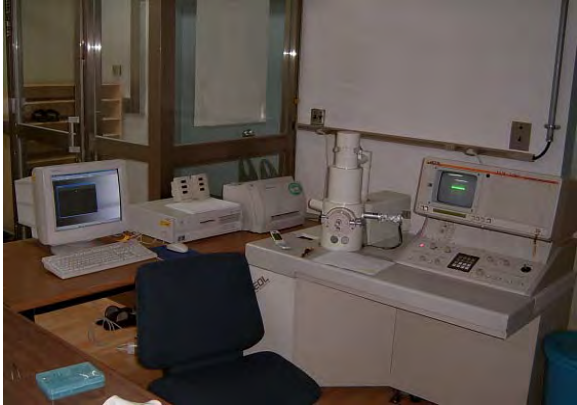
Fig.6 Scanning Electron Microscope (JEOL)

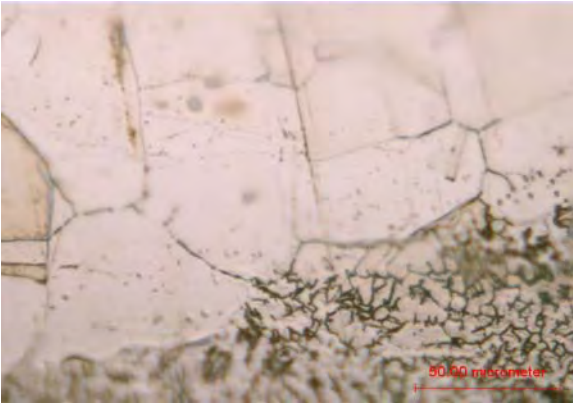
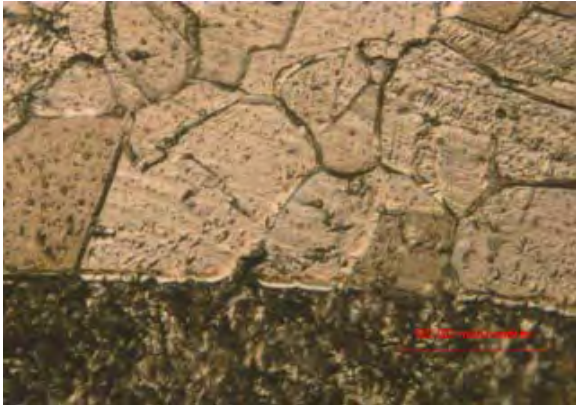
Figure 7 and Fig.8 show the interior geometrically nonlinear region where the cone structure was welded to the inside of the cylinder model after 100 cycles and 400 cycles, respectively, magnified 2200 times and the apparent creep-fatigue damage is hardly observed along the grain boundaries.

Fig.7 Interior Nonlinear Region (100cycles, X2200)

Fig.8 Interior Nonlinear Region (400cycles, X2200)

It is considered that the test time of 400 cycles is not yet ripe for the generation of the creep-fatigue damage in the test model other than the defect regions as shown in Fig.7 and Fig.8. In the vicinity of the defect front, the creep-fatigue occurred and formed microcracks since the stress values around the defect front were large enough to generate the creep-fatigue damage with a given amount of testing cycles as shown in Fig.9 ~ Fig.14. Another point of interest is the observation of the growth behavior of the microcracks initiated after a certain number of testing cycles. With 400 cycles of a testing, microcracks seemed to grow at a constant speed but it is premature to derive a conclusion regarding the crack growth behavior in this test model at this time. It is necessary to perform further cycles of a testing to examine the growth behavior of microcracks into macrocracks.

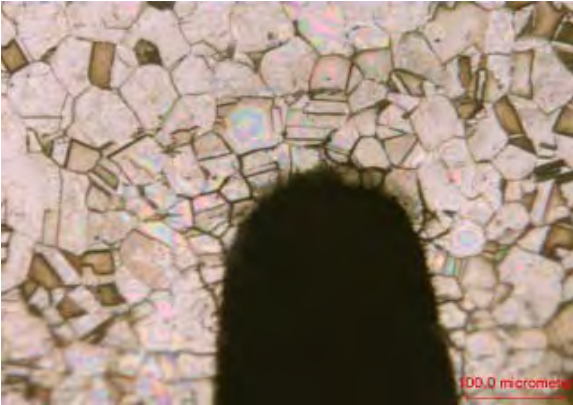
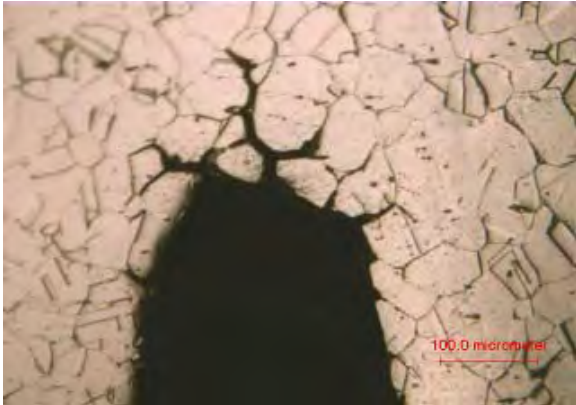
Figure 9 and Fig.10 show the vicinity of the vertical through wall defect of the test model after 100 cycles and 400 cycles, respectively, magnified 350 times. The creep-fatigue damage occurred and formed microcracks along the grain boundaries emanating from the edge of the defect front.

Fig.9 Vertical Defect Front (100cycles, X350)

Fig.10 Vertical Defect Front (400cycles, X350)

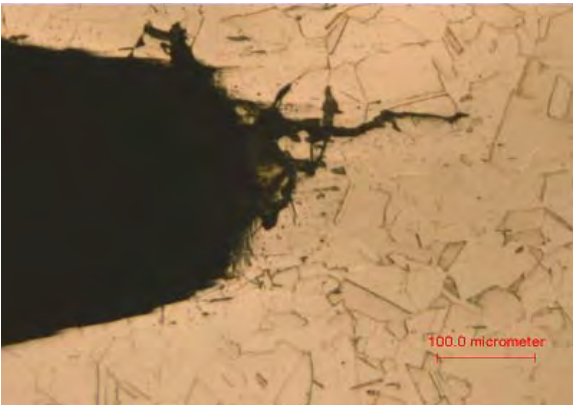
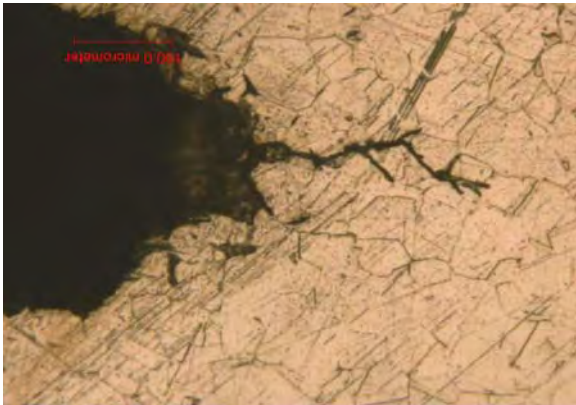
Fig.11 Horizontal Defect Front (300cycles, X350)

Fig.12 Horizontal Defect Front (400cycles, X350)

Figure 11 and Fig.12 show the vicinity of the horizontal through wall defect of the test model after 300 cycles and 400 cycles, respectively, magnified 350 times. The creep-fatigue damage occurred along the grain boundaries emanating from the edge of the defect front and had grown into a microcrack of which the size was approximately 0.32mm. Figure 13 and Fig.14 show the vicinity of the defect front observed by the SEM after 100 cycles and 400 cycles, magnified 2000 times, respectively. The surface was replicated on the spot for convenient observation using the SEM. After 400 cycles of a testing, it is clearly seen that the precipitations were produced along the grain boundaries due to the creep-fatigue damage.

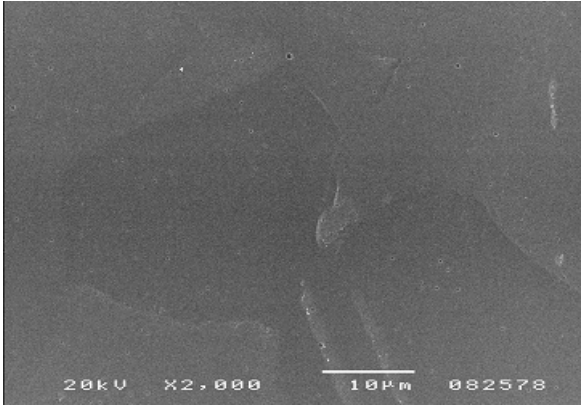
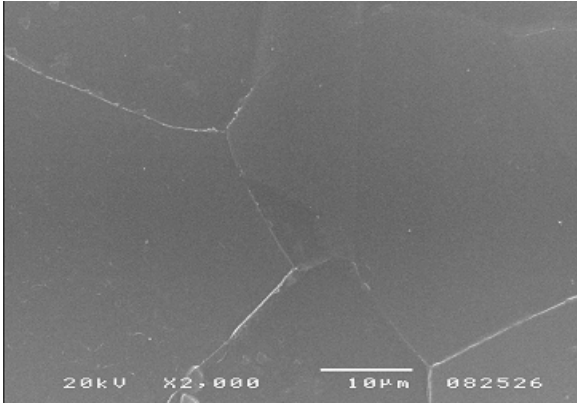
Fig.13 Horizontal Defect Front (100cycles, X2000)

Fig.14 Horizontal Defect Front (400cycles, X2000)

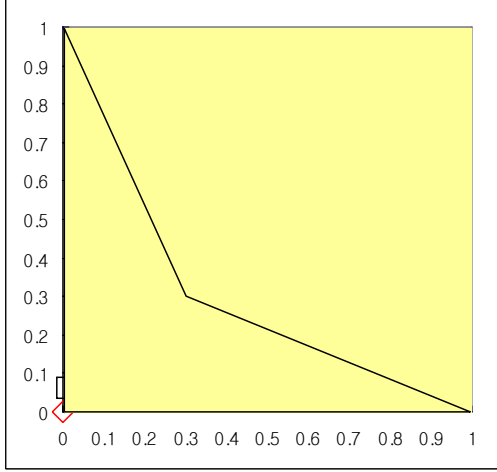
The above creep-fatigue damage was assessed by equation (7) and is indicated in the creep-fatigue damage interaction diagram, Fig.17, and it can be seen that a small amount of damage agrees with the test result.

Fig.17 Creep-fatigue Damage Envelop

The equivalent stress histories were segmented by several flat regions and the creep damage was calculated for each region. Linear summation of each creep damage leads to a total creep damage and it is 0.0013 at node 68. Creep-fatigue damage assessed by the inelastic approach is shown in Fig.17 and it can be concluded that the creep-fatigue damage for 400 cycles is very small as in the case of the elastic approach. The required number of test cycles to have an apparent creep-fatigue damage in the test model other than the defect region based upon the elastic approach is 4,000 and the one based upon the detailed inelastic analysis is 100,000. While it is premature to jump to a conclusion from the comparison of 400 cycles of the testing results and the analysis results, the creep-fatigue damage assessment near the defect region was carried out and compared with the test results.

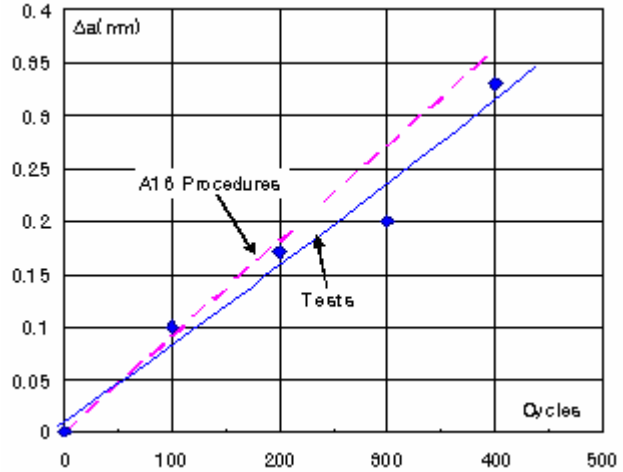
Fig.18 Crack Growth Comparison

The creep-fatigue crack growth after 400 cycles of a testing was 0.36mm and this slightly overestimates the test results as shown in Fig.18. Even though a good agreement between the analysis and the test results was obtained with 400 cycles, it is necessary to perform more cycles of testing to deduce final conclusion. After 800 or 1000 cycles of a testing, it is expected that the propagated crack may be regarded as a macrocrack and we can investigate the crack growth behavior of both a microcrack and a macrocrack.
