## Rupture Tests with Reactor Pressure Vessel Head Models

Heli Talja, Heikki Keinänen, Ensio Hosio, Pekka H. Pankakoski, Klaus Rahka

VTT Industrial Systems, Espoo, Finland

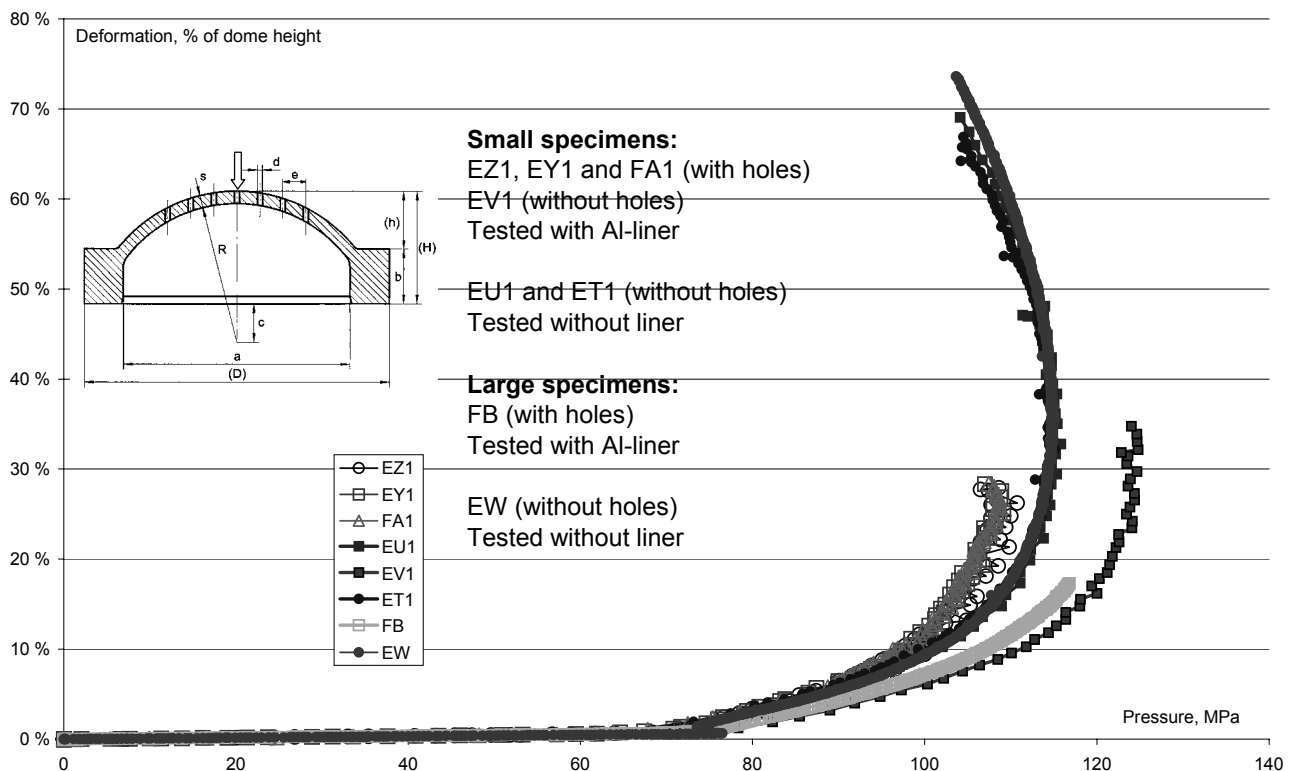
Fig. 3. Scaled dome displacement as a function of internal pressure.

Figure 3 shows the measured scaled dome displacement of each test as a function of pressure. The results seem to fall in four groups:

- 1) the tests with the specimens EU1, ET1 and EW without holes;
- 2) the test with the small specimen EV1 without holes which was tested with liner for comparison;
- 3) the three test results with small specimens EZ1, EY1 and FA1 with holes and
- 4) the test with the large specimen FB with holes.

Groups 2 and 4 contain both only one tests. Only in group 1 the tests continued beyond the strain at maximum pressure whereas this happened in none of the tests with a liner. Comparison of test groups 1 and 2 indicates that the liner increases the maximum pressure by about 10 MPa. The increase of maximum pressure appears to be an artefact due to the observed liner displacement during the test such that the strength of the lower ring of the liner increases the strength of the assembly.

Lowest maximum pressure values were obtained in the tests of group 3. The three tests in this group show very similar behaviour. The test with specimen FB (group 4) shows abnormal behaviour. The measured pressure values exceed clearly those in the corresponding tests with small specimens (group 3) while no difference was observed in the case of different specimen sizes without holes. Obviously the difference is thus connected to the behaviour of the liner.

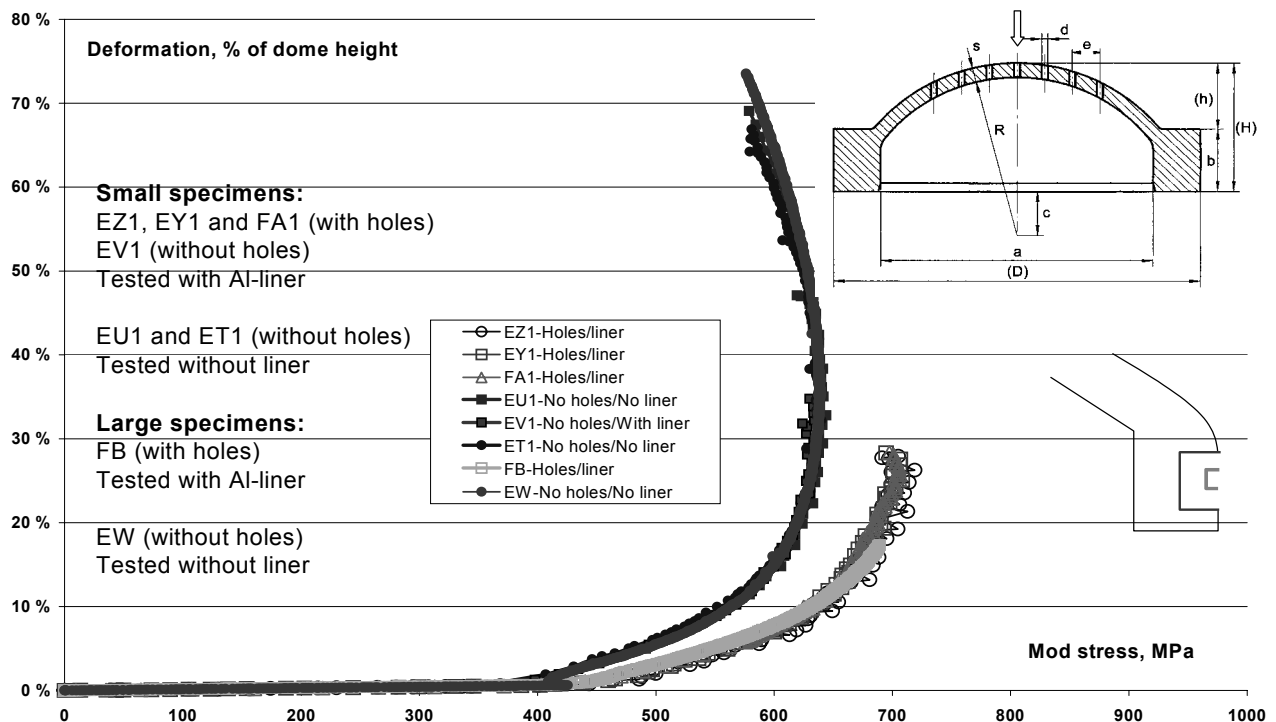
Fig. 4. Normalised membrane net stress for steel dome versus deformation of specimen.

Pressure-displacement records were normalised using global membrane stress and shape criteria and relative strength values for the steel specimens and the aluminium liners (Fig. 4). The test pressures were converted into steel net section membrane stress by adopting the usual sphere stress formula and factors for the liner thickness and strengths and the hole configuration.

It was found that a value for  $k = 0.32$  for the smaller liner and  $k = 0.72$  for the larger produced consolidation of the different test records (taking aluminium yield stresses as 234 MPa for both small and large liners). A ratio of 1.13 is found for the "strengthening" effect of the holes using these net section membrane stress criteria, or a factor of  $1.13/1.28 = 0.884$  for the weakening effect of the holes on the global behaviour disregarding holes in the stress calculation. The consolidated curves are shown in Figure 4.

The factor 1.13 on the net section strength is interesting because it is close to the ratio of fully plastic principal stress components for plane strain and equibiaxial strain thus proposing that the specimen ligaments between holes adopt a plane strain deformation mode whereas the dome without holes remains in the equibiaxial mode. This interpretation may be fortuitous, because the stress-strain concentration effect of the holes is neglected and the net section factor 1.28 is related to the less densely spaced 90 degree configuration prevailing in the dome centre.

The factors  $k$  for small and large liners differ by a factor slightly larger than 2 for several tentative reasons. The factor 2 can be deduced back to the retaining effect of the larger lower flange of the larger liner (relatively the O-ring groove is much smaller than in the small liner) preventing the larger liner to slip into the test specimen during pressurisation and causing the large liner into equibiaxial tension. The smaller liner was observed to slip into the steel dome during its deformation indicating that the small liner was forced into a "deep drawing" or pure shear deformation mode, which occurs at half the value of principal stress compared to equibiaxial tension. Hence the ratio around 2 between the factors  $k$  in the normalisation for the effect of small and large liners.

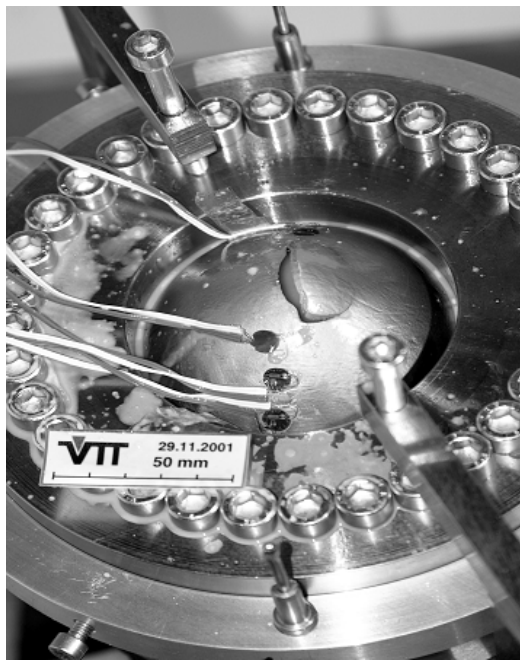
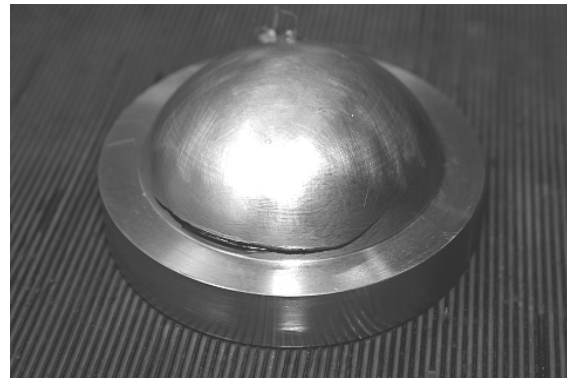
Fig. 5. Specimens EU1 (left) and EV1 (right) after testing. Specimen EV1 was tested using a liner, which caused a premature failure by a failure mode deviating from those tested without liner.

Figure 5 shows a typical example of a tested small specimen without holes. The failure occurred as a leak at the uppermost part of the dome where the tensile strains are the highest. The effect of the liner reduced the failure strain and changed the mode of failure as is also demonstrated in Figure 5. As shown in Figure 6, the failure of the large specimen without holes (EW) was quite dramatic. A part of a size of about  $20 \times 15 \text{ cm}^2$  fragmented from the specimen. The related damage around the test set up was contained due to the precaution of testing upside down. Accordingly the loose part hit against a rigid floor and no serious damage was caused to the surroundings.

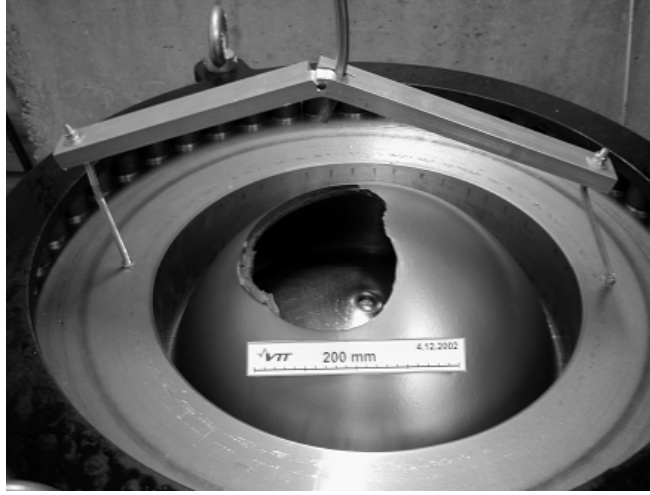
Fig. 6. Specimen EW (large size) after testing.

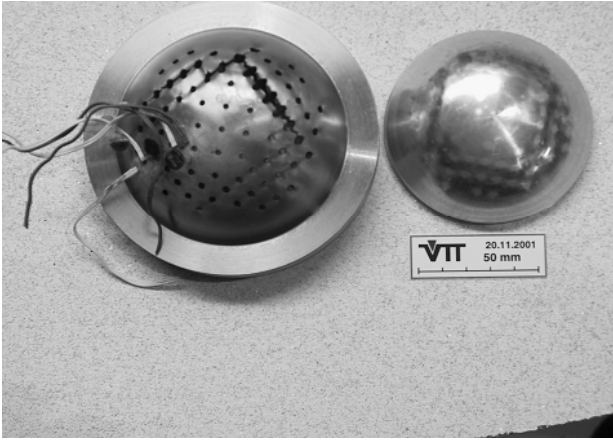
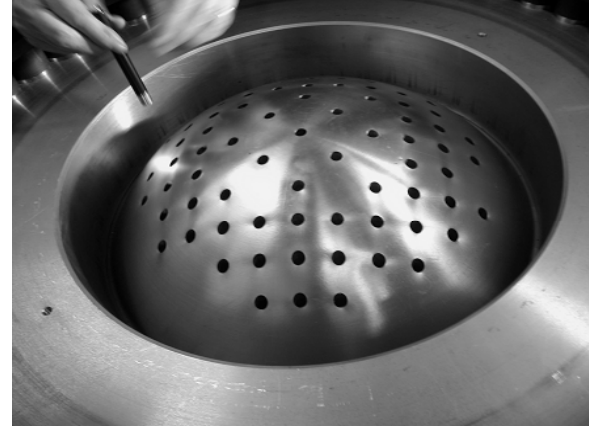
Fig. 7. Specimen EZ1 (small size) after testing, shown with the liner (left). Right: Specimen FB after testing. The test ended due to the failure of the liner.

Figure 7 shows tested specimens with holes. On the left hand side is a typical example of a tested specimen with holes. Also the liner is shown. In this case the specimen broke along the first row of densely spaced holes, counting from the dome top. The test with the large specimen FB ended somewhat prematurely due to the failure of the liner. However, a similar yield pattern can already be recognised to develop which has caused the failure of the specimen EZ1.

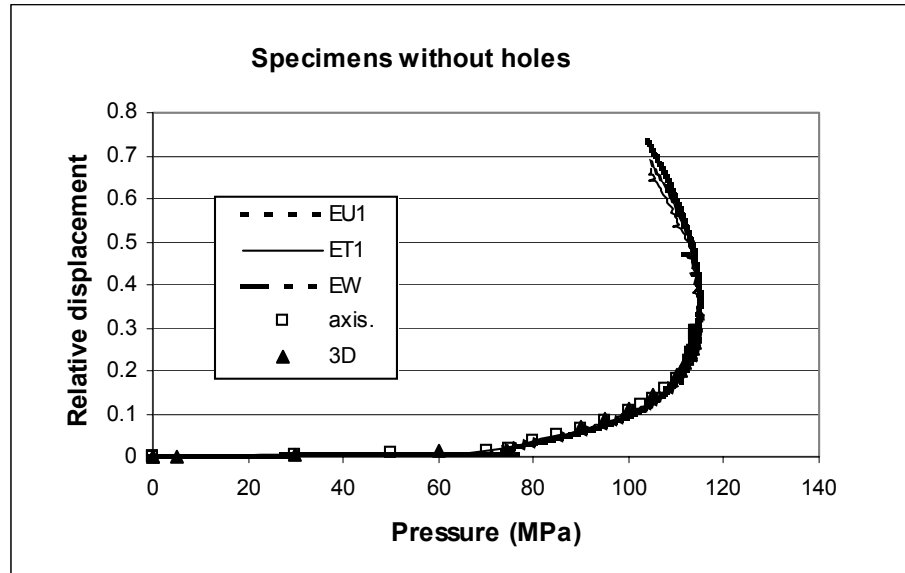
Fig. 8. Comparison of axisymmetric and three-dimensional FE results with the experimental ones for the specimens without holes.

Figure 8 shows a comparison of the results of the computations, which were aimed for planning of the experimental setup, to the measured ones for the specimens without holes. As the computed results were produced using a classical elastic-plastic material model without considering the softening effect due to damage, they reproduce only the ascending part of the load path. For this part the experimental results are predicted very well with both computations and the estimated maximum pressure is within 1% agreement with the experimental result.
