**SMILE: EXPERIMENTAL RESULTS OF THE WP4 PTS LARGE SCALE
TEST PERFORMED ON A COMPONENT IN TERMS OF CRACKED
CYLINDER INVOLVING WARM PRE-STRESS**

This paper deals with the results of the PTS type transient experiment on a component-like specimen subjected to WPS- loading, the so called Validation Test, carried out within the framework of

work package WP4. The test specimen consists of a cylindrical thick walled specimen with a thickness of 40mm and an outer diameter of 160mm, provided with an internal fully circumferential crack with a depth of about 15mm. The specified load path type is Load-Cool-Unload-Fracture (LCUF). No crack initiation occurred during cooling (thermal shock loading) although the loading path crossed the fracture toughness curve in the transition region. The benefit of the WPS-effect by final re-loading up to fracture in the lower shelf region, was shown clearly. The corresponding fracture load during reloading in the lower shelf region was significantly higher than the crack initiation values of the original material in the lower shelf region.

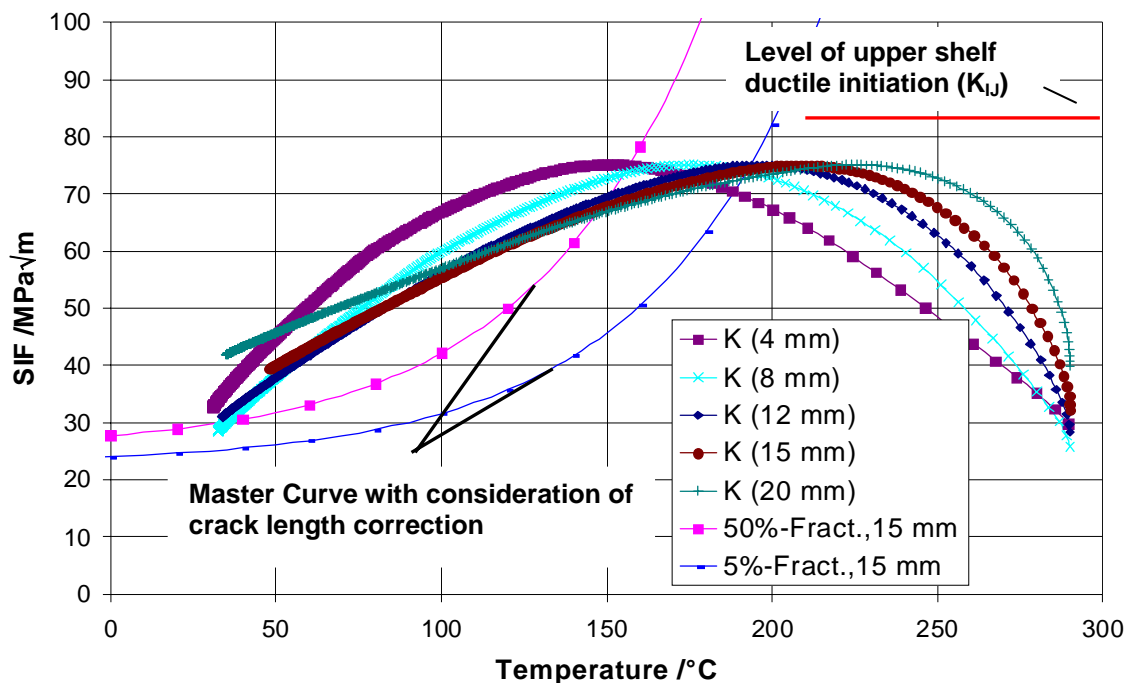
Fig. 5: Calculated load paths for crack depths 4, 8, 12, 15 and 20 mm of the Test Specimen

The goal for pre-loading was defined in reaching a load level of about 10% under the lower line of the K_{IJ} – scatter band in the upper shelf region, where $K_{IJ}^2 = E'J_i$. This value amounts to $75 \text{ MPa}\sqrt{\text{m}}$. Since this value cannot be reached by thermal shock loading only, an initial tensile load is applied. Figure 5 shows the non-linear design-calculations of MPA by means of the Finite Element Code ABAQUS. 50%- and 5%- Master Curves, which have been corrected to the actual component crack length, are shown as well in Fig.5. The influence of the total crack lengths on the Master Curves is rather small, so that the presented 50% Fract. and 5 % Fract. Master Curves (crack length: 346 mm, crack depth: 15 mm) are representative for all the depth values considered.

- Crack depth 4 mm: High risk of initiation during warm pre-stress
- Crack depth 12 mm: Low risk of initiation during warm pre-stress
- Crack depths 15 mm: Nearly no risk of initiation during warm pre-stress

The design calculations show that for crack depths greater than 12 mm the intersection-point with the Master Curves lies in the decreasing part of the load-paths, where there is no risk of failure due to the warm-pre-stress-effect.

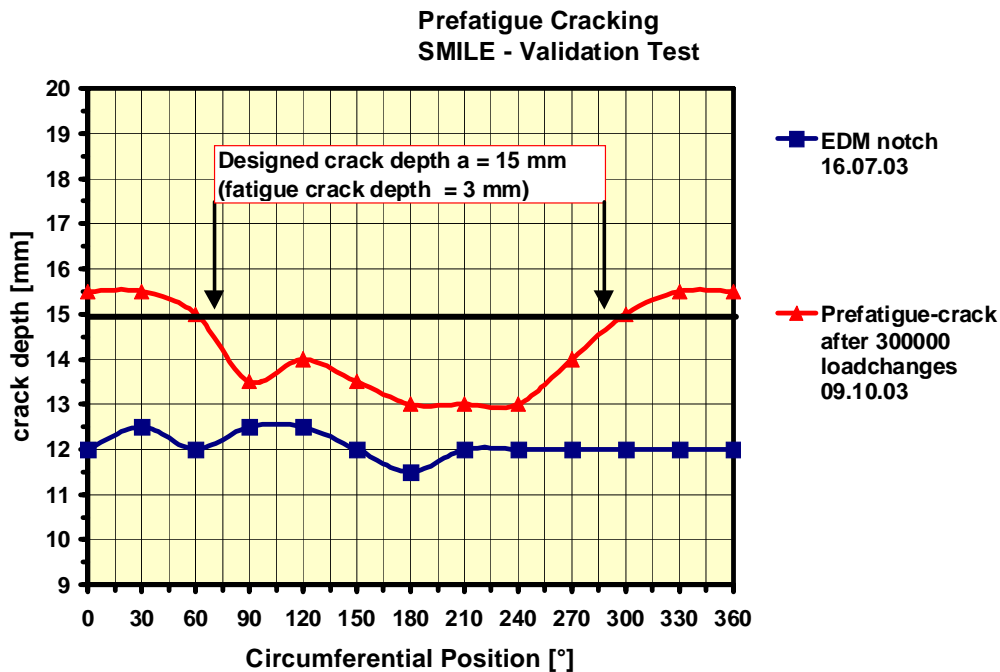
Fig. 7: Depth of the circumferential crack in the validation test specimen

The initial crack was induced by electrical discharge machining (EDM) and then further extended by fatigue with internal pressure, Fig. 7. This produced slightly non-symmetric crack-growth and was stopped at an average crack depth of 14.3 mm based on online ultrasonic measurements. Post-test investigations of the crack surface yielded an average crack depth of 14.9 mm.

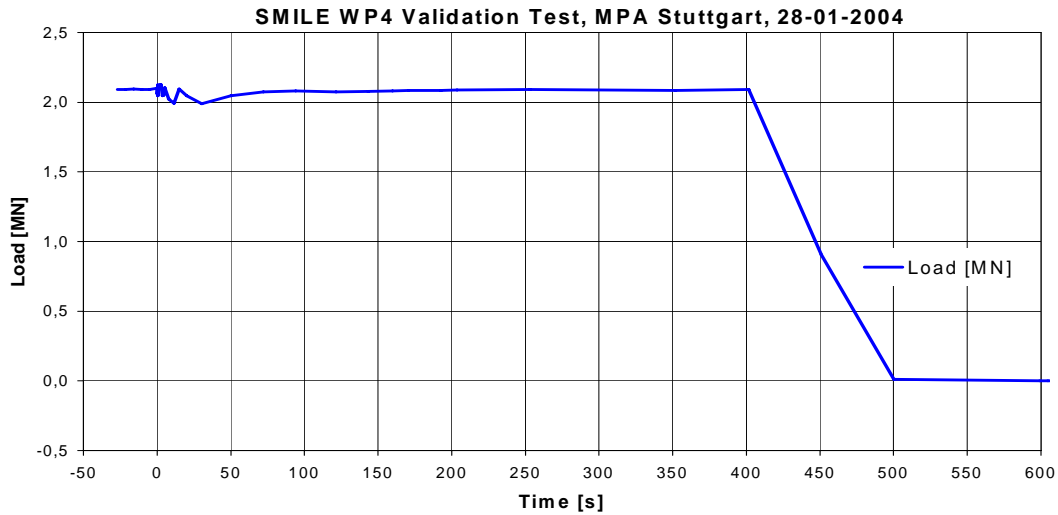
Fig. 8: Tensile load during thermal shock transient PTS

As mentioned above the specimen was loaded by a combined tensile load and thermal shock. The tensile load applied by the testing-machine is regulated manually. Immediately after thermal shock at $t \sim 0$ s the tensile load was held at a value between 2.0 MN and 2.1 MN until 400s after starting PTS (Fig. 8). On-line calculations of K_I versus time on the basis of measured temperatures showed that the real load path was close to that specified, Fig. 9.

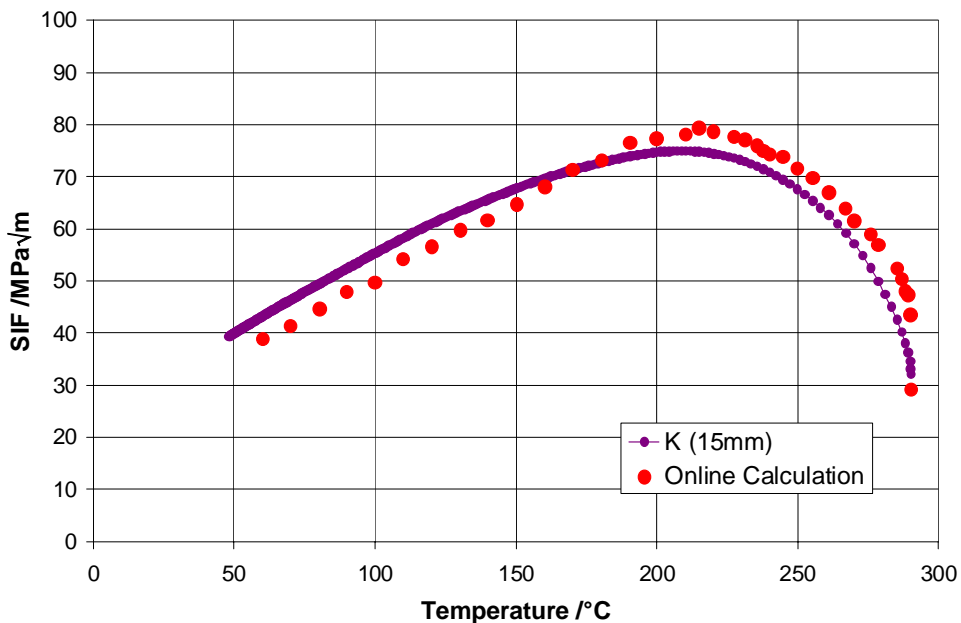
Fig. 9: Comparison of designed load path with the online-calculation

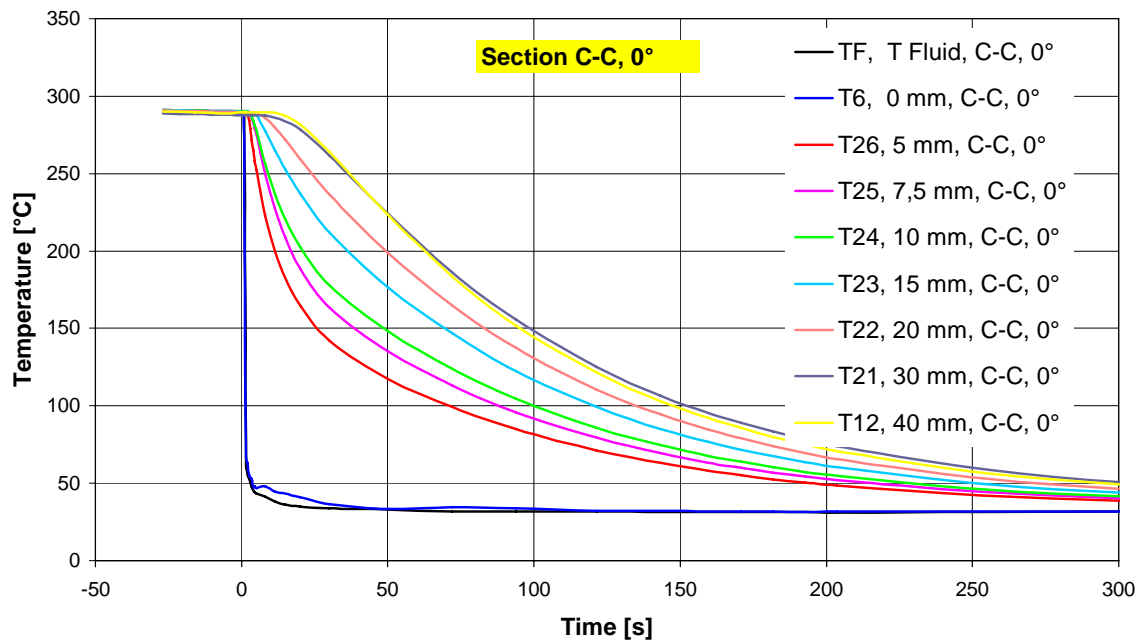
Fig. 10: Temperature distribution versus time over wall-thickness in cross-section C-C

A reset to zero of all measurement data was carried out at the beginning of heating and before reloading up to fracture. Figure 10 demonstrates the temperature distribution versus time during the transient close to the crack in cross-section C-C.

A check that the cooling was homogenous in longitudinal direction was carried out by means of temperature measurements in three cross-sections A-A, C-C, D-D (Fig.4). All temperature curves at the inner and outer wall surface along the cylinder (cross sections) lie very close together. At a depth of 5 mm the temperature is nearly identical in 3 different cross-sections along the cylinder.

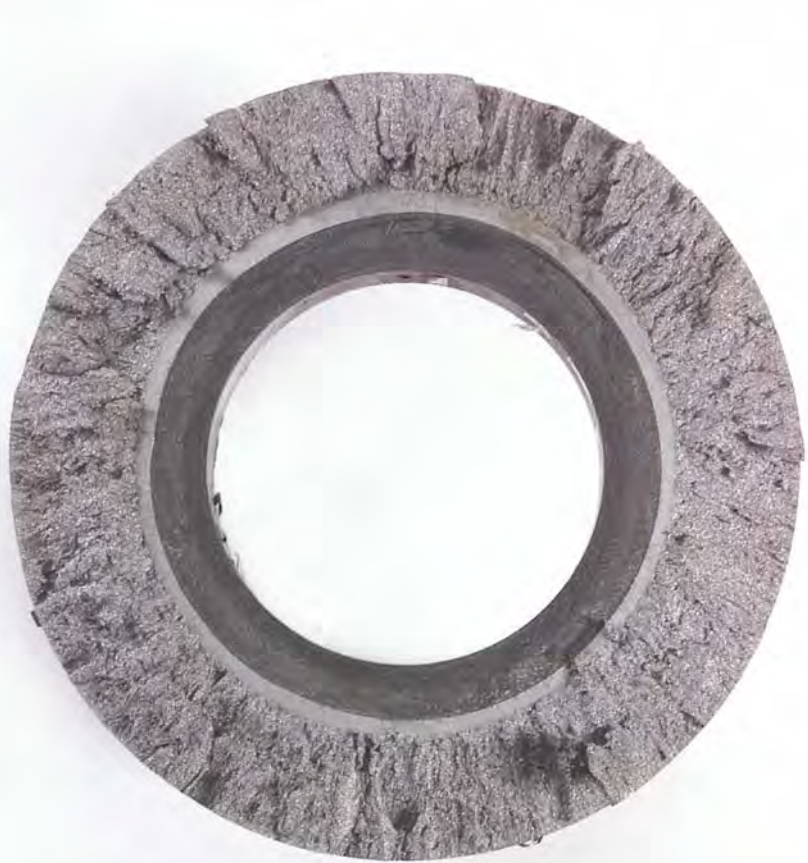
Fig. 14: Rough fracture surface of specimen

Following the test, the fracture surface of the test specimen was examined in detail. An overall view is shown in Fig. 14, in which the limit of the fatigue pre-crack and the subsequent fracture is clearly visible. SEM examinations, confirmed that the fracture morphology is predominantly cleavage, as anticipated from the isothermal and WPS tests performed on standard fracture mechanics specimens fabricated from the same material. No isolated cleavage initiation sites were identified, suggesting that this occurred at multiple sites all around the crack tip. Only limited signs of crack tip plasticity and local dimple fracture were found (Fig.15). The overall roughness of the fracture surface was noted. Furthermore metallographic sections confirmed that the fracture occurred on several different planes with frequent instance of multiple cracking. Similar behaviour has been observed on C(T) type specimens tested using WPS type loading cycles, whereas specimens tested under standard conditions show a much smoother fracture surface (and lower toughness).
