EROSION OF BANKS ALONG PIEDMONT URBAN STREAMS

Michael P. Wilson
Department of Geology
Texas A&M University
College Station, TX 77843

February 1983

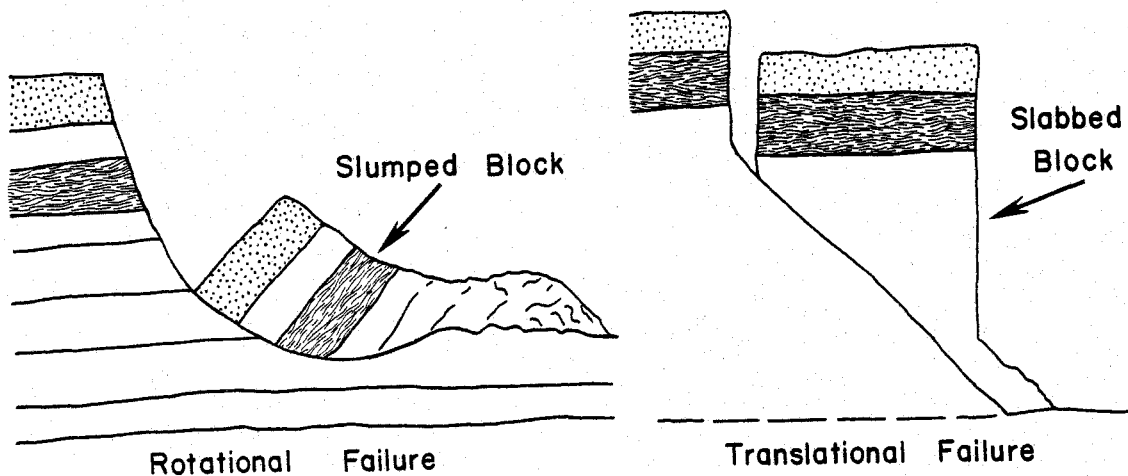
Fig. 1 Mechanical Failure Modes. (from Slavin, 1977)

"Mechanical failure" of banks means that bank material collapses into the stream as a coherent mass. Mechanical failures are usually envisioned as slabs (translational movements, Fig. 1) or slumps (rotational movements, Fig. 1).

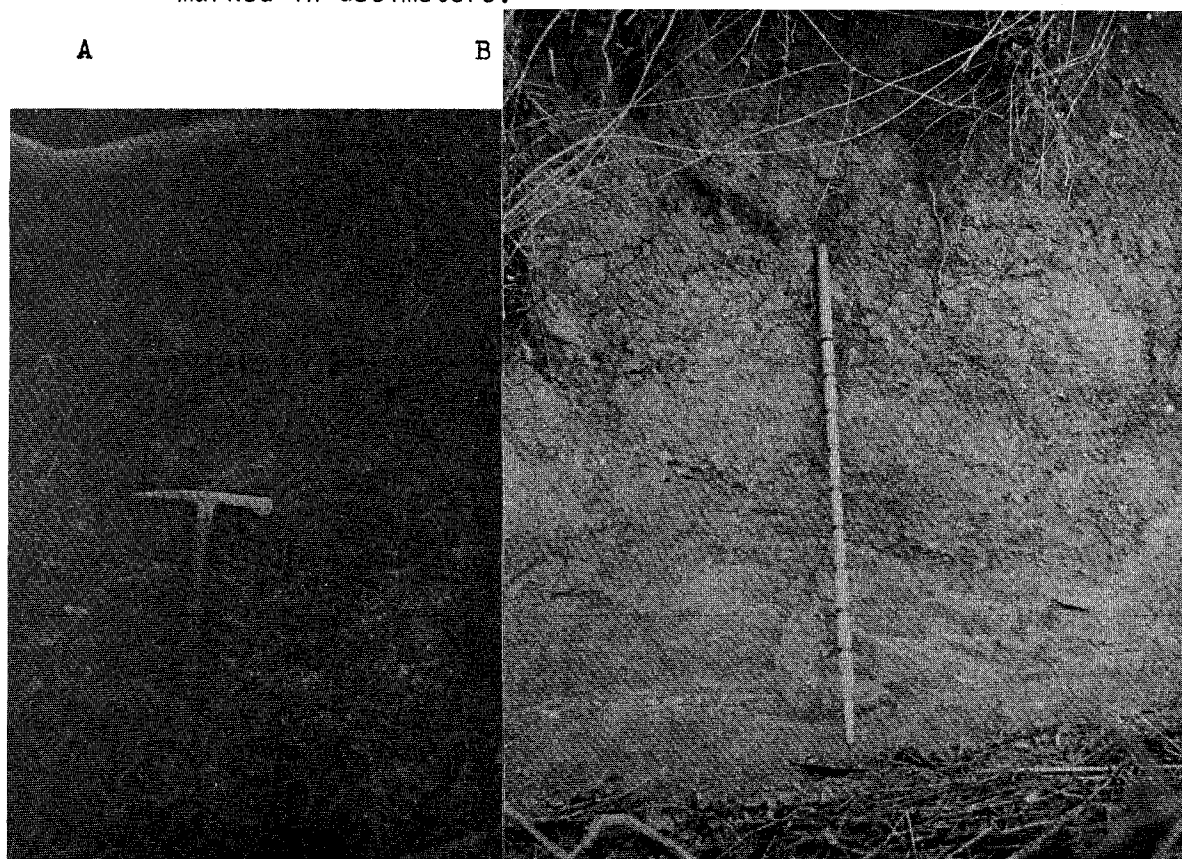
Fig. 3 Saprolite. Fine-grained fluvial deposits over saprolite. The saprolite (weathered bedrock) shows the original structure (color bands) of the metamorphic bedrock. A. wet sediment (Winson-Salem); B. dry condition (Charlotte). Hoe handle is marked in decimeters.

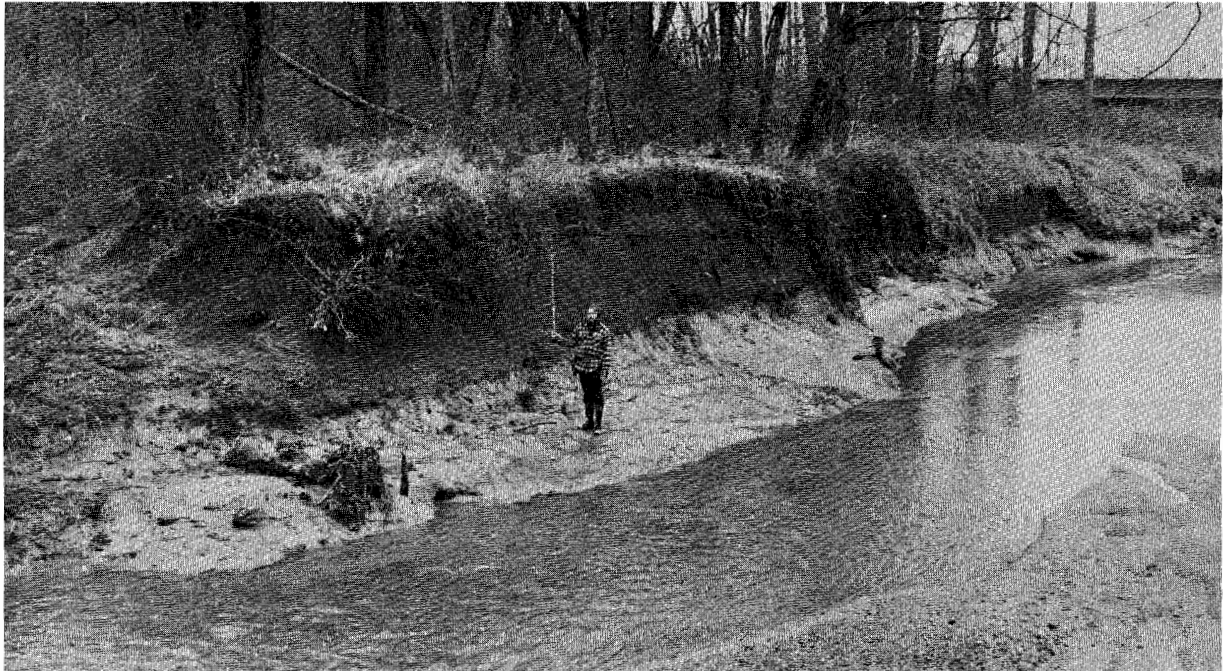
Fig. 4 Red Soil Overlying Gray. Left bank of Briar Creek near its juncture with Little Sugar Creek, Charlotte. Note erosion, and old tree stump at lower left.

In the left bank, where Briar and Little Sugar creeks join (Charlotte), the pre-European age flood-plain (marked by the paleosol at the top of the gray sediment) drops about five feet in elevation over a horizontal distance of about twenty feet. The top of the modern flood plain (red sediments) remains level. No faulting or igneous dikes are observed. The cause of the disparity in elevations between the Briar Creek and Little Sugar Creek pre-European flood plains is not obvious. Possibly the present course (channelized) of Briar creek is cutting an old terrace buried by the red sediments.

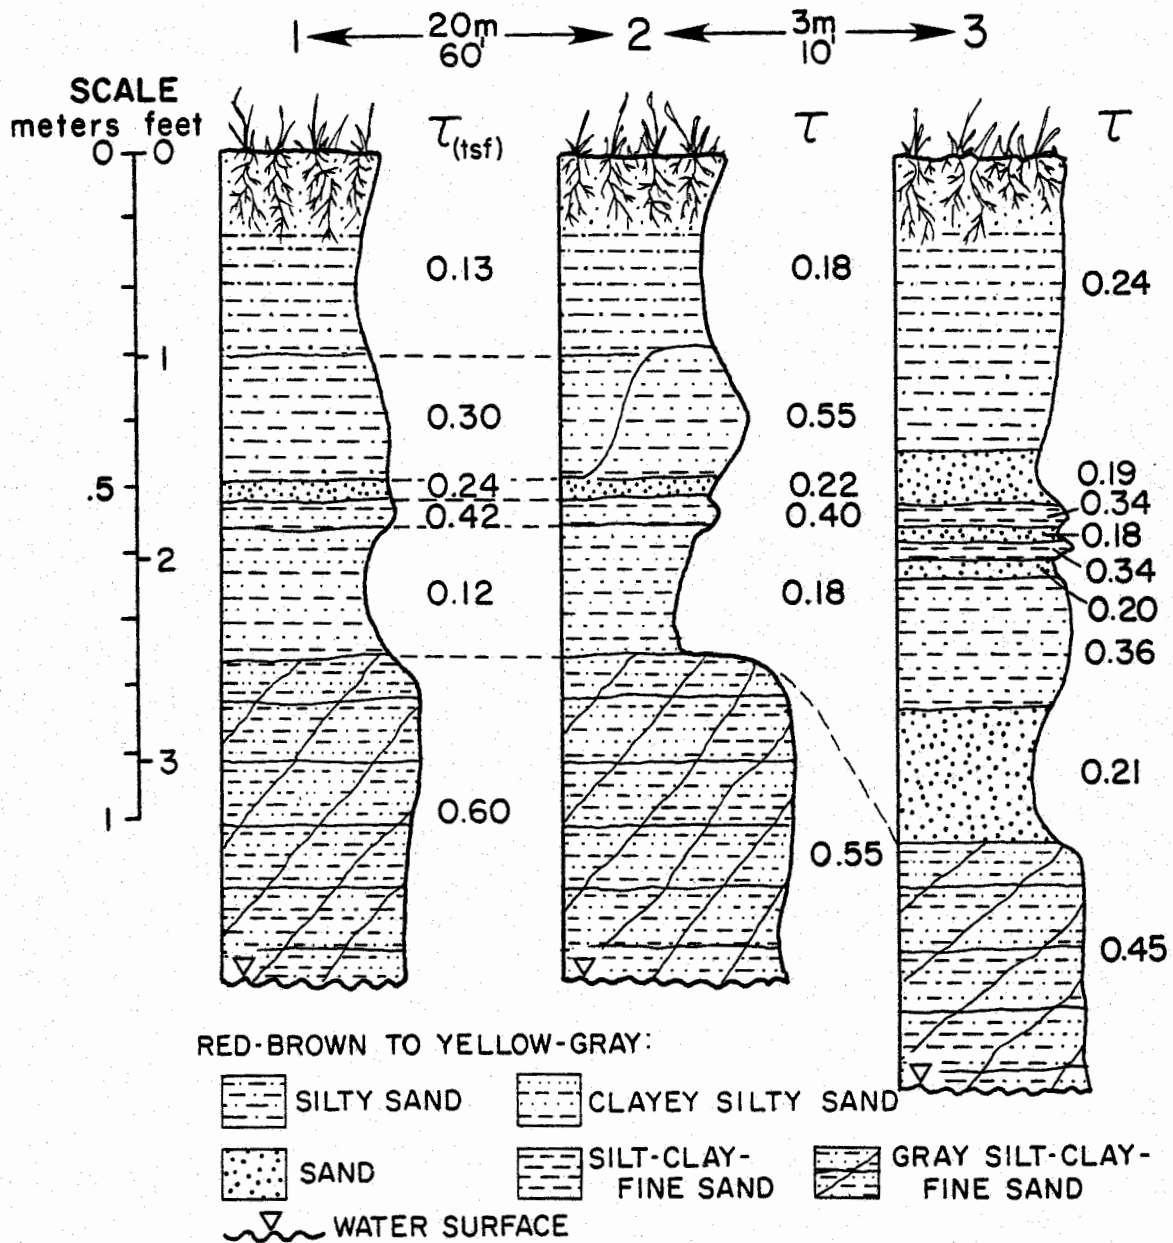
Fig. 6 Variable Properties of Red Alluvial Soils. An example of lateral and vertical variability in red alluvial sediments overlying gray alluvial sediments. Toby Creek, Charlotte.

Red fluvial sediments are vertical accretion deposits mixed with splay deposits. Figure 6 indicates the range in properties of these materials. Banks of third-order streams are commonly composed of dozens of sheet-like or lenticular deposits ranging from clayey or silty sands to clayey silt. A well-sorted (poorly graded) layer is rare. Individual layers can sometimes be traced for a hundred feet or more but in other places there is significant change in a few feet. No lateral accretion deposits or channel fills were observed in the red sediments.

The gray sediments are very fine grained vertical and lateral accretion deposits. Little or no layering was observed in the vertical accretion deposits (grays of Fig. 6 for example); root or stump casts were common near the tops of the deposits. Lateral changes from clayey to more sandy vertical accretion deposits were noted along several banks. Such changes may have been caused because the modern bank was cut diagonally across an old channel such that the observer traversed from slack-water deposits to natural levee deposits. However, the actual observation of an old filled channel was quite rare. Another explanation is that a tributary brought coarser sediment to the flood plain and produced an alluvial fan.

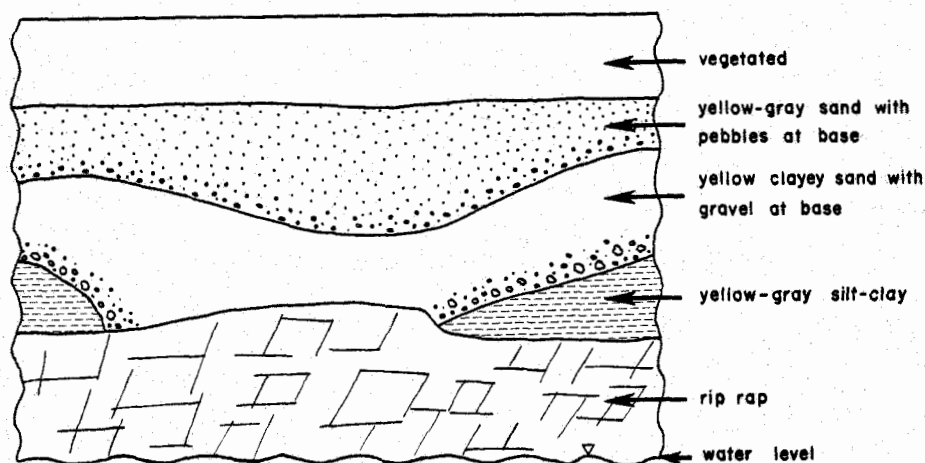
Fig. 7 Terrace Remnant. Exposed in eroded bank of Briar Creek, Charlotte. Height of view is ten feet.

Several peculiarities were noticed regarding the gray sediments. A remnant of a terrace was discovered along Briar Creek (at Myer's Park Country Club, Charlotte). The sandy deposit is sketched in Figure 7. The terrace formed a knoll several feet above the flood plain with well-defined side slopes. Due to vegetative cover the relationship between this terrace and other flood plain sediments could not be examined. The shape and isolation of the knoll imply that it is an erosional remnant.

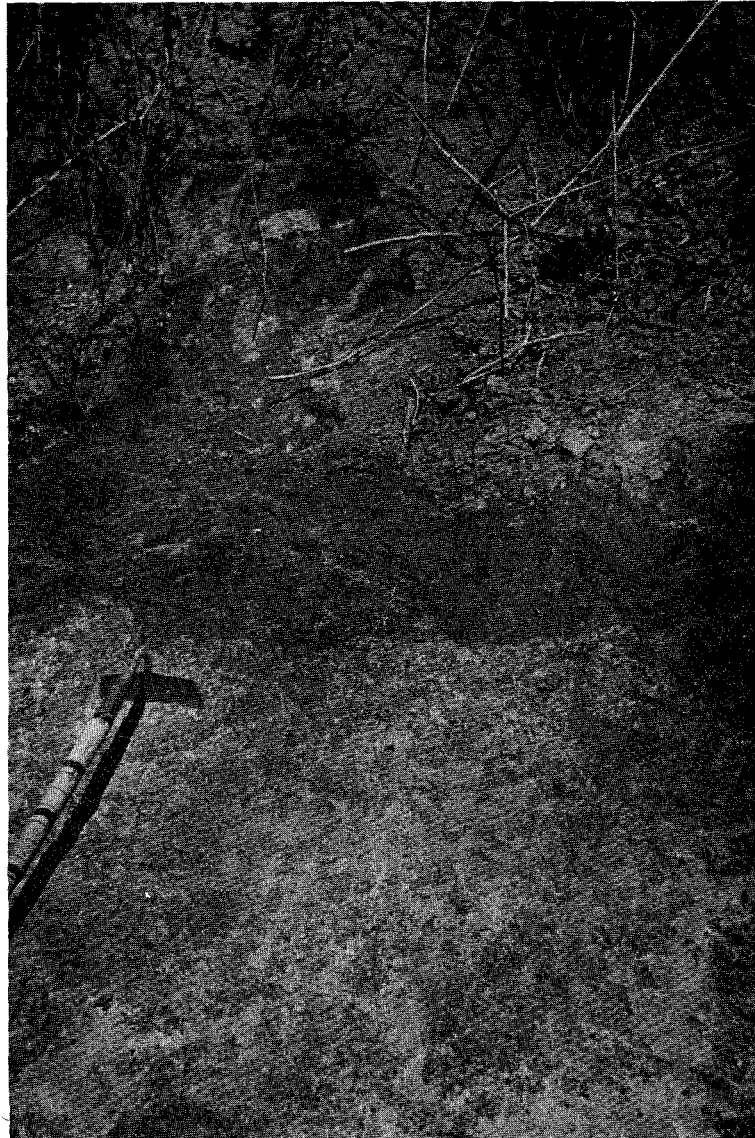
Fig. 8 Fill. Red sediment over gray showing disturbance of upper red sediment. Chunks of gray sediment are incorporated into the red soil by dredging and dumping. The contact between red and gray soils has been deformed, perhaps by the weight of heavy machinery. Briar Creek at Methodist Park, Charlotte.

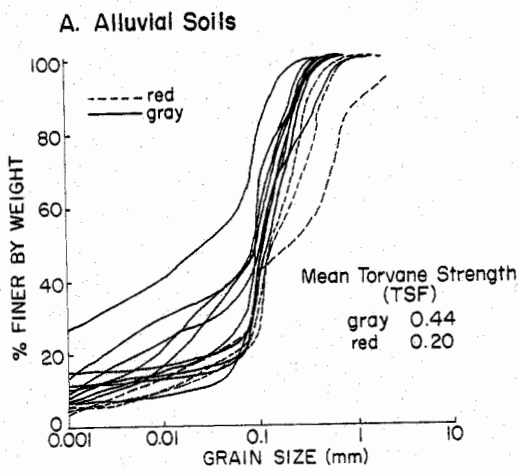
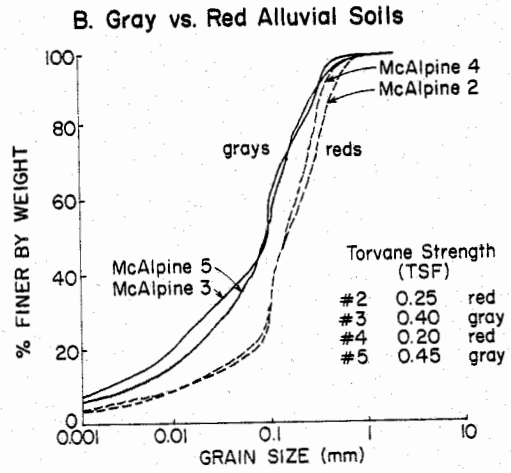
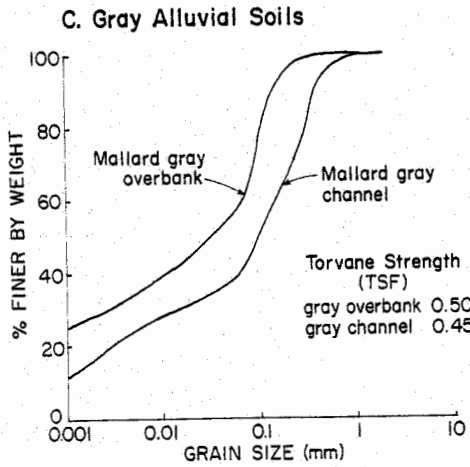
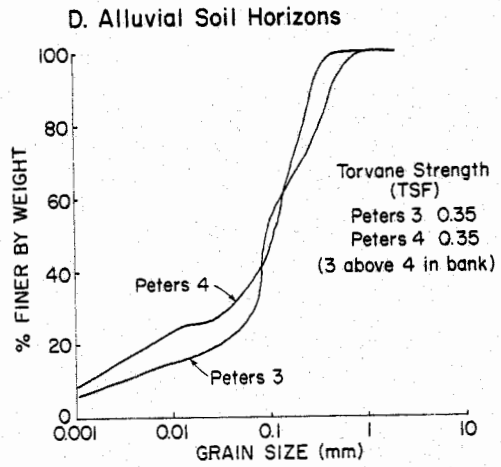
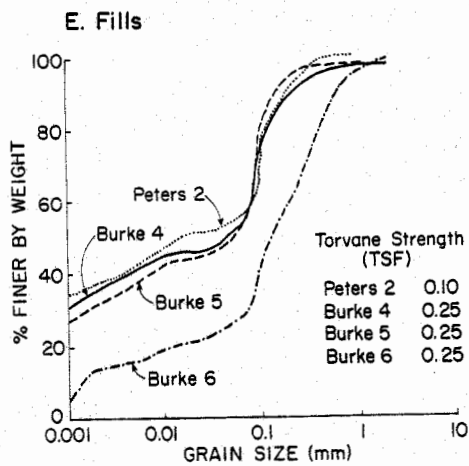
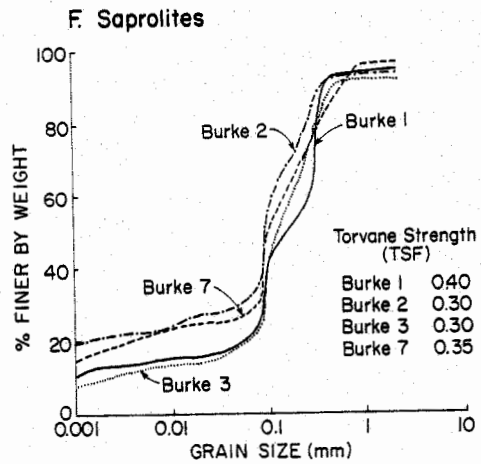
Fig. 9 Grain Size and Strength for Several Alluvial Soils.

The cohesiveness of bank sediments varies in a manner similar to the particle size distributions. Fills and saprolites are highly variable within and between deposits. Red and gray alluvial sediments are predictable. Atterberg limits for gray sediments are higher than for reds. Liquid limits of thirty to sixty, plastic limits of eighteen to thirty, and plasticity indices of eleven to forty for gray sediments compare to non-plastic red sediments with liquid limits of twenty to thirty.

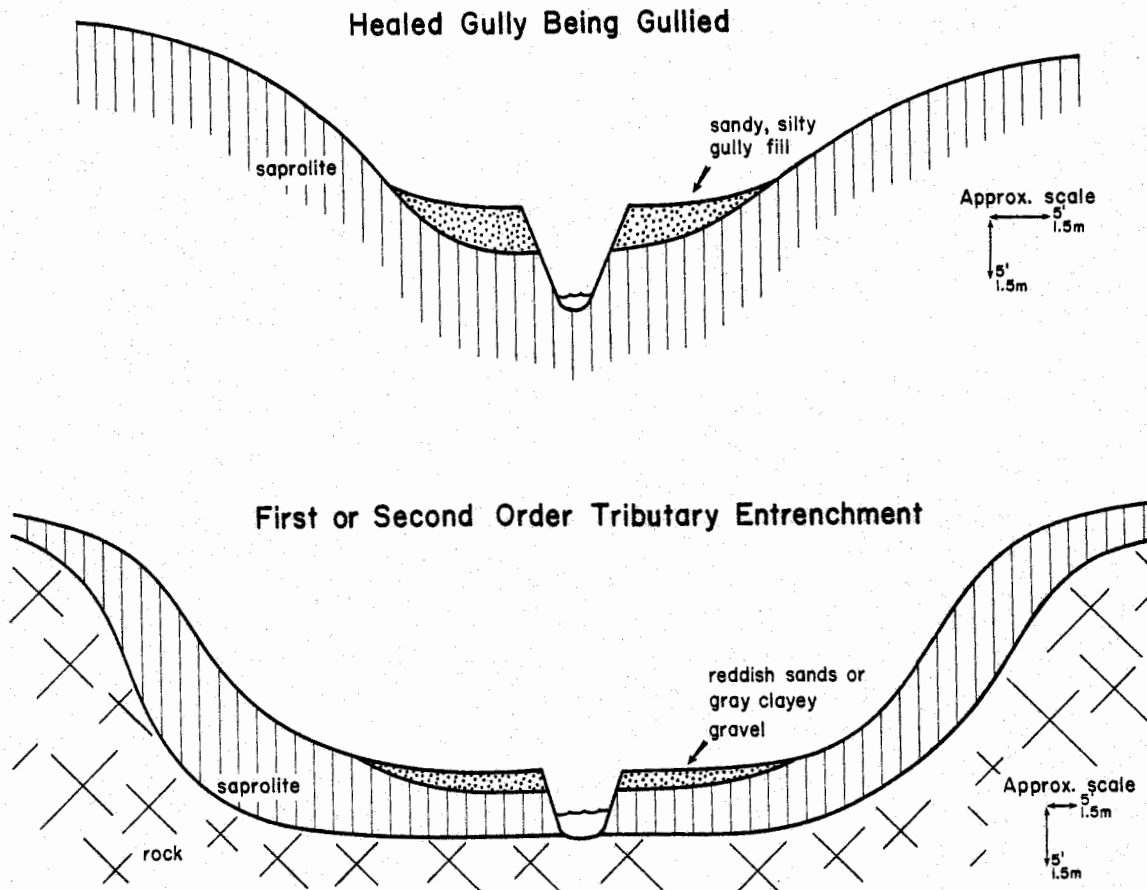
Fig. 10 Schematic Profiles of First- and Second-Order Valleys.

Once the upland streams degrade to bedrock they may widen, meander, or scour rock. They usually do all three at once, but broad active meanders are not seen. Much of the upland streams energy is dissipated on irregularities in its bed. These irregularities are either inherited due to variability in saprolite erodibility

(variation in original rock structure) or relate directly to varying rock resistance when bedrock is encountered.

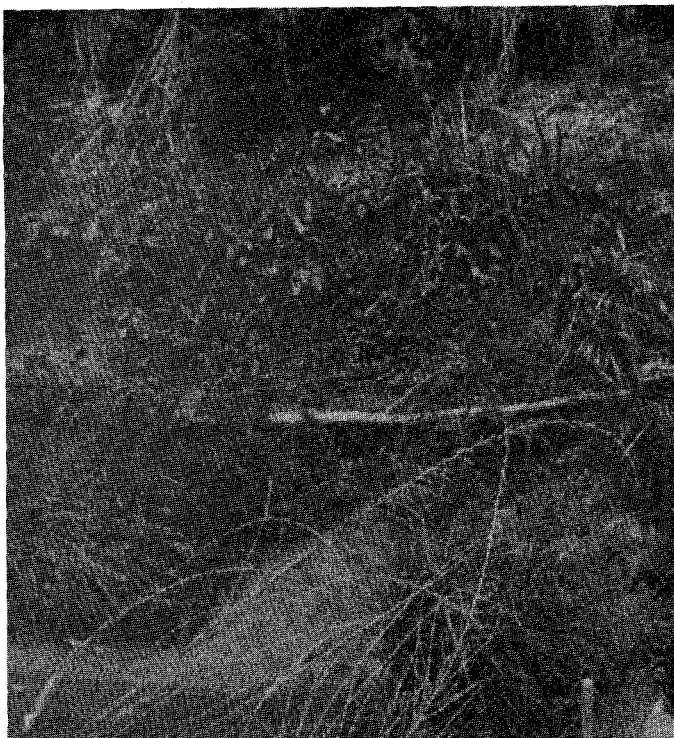
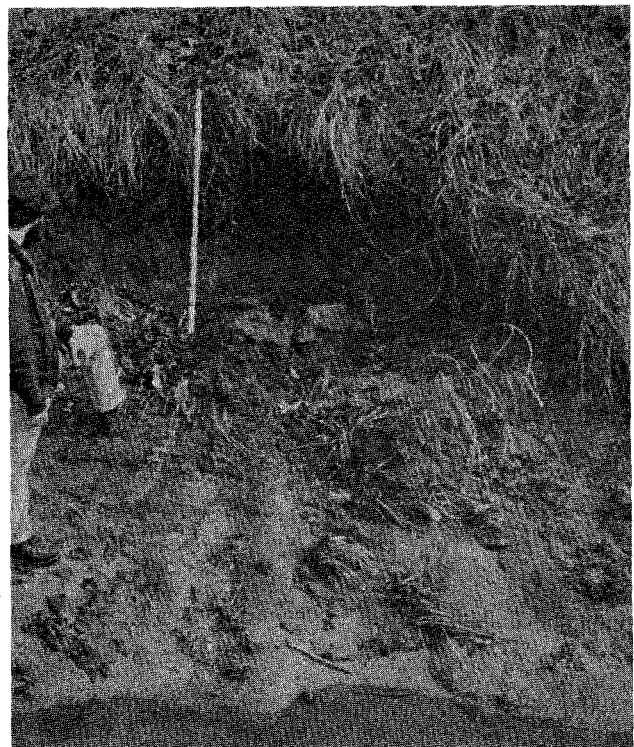
Fig. 12 Two Views of Doby Creek Showing Small Vegetated Blocks Gliding Over Gray Soil.

A 1000 foot segment of Doby Creek was investigated north of Harris Blvd. in Charlotte. Most of its drainage basin is park land with scattered buildings (research park), interstate highway and woodland. The channelized, grassed banks are subject to translational failure. Blocks of red sediment, often matted with roots, glide over the sloping gray-sediment banks into the channel. As the gray alluvial sediments become scoured more blocks fail and the stream widens. In 1980 this stream segment had dozens of small, failed blocks (one to fifty cubic feet) translating slowly down the banks. Some banks were still completely grassed; others showed bare soil for the lower half of their height (Fig. 12).

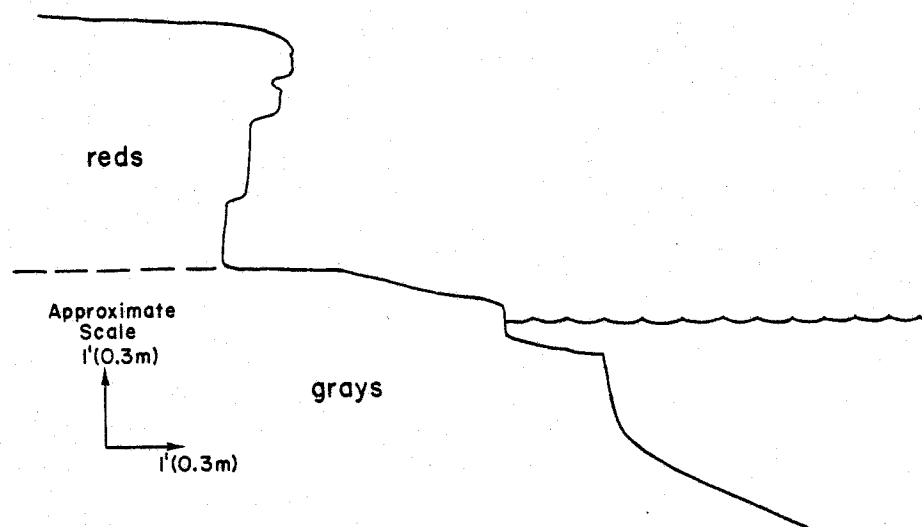
Fig. 11 Profile Showing Variable Erodibility by Scour. Left bank of Toby Creek, Charlotte.

In a 1400 foot reach of Toby Creek, six eroding sections of bank totaled 240 linear feet, i.e. eight percent of the banks were eroding. Width-depth ratios were two to three; cross-sectional areas were fifty to seventy-five square feet. Erosion was caused by scour around small stumps or on the outside of incipient meanders. Occasionally, cubic-foot size blocks of sediment had tumbled into the stream from undercutting. Some blocks were composed of root mats; others were formed from stiff clayey lenses. A handful of slab failures (less than six by four by one foot) were noted. Most interesting was the observation that the red sediments in the upper bank were susceptible to scour as evidenced by steps in the channel cross-section (Fig. 11). Channel fills (both natural and artificial), saprolite, and bedrock were also noted at places in the channel banks or bed. Fills were relatively erodible. Igneous rock dikes and quartz veins formed riffles in the bed.

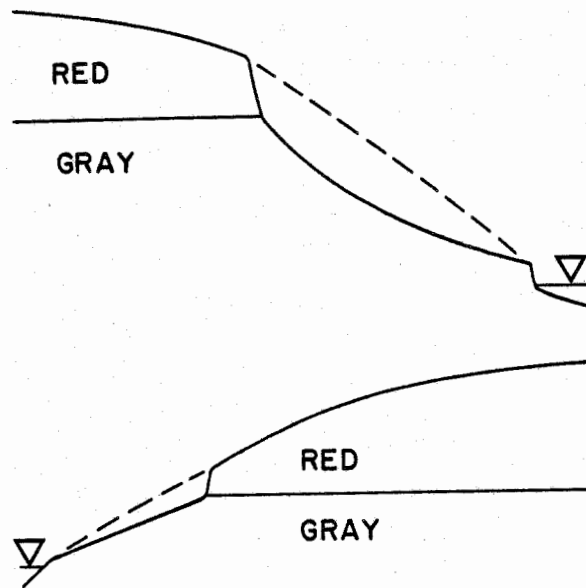
Figure 13. Profiles of McAlpine Creek. Dash line shows approximate profile following channelization but prior to erosion.

blocks of root-mats were noted, but their total volume was minor. Scour of the lower banks was evident. This stream segment had been channelized a few years previously. Sections with rip-rap in the lower bank were most stable. Twenty percent of the banks were experiencing minor erosion. A few percent of the banks without rip-rap were developing distinctive profiles as shown in Figure 13.

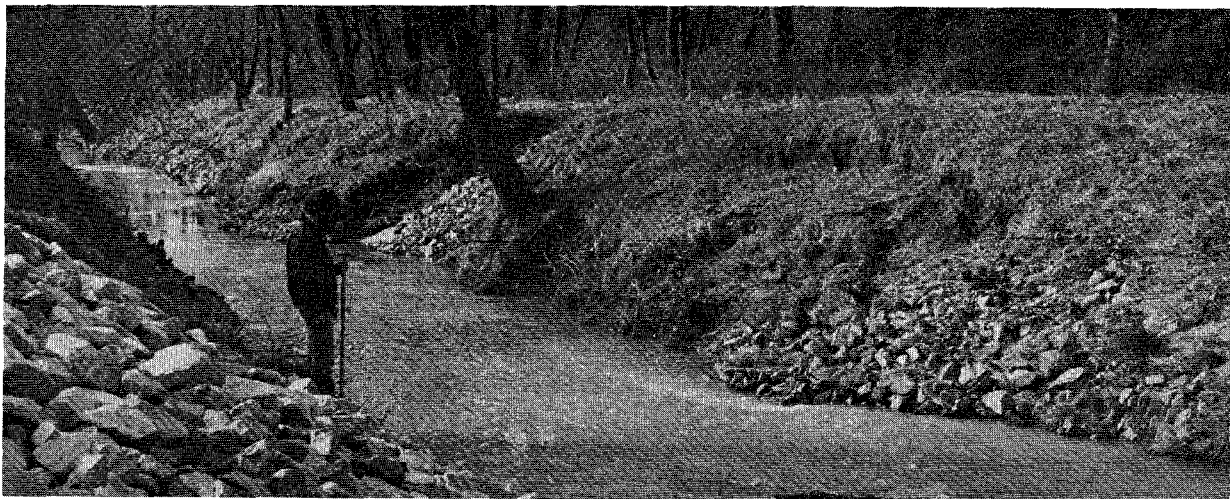
Fig. 14 Slide Scar and Slide. Viewed From Harbinger Court, Briar Creek, Charlotte.

No positive identification has been made of a rotational slump. However, several indeterminate forms of bank failure might be slumps. A large subaqueous failure along Briar Creek near Harbinger Court in Charlotte may have been rotational. The slump occurred downstream from a tree growing in the channel bank during a bankfull flood. The vortex downstream from the tree was powerful enough to omit audible sounds heard by a local resident standing about a hundred feet away. The slide mass was removed during the flood. An arcuate scar remained (Fig. 14). But a scar modified by scour is an indeterminate form.
