## Retrofitting of Stainless Steel Liners To Existing CANDU 6 Spent Fuel Bays

Venera Cislaru <sup>1)</sup>, Simon Chen <sup>2)</sup>, Lingam Vaithilingam <sup>2)</sup>, Dejan Dikic <sup>2)</sup>, Azhar F. Khan <sup>2)</sup>, Medhat Elgohary <sup>2)</sup>

- 1) SNN CNE-INVEST, Cernavoda, Romania.
- 2) Atomic Energy of Canada Ltd (AECL), Ontario, Canada

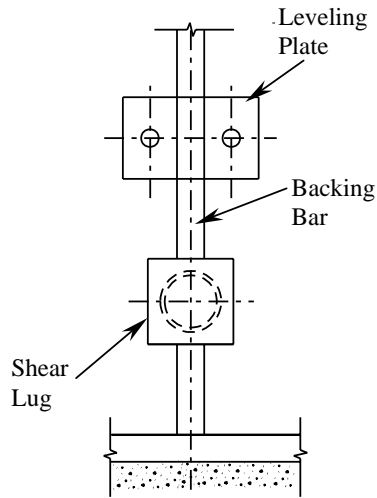
The stainless steel liner was supported by a series of continuous backing bars. These backing bars were supported by a set of leveling plates, shear lugs and Hilti expansion anchor bolts. For construction convenience and to avoid cutting of main reinforcing steel, the leveling plates could be moved along the backing bar. Each leveling plate had two holes for expansion anchor bolts. Only one expansion anchor bolt was required to anchor each leveling plate. Each vertical backing bar, at its bottom and top, was anchored with the shear lugs. Figure 1 shows a typical backing bar, a shear lug and leveling plate.

Figure 1 - Vertical Backing Bar with a Shear Lug and Leveling Plate

Figures 1 and 2 show the typical details for anchoring the stainless steel liner plates to the existing concrete wall. A similar detail was used for the floor stainless steel liner plate.

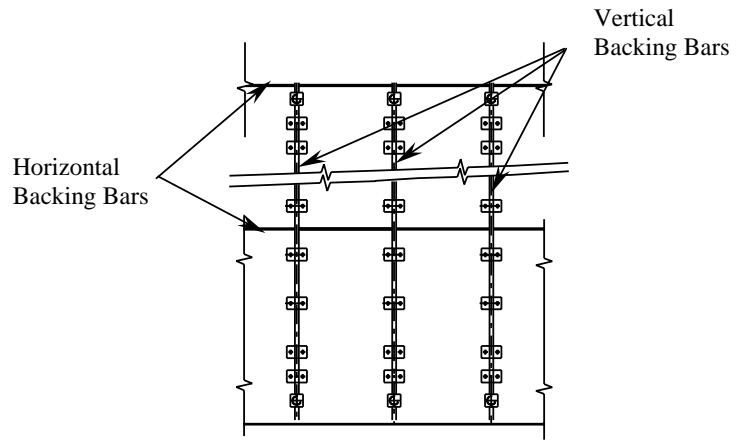
Figure 2- Typical Arrangement of Vertical and Horizontal Backing Bars

Figure 2 shows continuous vertical and horizontal backing bars, which were welded with a series of leveling plates and shear lugs. The shear lugs were located typically at top and bottom of each vertical backing bar.

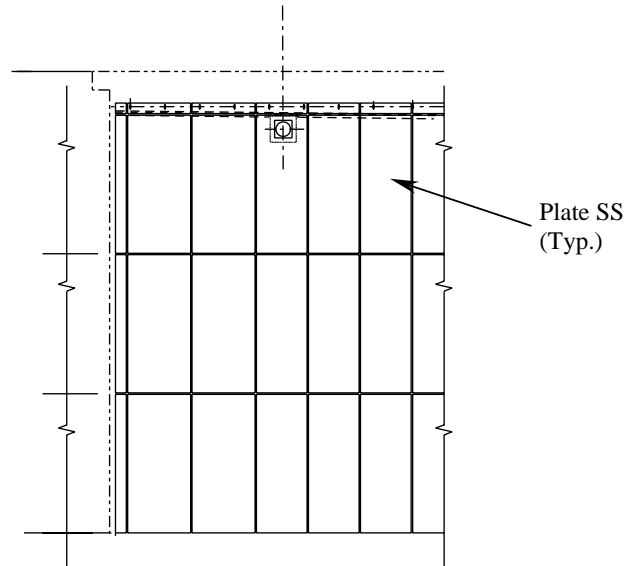
Figure 3 - Layout of Wall SS Liner

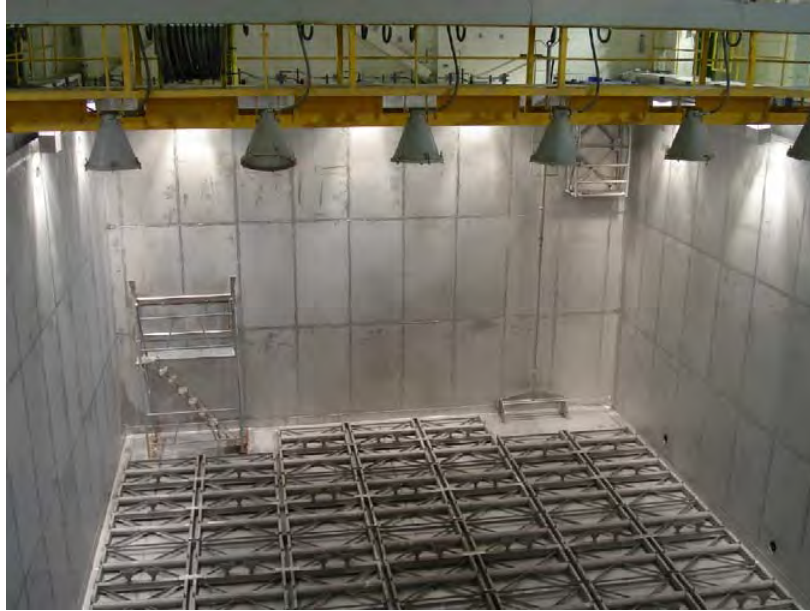
Figure 4 - Spent Fuel Storage Bay Liner after the Pickling and Passivation

- The stainless steel liner was installed in three steps. Each step consisted of one piece of the liner with a height of approximately 2.44 m. The first step of the vertical liner was installed at the bottom of the bays (Figure 4). The liner plates were connected by butt-welding. After the inspection of all the welding, the formwork was erected in place. Then, the gap between the stainless steel liner and the existing concrete surface was filled with the concrete. After the completion of concrete pour, the preparation to install the next row of liner was commenced. The same procedure was repeated until completion of all the vertical liner sections.

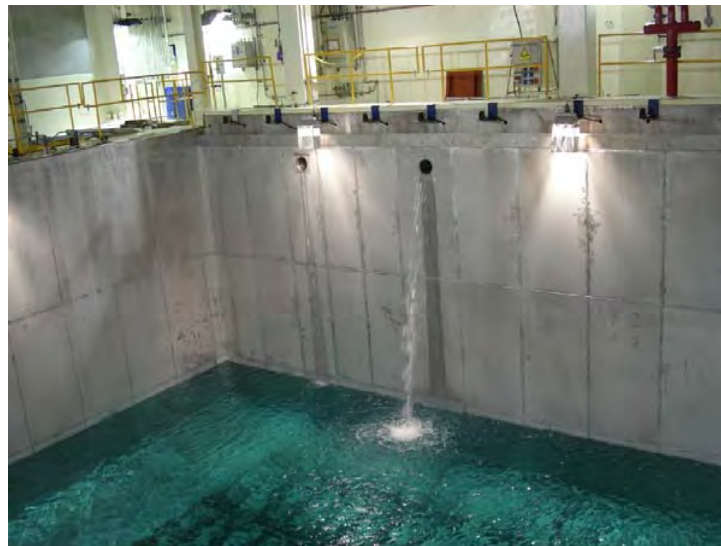
Figure 5 - Spent fuel bay filling with demi-water.
