Designing an Efficient Nighttime Sign Inspection Procedure to Ensure Motorist Safety

Draft Final Report
Project: 2005 – 08

June 2006

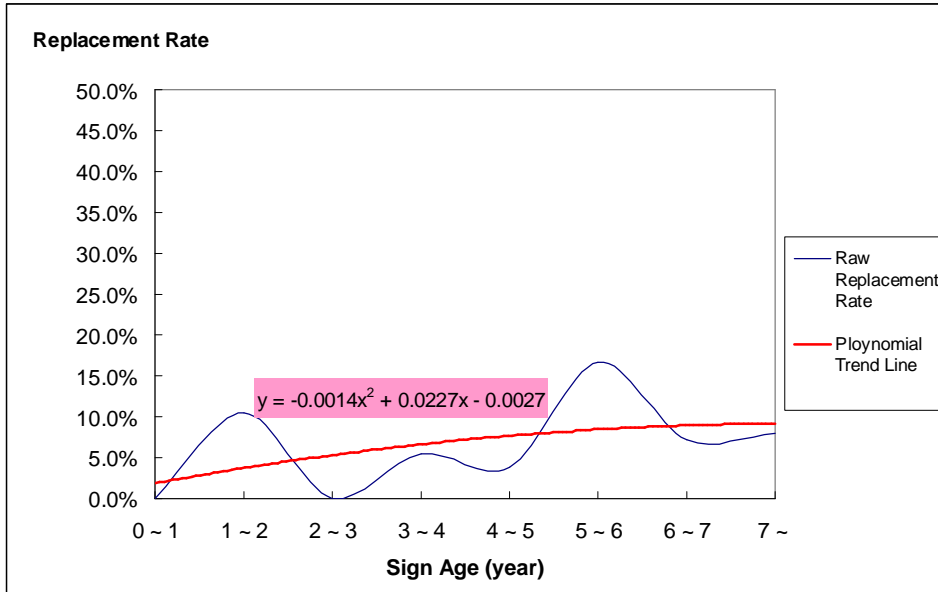
Figure 9.5. Type I White Sign Modified Replacement Rate

As the raw replacement rate in Table 9.19 for Type I white sign showed irregular increase by the age group of signs, the modified replacement rate was created using a polynomial trend line expressed in Figure 9.5.

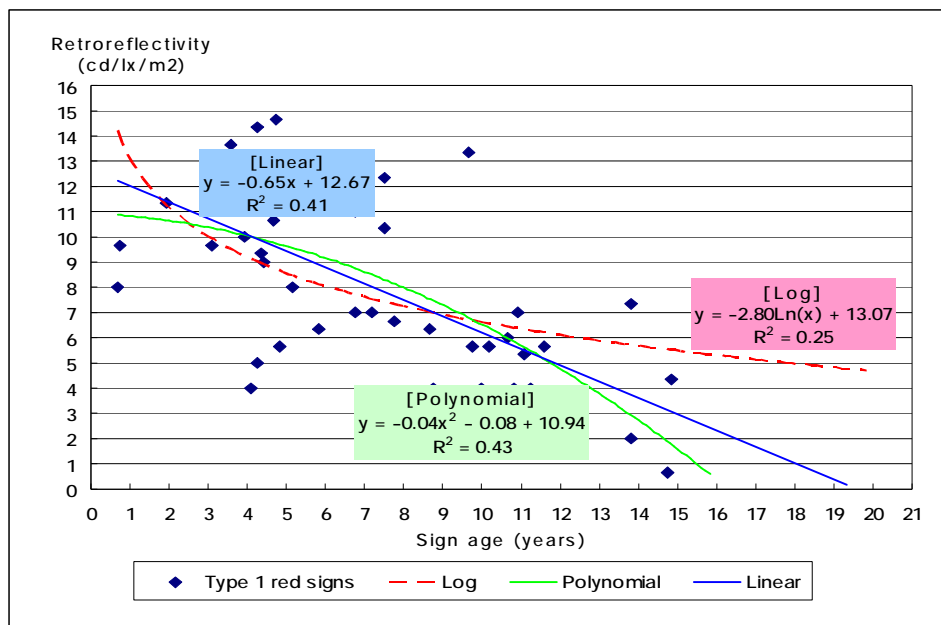
Figure 9.10. Various Deterioration Curves for Type I Red Sign from the NCSU Field Data

Figure 9.10 shows Type I red sign data from the NCSU field study to explain how the best deterioration curve was selected for the best curve model. For each color of sign, the team created five different deterioration curves, extended the curves as necessary to hit zero retroreflectivity, and computed the R^2 values using a spreadsheet program. Examples of three curves – linear, log, and polynomial – from NCSU field data for Type I red signs are expressed in Figure 9.10. The other two types of curves were power and exponential curves.

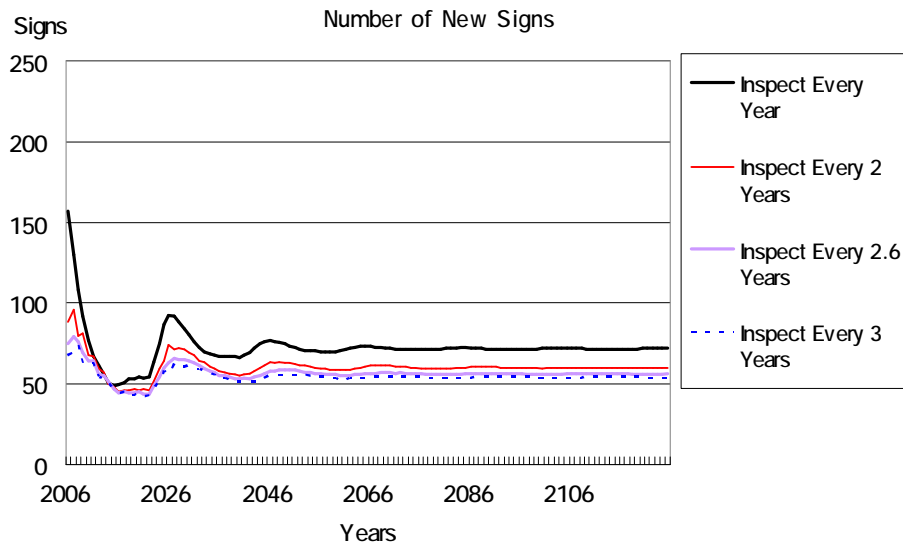
Figure 9.17. Combined Simulation Results for All Signs

As next step, the team combined the results of all sign color following the same ratio of NCSU field sign data obtained from five divisions in 2005. Figure 9.17 shows the combined results of all signs. Note that only four sign colors were combined to show the tendency of new sign cost and sign condition in the future as other sign colors probably will follow these results.
