Field Investigation of Highway Sign Damage Rates and Inspector Accuracy

The overall purpose of the research study reported here was to create a simulation model that could provide the NC Department of Transportation (NCDOT) with recommendations to improve their sign inspection and replacement procedures. The research reported in this paper focuses on two key factors built into the model: 1) the rate at which signs are damaged beyond usefulness based on natural or man-made causes, and 2) the accuracy rate of visual sign inspections based on retroreflectivity. To explore those factors, the research team conducted night time rides with sign inspectors in 5 of the 14 NCDOT divisions. During subsequent daytime rides along the same routes the research team measured sign retroreflectivity to allow estimation of sign deterioration and inspector accuracy rates. Data were collected for white, yellow, red, and green signs and for sheeting Types I and III. Two key results emerged. First, about 2.3 percent of the inspected signs (per year) were damaged to the point of needing replacement. Second, inspectors did not reject a large percentage of signs that had retroreflectivity values below the

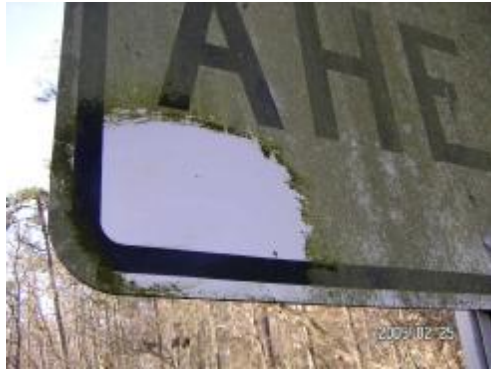
a) Sign Cleaned of Dirt from Feed Mill

Figure 2 shows photographs some of the damaged signs encountered during data collection. Note that dirty signs can be cleaned and will recover much of their reflectivity if this is done. Also note that some damaged signs were quite readable by day but did a poor job of conveying information at night. That is one reason that it is crucial to conduct inspections during the night.

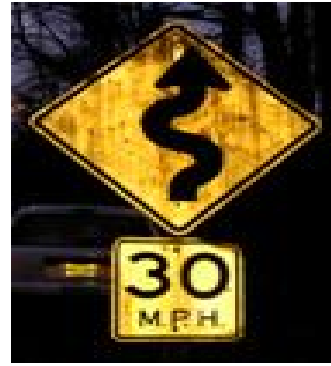
b) Sign with Tree Sap

The second type of damage is that caused by nature. This includes damage to signs because of tree sap, scratches on signs from tree branches, etc. Occasionally, signs are damaged by rocks or bullets that penetrate the protective outer sheeting layer and cause water to interfere with the reflective properties. The damaged area will then grow via the freeze/thaw cycle, creating dead cells or lost of retroreflectivity. All of these forms of natural damage are unintentional and, to a large extent they are unavoidable.

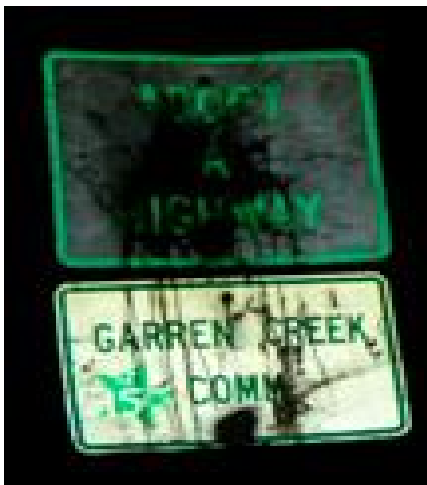
c) Sign with Paint Ball and Egg

Among the damage caused by humans, paint balls, gun shots, and eggs were the most common. About 66% of vandalized signs were damaged by paint balls, while about 26% were damaged by gun shots, and about 8% by eggs. More vandalism was found on secondary roads and yellow signs were found to be more prone to vandalism than other colors.

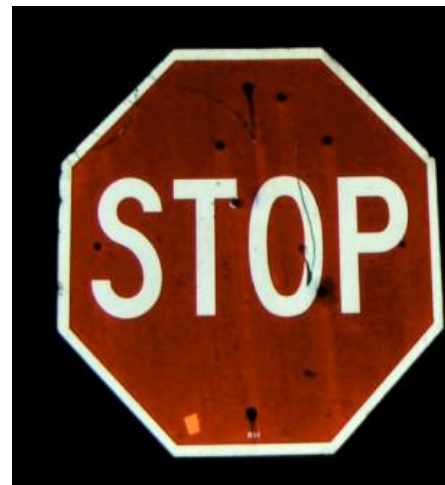
d) Sign with Gun Shots

Typically, knockdowns are replaced by the NCDOT when they are discovered. Mower damaged signs are primarily replaced seasonally in the early to late fall. (Gunshot damaged signs are also replaced seasonally – usually in early winter during hunting season). Since our data were collected during the late winter and spring, neither mowing nor gunshot damage was evident because most of these signs had already been replaced.

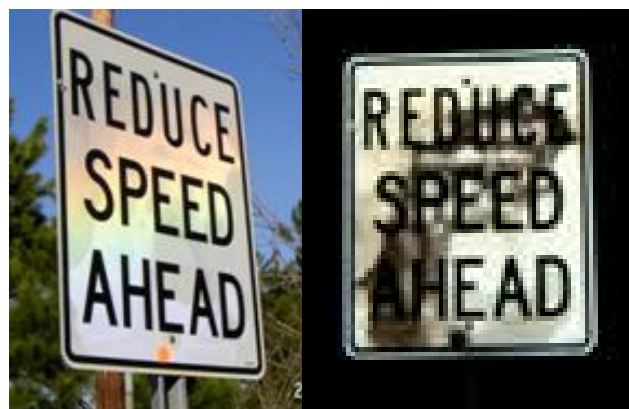
e) Daytime and Nighttime Comparison of Sign Damage
