**THE EFFECTS OF CULVERTS AND BRIDGES ON
STREAM GEOMORPHOLOGY**

by
Maximilian Atlas Merrill

A thesis submitted to the Graduate Faculty of
North Carolina State University
in partial fulfillment of the
requirements for the Degree of
Master of Science

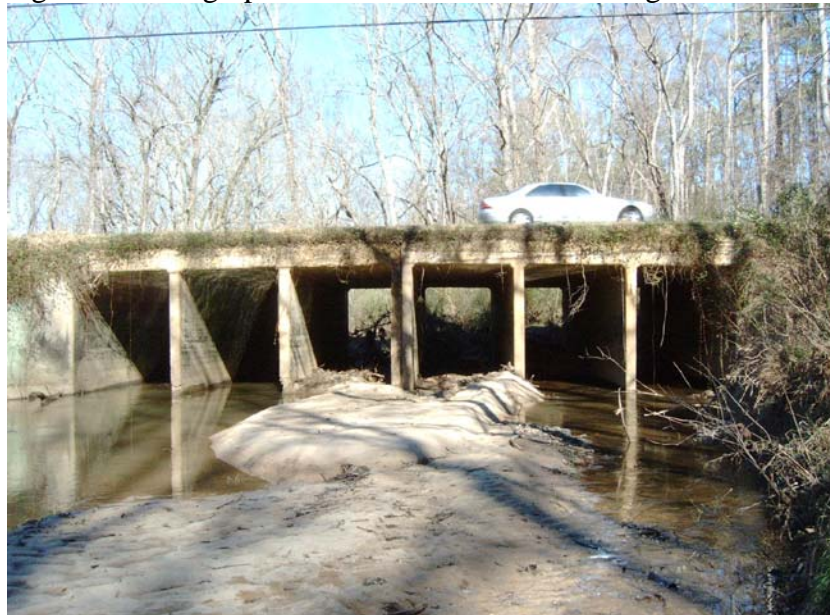
Figure 3. Photograph of Mid-Channel Bar Forming.

Because some of the culverts are oversized for low flows, mid-channel bars have formed (Figure 3). This is a definite sign that the channel cross section is too large and therefore normal sediment transport is not taking place. Furthermore it seems that over time some of these oversized culverts are forming bankfull benches in the culvert openings not readily used during low flows. These culverts with bankfull benches established inside, seemed to have the least impact on downstream conditions, and resulted in a more stable channel environment (Figure 4). In effect, where ample cross sectional flow area is available in a multi-opening box culvert, the stream has re-established a low flow channel in one or more openings and using the remaining openings as the bankfull channel. The larger multi-opening box culverts exhibited little perching (Figure 3 &4). However, relatively small pipe culverts that severely restricted high flows often had an incised pool downstream of the culvert resulting in perching of the downstream end of the culvert. (Figure 5).

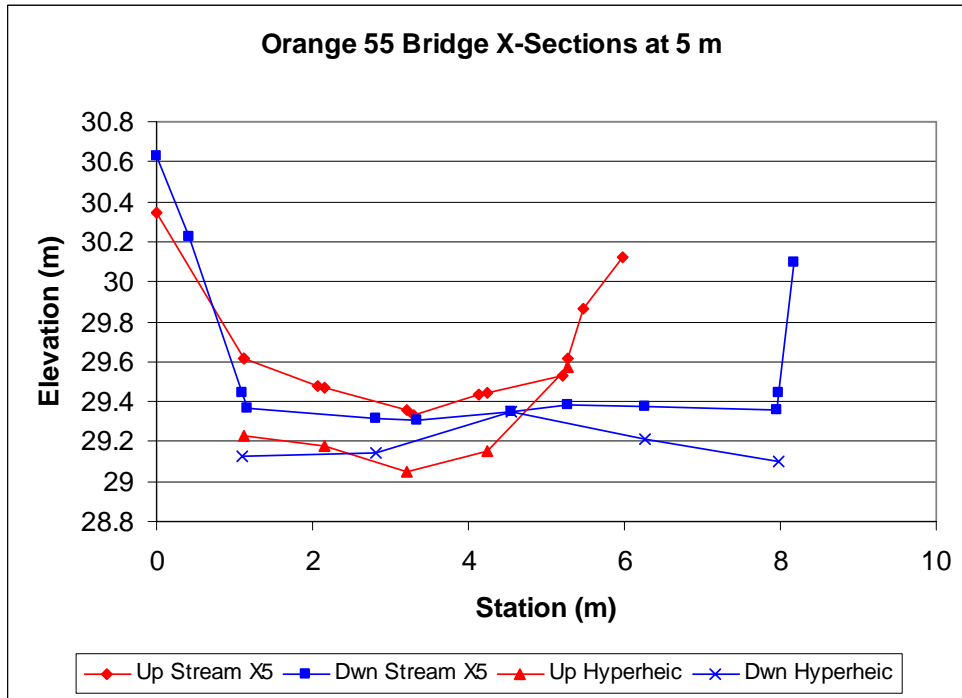
Figure 9. Example of Upstream Cross Section VS Downstream Cross Section

The statistical comparison of downstream versus upstream cross sections show that box culverts have less effect on increasing downstream cross sectional area than the other crossing types. This is concurrent with the observations in the field. While doing the preliminary study, it was noted that box culverts seemed to be often oversized compared to the other types. Box culverts do not restrict high flows as severely as do smaller culvert types that can create a back water affect. Many of these box culverts only used a few of the openings during low flows while bankfull benches were formed or forming in the other openings (Figure 4). This allowed for sediment transport during low flows and floodplain access during higher flows. All crossings seem to have increased cross section areas downstream, except for the larger streams where the regression line crosses the 1:1 slope line, at which point the larger streams seem not have increased in cross sectional area downstream. This is probably due to the fact that the larger streams are crossed with large box culverts or bridges which have less effect on the downstream cross sectional area (Figure 10). These culverts and small bridges restrict the floodplain hydrology causing channel scour and bank erosion that increases downstream cross sectional area and degrades mussel habitat.

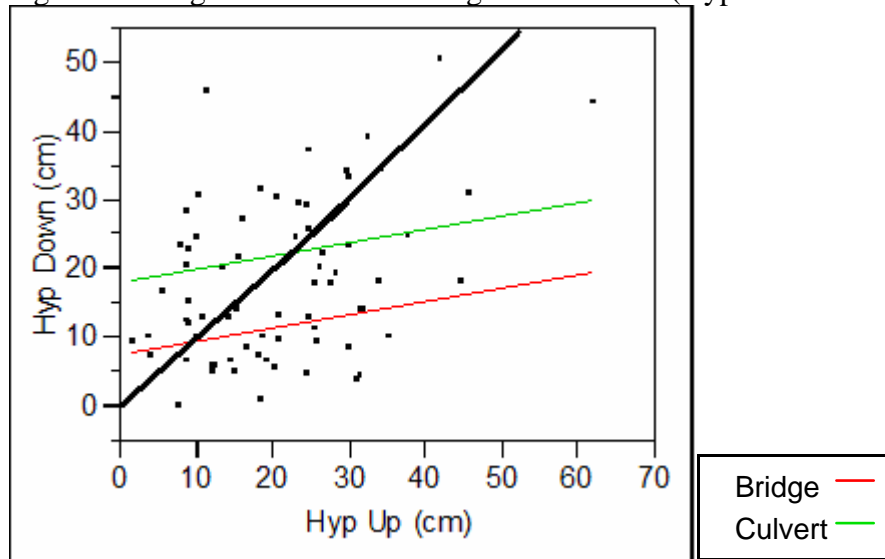
Figure 11. Regression Plot for Bridges vs Culverts (Hyporheic Zone Depths).

trend for decreased hyporheic zone depths downstream of the crossings is only true for the larger depths. For the streams with shallow hyporheic depths, this trend is not as clear. Each regression line crosses the 1:1 slope line between 10 and 20 cm of hyporheic zone depth, showing that these effects are not as significant with streams that have shallow hyporheic zone depths. This is intuitive because if the stream is already degraded or has scoured the bottom sediments down close to a restrictive layer with very shallow hyporheic depths the scour will have less effect downstream. If the stream flows on bedrock upstream then it can not get much shallower in depth downstream.

*Black line shows 1:1 slope line

The results show that bridges have the greatest effect on hyporheic zone depths while pipes and box culverts have the least effect. This may be due to the fact that cross sectional areas at the pipes and boxes (with bankfull benches) allow for sediment transport in low flows because they keep their velocities. The other crossings are wider and thus create slower flow velocities upstream of the culvert. Therefore they settle out sediments and do not allow for as much sediment transport at these low flows. This causes downstream sections to be sediment starved. Scour may control the bed gradient but it seems that low flow transport may control hyporheic zone depth.

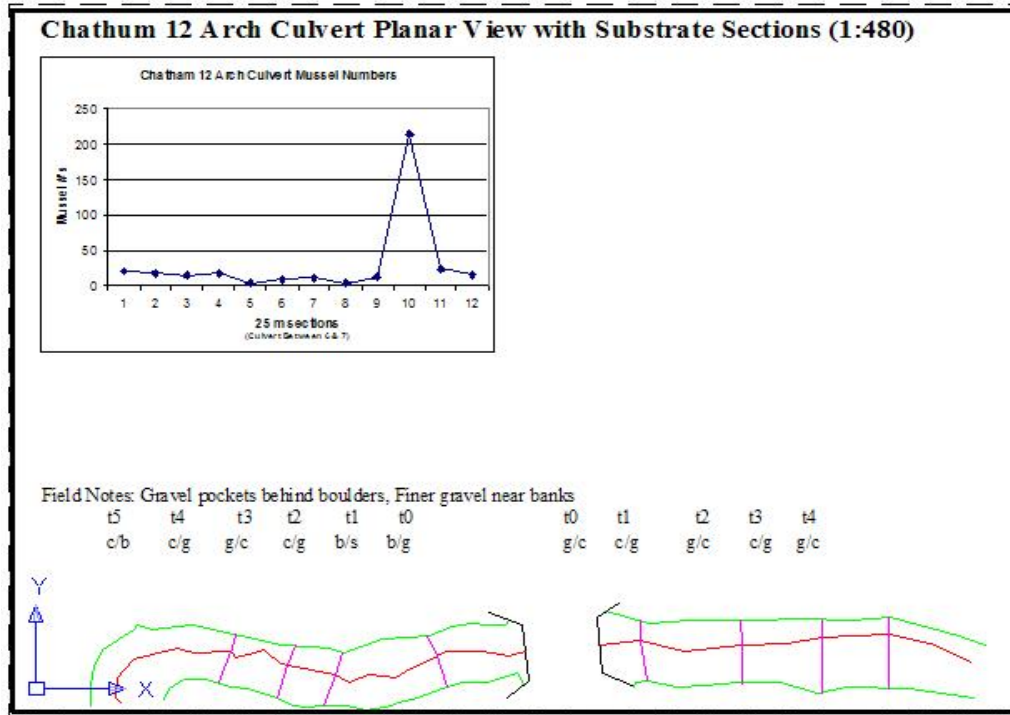
Figure 14. Planar Graph with Mussel Numbers Graph (not to scale)

especially, in front of a culvert where aggradation can occur. Areas dominated by bedrock obviously have small counts of mussel individuals because of the inhospitable habitat (Figure 14 and Appendix C).

*Stream Flow from left to right
 **change in t# is change in substrate section
 ***for better resolution please see Appendix C

The substrate analysis points to the fact that mussels do seem to prefer more stable substrates and can be affected by sedimentation and scour. Therefore the stream degradation and cross section expansion downstream of these crossings can have a negative effect on mussel numbers. Since bank erosion is occurring downstream mussels can be buried by these extra sediments entering the system.

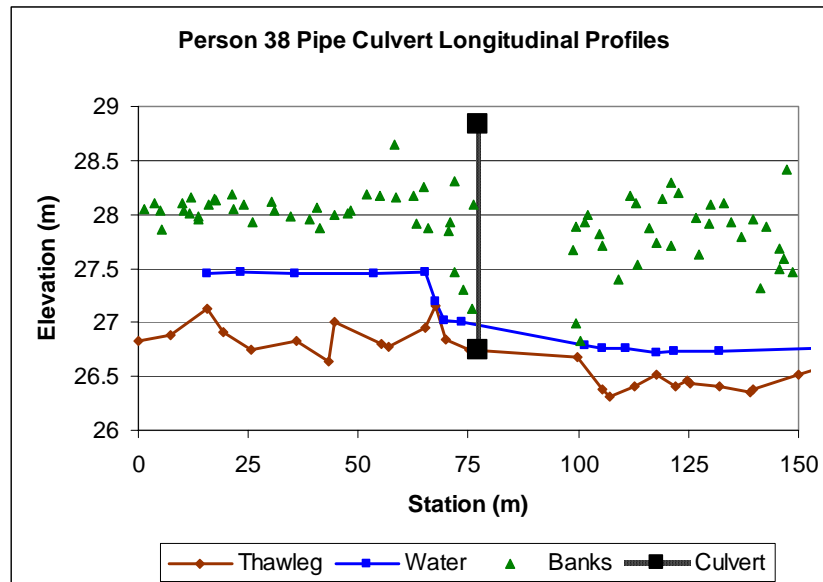
Figure 15. Longitudinal Profile of Steep Gradient after Crossing Structure

All sites were surveyed along the thalweg, banks, and water surface to determine the longitudinal channel gradients through these stream reaches with crossings. The longitudinal profiles show that pipe culverts and one bridge (Orange 67) had the most influence on stream gradient below the crossing (Figure 15). Most bridges, arch culverts and box culverts seem not to cause a significant change in the stream elevation (See Appendix C).

Contraction scour is the factor that appears to cause the decrease in channel elevation along the thalweg downstream of the crossing. The longitudinal profiles of all the pipe culverts and Orange 67 bridge show a significant drop in bed elevation downstream of the crossing. This contraction creates scour and degrades bed levels. Even though these pipe culverts may be allowing low flow sediment transport, at higher

flows they are causing scouring of bed levels. This is directly related to the floodplain restriction and thus all of the water's energy is focused through those pipes, when its energy would otherwise be dissipated in the floodplain. The Orange 67 bridge also had this same effect of a drop in bed elevation downstream of the structure because it is one of the smaller bridges with wingwalls in the study that is constricting higher flows and also scouring the downstream section.

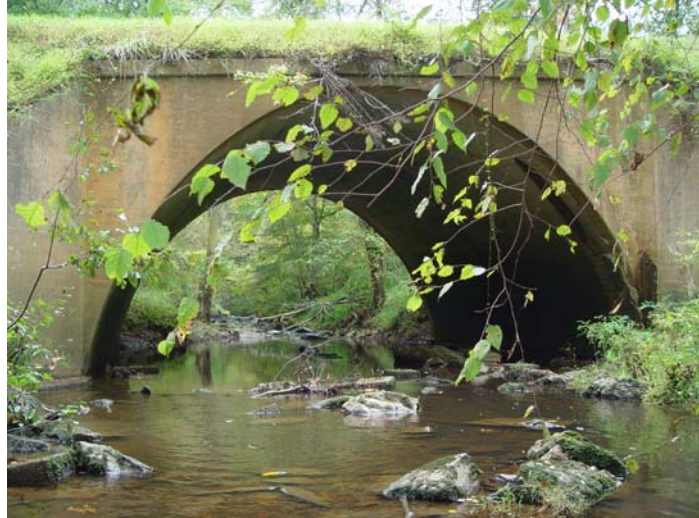
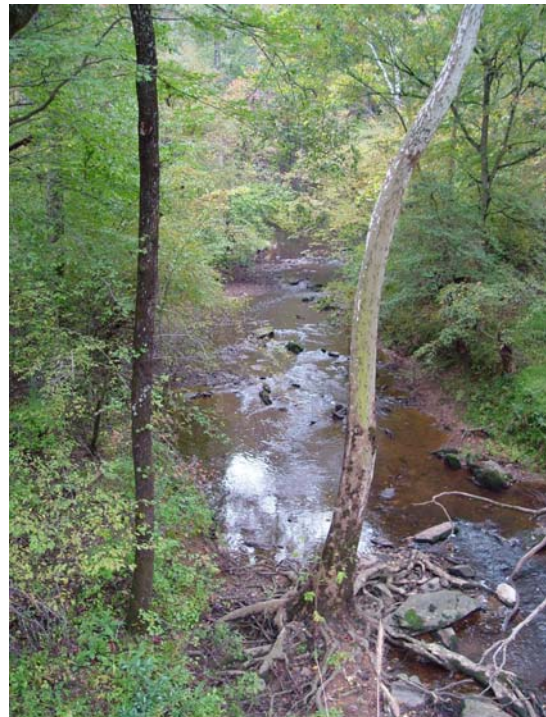
Site 11
BR#12
CO Chatham
BASIN Cape Fear

BFW= '
THD= '
CW= 45'
CT= Single 38'18' RC Arch
Built=1933
Substrate= cobble, gravel, bedrock
Channel cond= bank protection needs minor repairs
Scour Status= scour above top of footing

Conditions= slightly incised
both up and downstream,
much more downstream,
more rocky upstream
Land Use= Wooded?
Opinion= OK Site

* Pic 1 of arch culvert looking upstream
**Pic 2 looking upstream from top of culvert

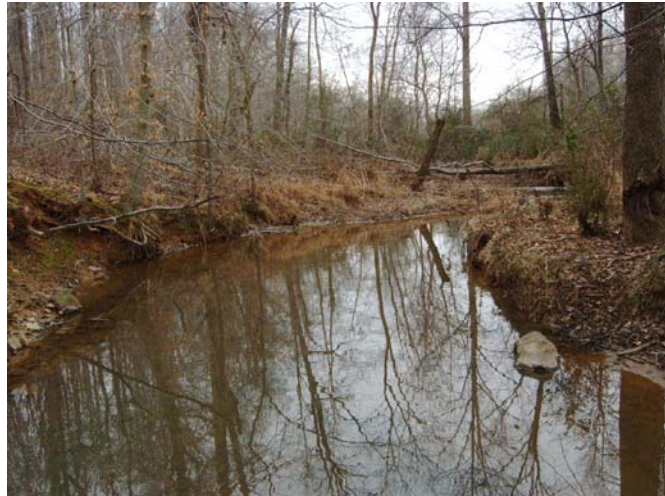
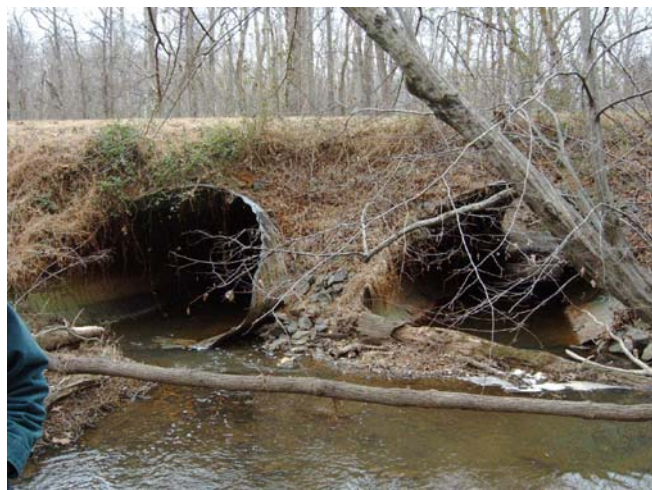
Site 36
BR#38
CO Person
BASIN Neuse

BFW=25'
THD= 2'5"
CW= '80
CT= Double 117"x79" corrugated pipe
Built= 1991
Substrate= rocky and sandy pools,
Channel cond=banks well protected or well
vegetated, no control devise needed
Scour status= scour above top of footing

Conditions= slightly incised , gravel bar below
Land Use= wooded?
Opinion=Ok site

***Pic 1 looking upstream into arch culvert**
****Pic 2 looking upstream from top of culvert**

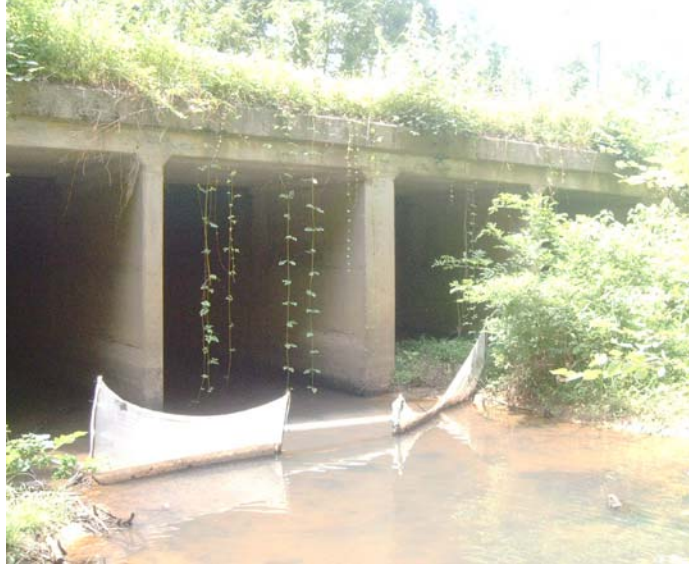
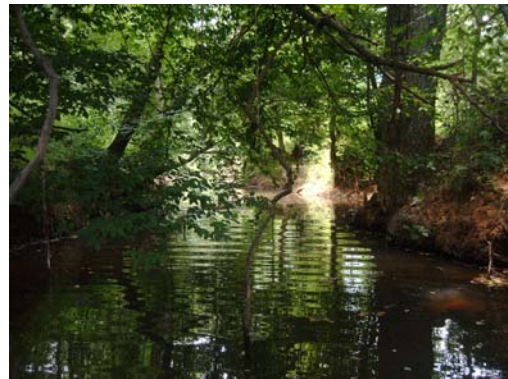
Site 02
BR#20
CO Alamance
BASIN Cape Fear

BFW=23.6'
THD= 2.4'
CW= 58. 6'
CT= Quadruple 8x9 RC box
Built=1930
Substrate= sand and gravel
Channel cond= bank beginning to slump , debris
restrict channel
Scour Status= scour above top of footing

Condition notes= incised below and above
Land Use= Wooded, grassy bank
Opinion= not a good site

***Pic 1 looking downstream at the culvert**
****Pic 2 looking upstream from culvert**

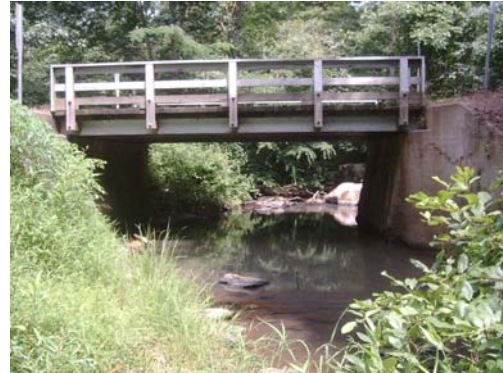
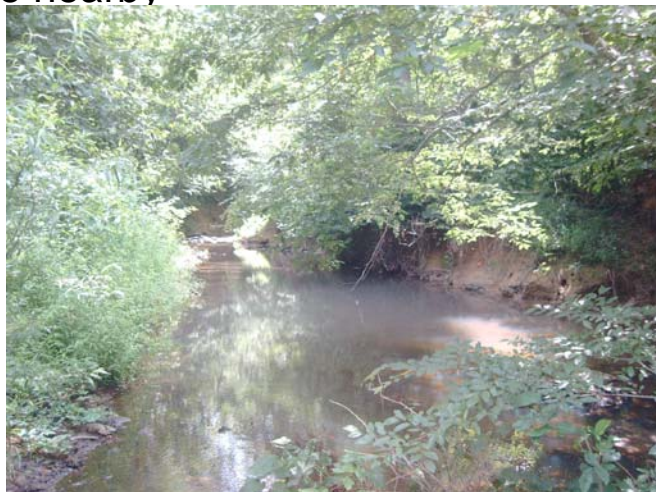
Site 03
BR#67
CO Orange
BASIN Neuse

BFW= 12.2'
THD= 1.2'
CW=
CT=
Built= 1953
Substrate= Cobble and gravel
Channel cond= unknown
Scour status= unknown
Conditions= Extreme erosion on banks
 downstream
Land use= Wooded some nearby
 houses
Opinion= OK site

***Pic 1 looking upstream at bridge**
****Pic 2 looking downstream from bridge**

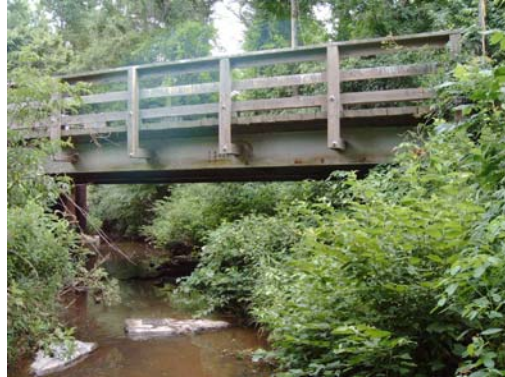
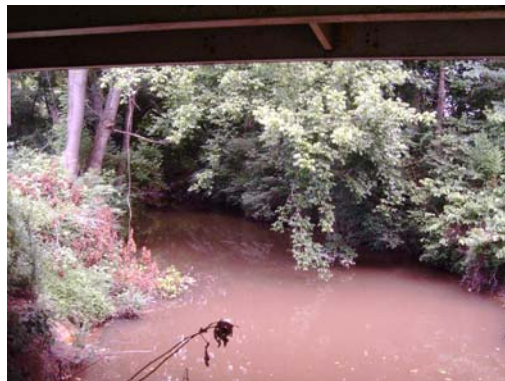
Site 10
BR#12010
CO Randolph
BASIN Cape Fear
WB= BACHELOR CREEK
BFW=15'9"
THD= 2'7"
BW= 159
BT= Wood and Metal
Built= 1954
Substrate=Sand and
Gravel, bedrock below
Channel cond= stable
banks
Conditions= Wooded w Ag

Opinion= half a wing wall
on each side

***Pic 1 looking downstream at bridge**

****Pic 2 looking downstream from under the bridge**

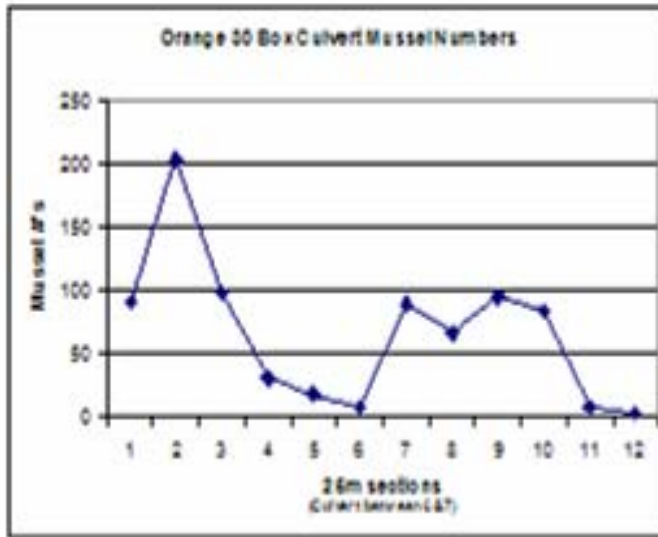
Orange 30 Box Culvert Planar View and Substrate Sections (1:480)

Field Notes: Bankfull being established on left bank below and in culvert, Sandy banks, undulations in longitudinal profile due to bedrock under sand, methane, anaerobic conditions

t8 t7 t6 t5 t4 t3 t2 t1 t0
g/b g/c c/g g/c b/s g/s b/g g/s c/g
