The State of Stream Restoration in the North Carolina Piedmont: An Assessment of Instream
Structure Durability and Stream Bank Erosion

by
Kimberly Mae Spangler Hamlin

A thesis submitted to the Graduate Faculty of
North Carolina State University
in partial fulfillment of the
requirements for the degree of
Master of Science

2011

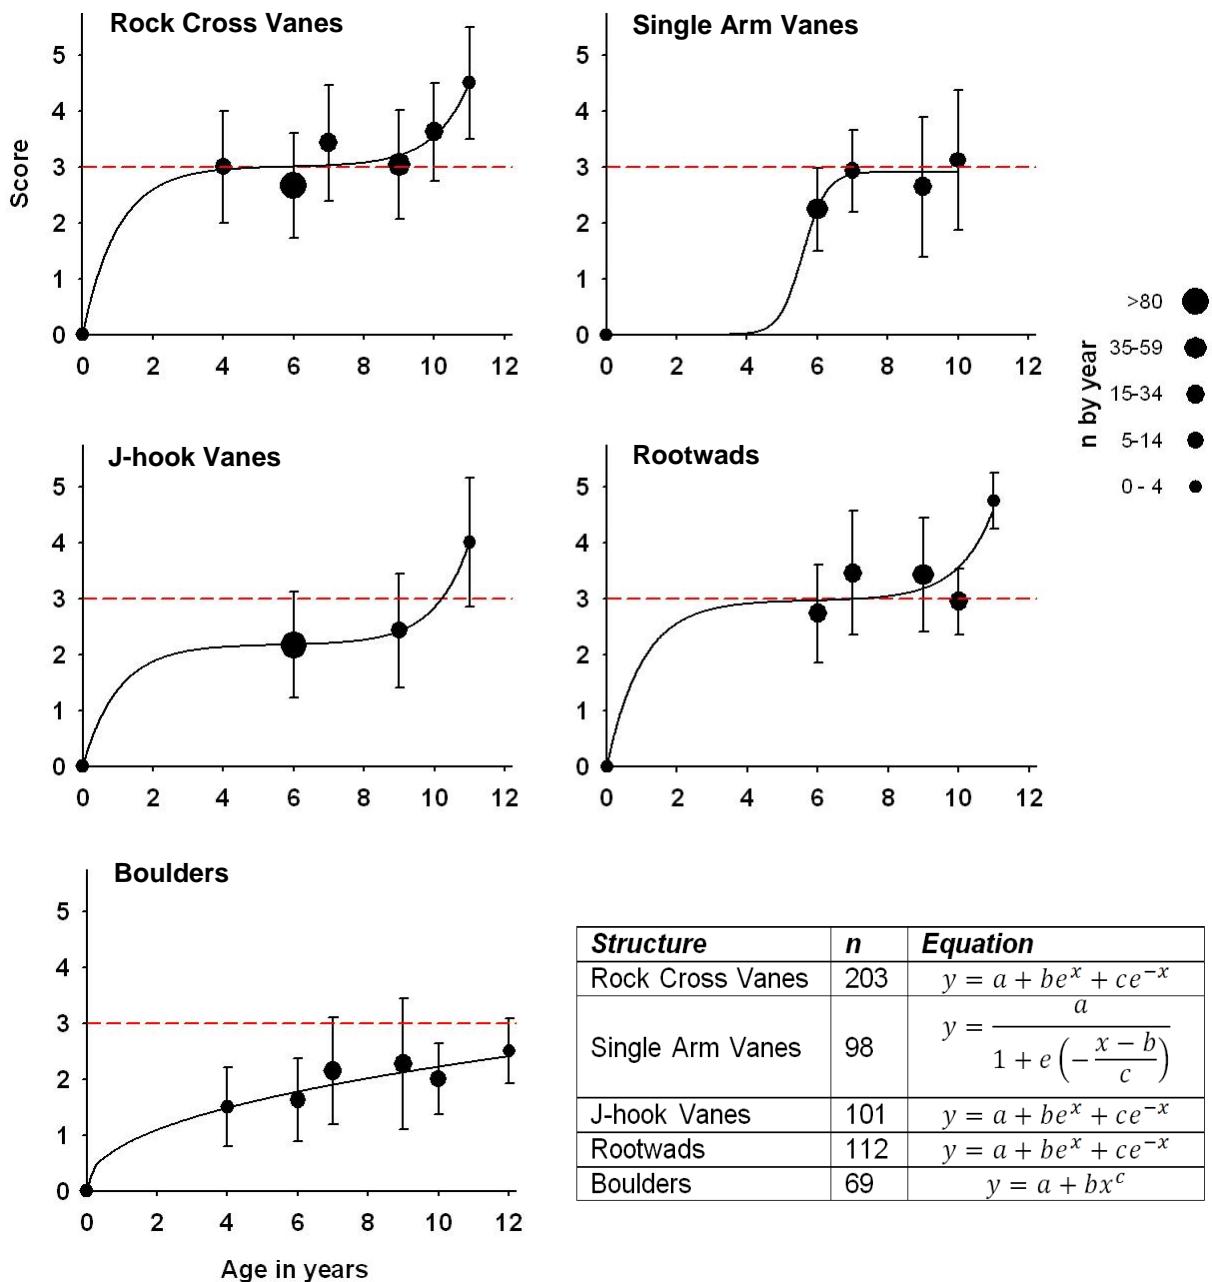
Mean rock cross vane scores reached the threshold value at year four and remained steady through year nine. Structural integrity decreased after year nine, reaching an average score of 4.5 by year eleven (Figure 1a).

Mean single arm vane scores at year six were approximately two. Scores approached the threshold value in years seven through nine and reached the threshold value in year ten with a score of approximately 3 (Figure 1b).

J-hook vane mean scores in years six and nine were just above two, but by year eleven the average score was approximately four (Figure 1c).

Rootwad revetment mean scores were similar to scores for rock cross vanes. Average scores reached the threshold value by year six and were steady until year ten (Figure 1d). At year eleven the average score was approximately five.

Boulders exhibited the least damage over time. From years four to twelve the average score slowly climbed to about 2.5 (Figure 1e). Only one stream restoration was 12 years old and contained only boulders according to design plans.

Figure 1 – Average Condition Scores of Instream Structures in Each Age Class. Asymptotic curves were fit for average condition scores of (a) rock cross vanes, (b) single arm vanes, (c) j-hook vanes, (d) rootwad revetments, and (e) boulder revetments. The error bars represent 1 standard deviation. A score of three and above was designated as the threshold value where structural integrity was compromised.

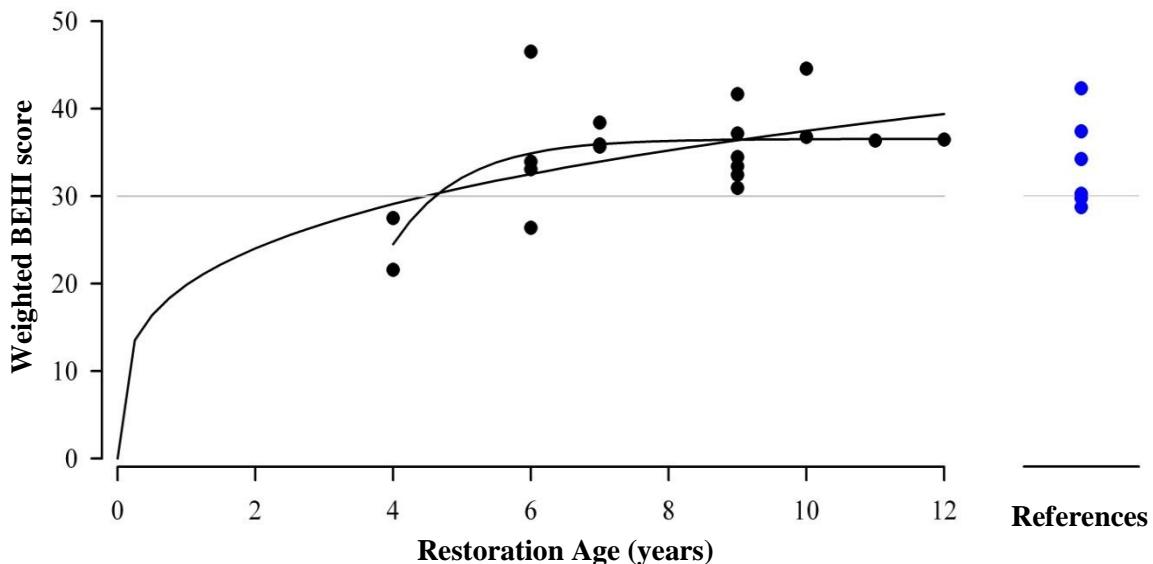
Weighted BEHI scores in stream restorations approached the threshold value at age four in both curves (Figure 2). The BEHI scores surpassed the threshold value by age six and remained relatively constant through age twelve (Figure 2). The average weighted BEHI score for reference streams was 34, with a range of 29 to 42.

Figure 2 – Weighted BEHI Scores for Stream Restorations and Reference Streams. A BEHI score of 30 or more was designated as the threshold value where bank erosion became concerning. Asymptotic curves were fit starting at ages 0 and 4 to note if assumptions affected the output.

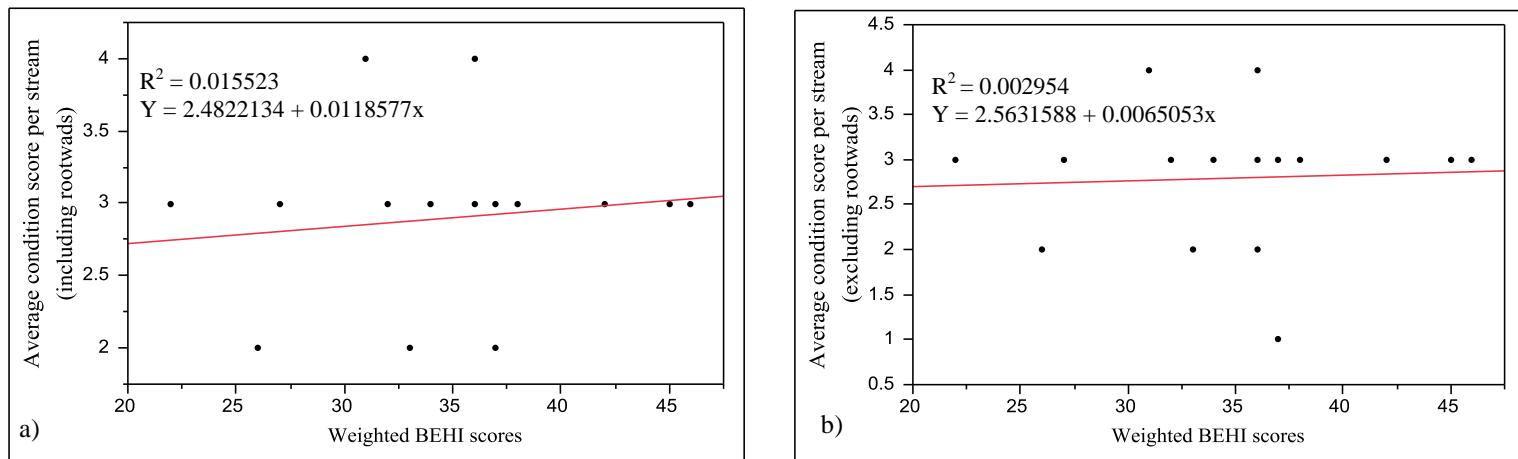
Structure condition was not related to average weighted BEHI scores (Figure 3 a-b).

Figure 3 – Comparison of Average Structure Condition Scores and Weighted BEHI Scores a) including rootwads and b) excluding rootwads.

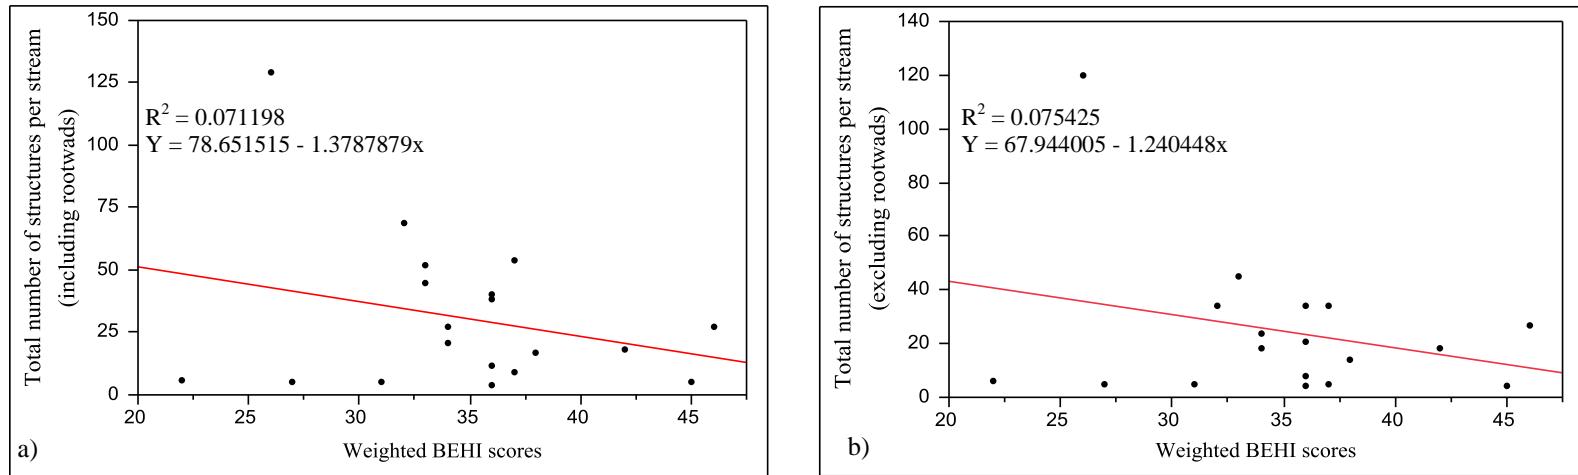
Weighted BEHI scores were also not related to the total number of structures per stream (Figure 4 a-b) and the structure density per stream (Figure 5 a-b). Excluding rootwad revetments from the analyses had no effect.

Figure 4 – Comparison of Total Number of Structures and Weighted BEHI Scores a) including rootwads and b) excluding rootwads.

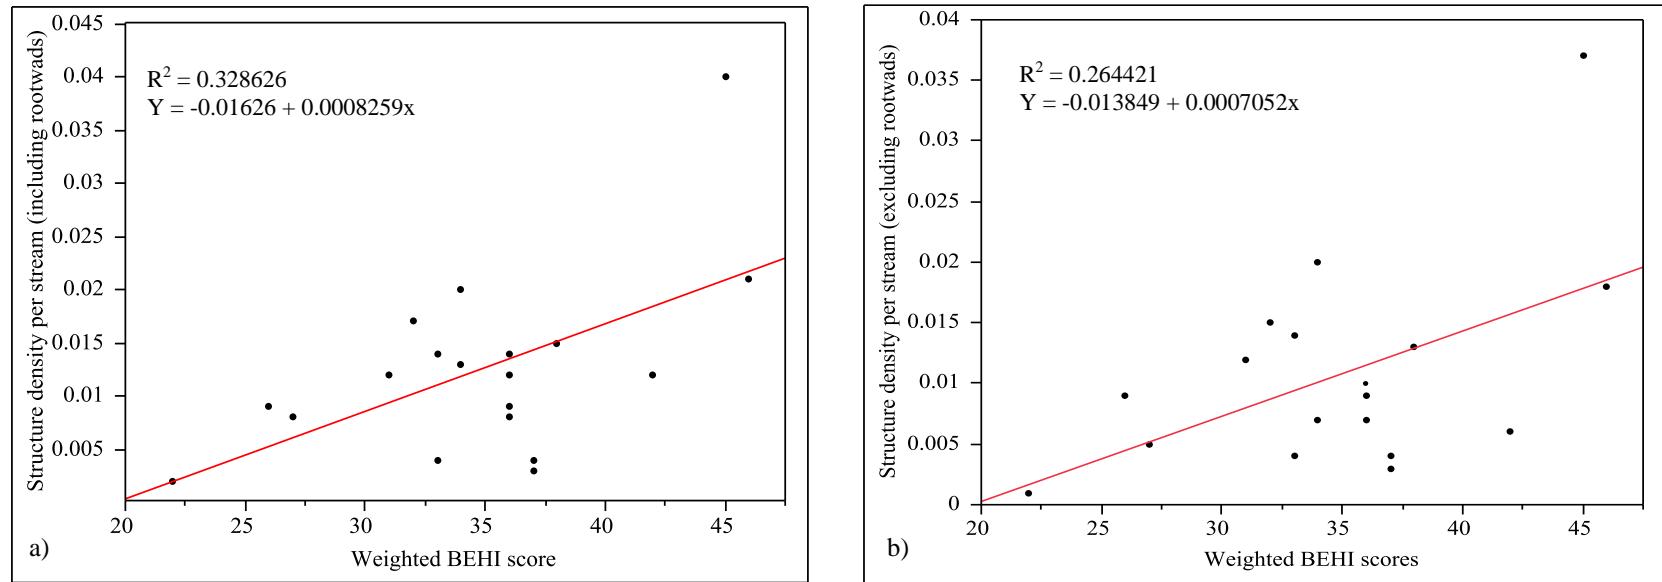
Figure 5 – Comparison of Structure Density and Weighted BEHI Scores a) including rootwads and b) excluding rootwads.
