MILLER, ANTHONY D. Repair of Impact-Damaged Prestressed Concrete Bridge Girders Using Carbon Fiber Reinforced Polymer (CFRP) Materials. (Under the direction of Dr. Sami Rizkalla).

**REPAIR OF IMPACT-DAMAGED PRESTRESSED
CONCRETE BRIDGE GIRDERS USING CARBON FIBER
REINFORCED POLYMER (CFRP) MATERIALS**

A thesis submitted to the Graduate Faculty of
North Carolina State University
in partial fulfillment of the requirements for
the Degree of Master of Science

2006

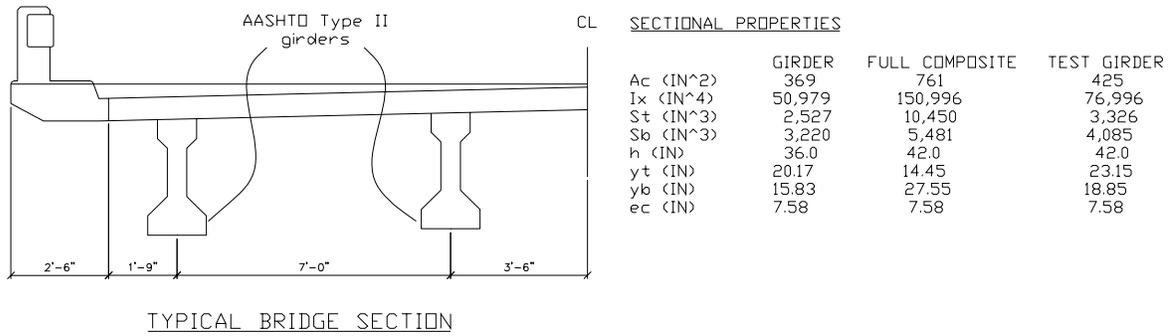
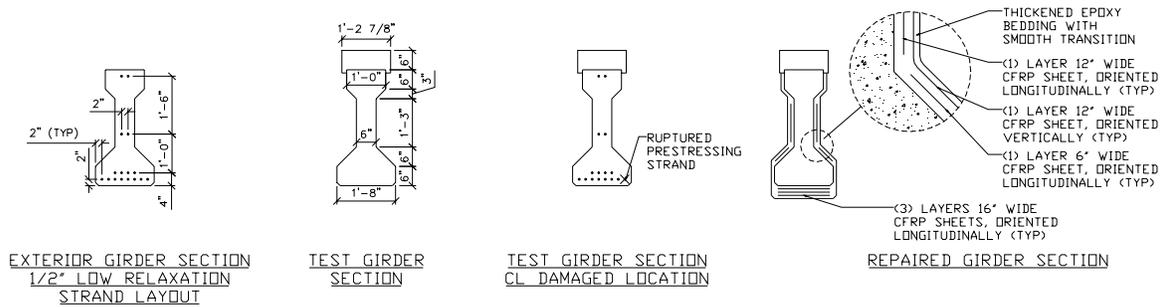
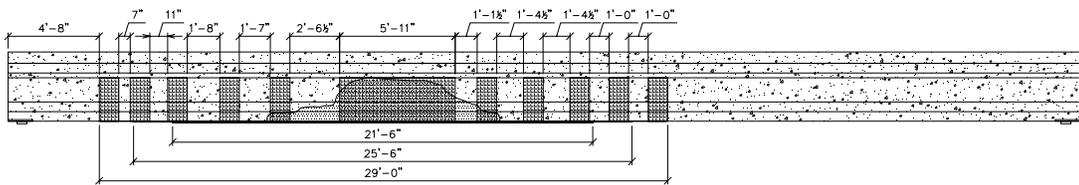
Figure 3.3 AASHTO I girder cross section, elevation, and CFRP design details

AASHTO1 was the first girder tested in this research project. The test girder was an AASHTO Type II girder prestressed with sixteen 0.5 in (12.7 mm) – 7 wire 270 ksi (1862 MPa) straight prestressing strands, as shown in Figure 3.3. The total length of the tested girder was 54.84 ft (16.71 m) with a center-to-center support span of 53.34 ft (16.26 m). The girder after impact damage from an overheight vehicle is shown in Figure 3.4. The cross section and elevation of AASHTO1 are shown in Figure 3.3. The loss of concrete section extended a length of 11.9 ft (3.63 m) on the front side and 6.0 ft (1.83 m) on the back side with an approximate volume of damaged concrete equal to 4.8 ft³ (0.1 m³). In addition to the loss of concrete, one prestressing strand on the bottom layer was ruptured on the front side, resulting in a 6.3 percent loss of prestressing force. The full 7 ft (2.13 m) composite bridge deck was not part of the test specimen since it was cut through in order to remove the damaged girder from the bridge superstructure. The average width of the composite deck of the test girder was 14.9 in (388 mm), ranging from 16.9 in (430 mm) to 13.9 in (353 mm). Several transverse cuts were located along the length of the composite deck. These cuts, originating during the cutting of the cast in place diaphragms, were approximately 0.4 in (10 mm) in width.

To restore the original ultimate flexural capacity of the girder, a procedure similar to the one described in Appendix A was used. The analysis concluded that three layers of 16 in (406 mm) wide longitudinal CFRP layers were required. In order to minimize the initiation of new cracks in the repaired concrete, additional longitudinal sheets were installed; a 6 in (152 mm) wide sheet was placed on the top of the bottom flange and a 12 in (305 mm) wide sheet was placed in the middle of the web. These additional longitudinal sheets were placed on both sides of the girder to ensure symmetry of the section. In order to ensure proper utilization of the CFRP's strength and strain capacity, adequate development length of the sheets was provided. The full details of the CFRP reinforcement are described below, as well as a full schematic shown in Figure 3.3:

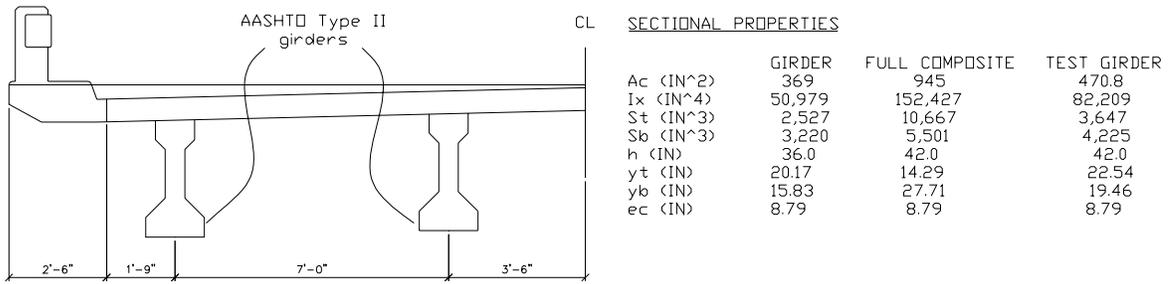
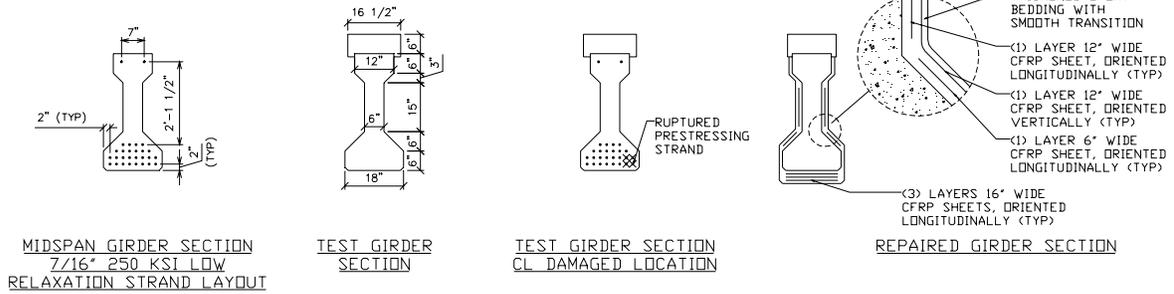
Figure 3.5 AASHTO2 girder cross section, elevation, and CFRP design details

As previously mentioned in Section 3.1, AASHTO2 was received by the researchers undamaged, except for several transverse cuts approximately 0.4 in (10 mm) wide in the composite deck after the removal of the diaphragms. In order to simulate impact damage, a large portion of the tension flange of the girder was removed (Figure 3.6), and four prestressing strands were ruptured (Figure 3.7), corresponding to a reduction in prestressing force of 14.3 percent. The length of the damage was extended to a total of 2.0 ft (0.61 m) on either side of midspan on the front side of the girder only. Approximately 2.2 ft³ (0.06 m³) of concrete was removed, as shown in Figure 3.7.

mm) wide transverse CFRP U-wraps were provided along the repaired section to prevent interfacial debonding of the longitudinal sheets. Full details of the CFRP reinforcement are described below, as well as a full schematic shown in Figure 3.5:

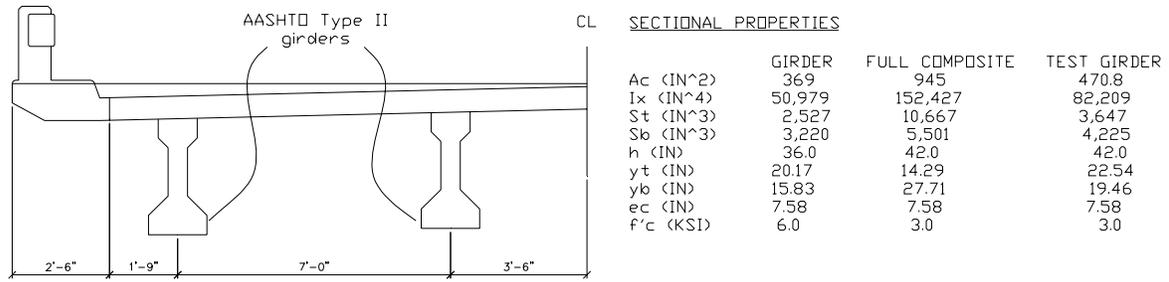
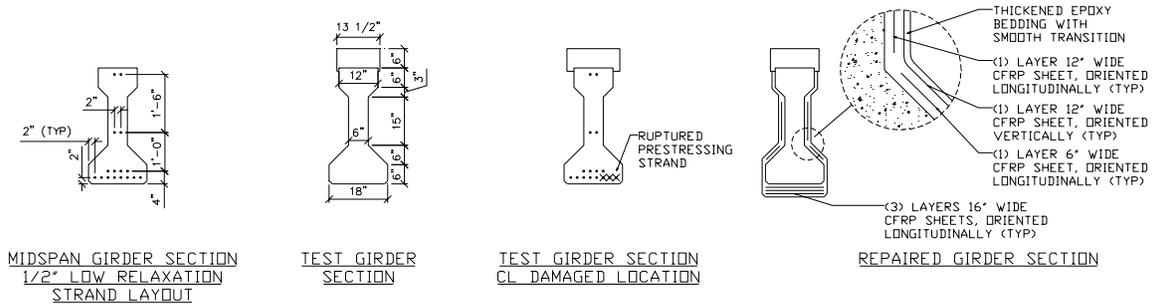
Figure 3.9 AASHTO3 girder cross section, elevation, and CFRP design detail

AASHTO3 had been impacted several times prior to being removed from the bridge. Figure 3.10 shows one section where an earlier concrete repair had been performed along with epoxy injection of the cracks caused by vehicular impacts. In order to simulate impact damage to this girder, a large portion of the tension flange was removed, similar to girder AASHTO2, and three prestressing strands were ruptured (Figure 3.11), corresponding to a reduction in prestressing force of 18.8 percent. The length of the damage was 2.0 ft (0.61 m) to the left of midspan and approximately 5.0 ft (1.52 m) to the right on the front side only. It was intended for the damage to be symmetrical about midspan, but the presence of earlier repairs made it difficult to cut as planned. A total of approximately 2.4 ft³ (0.07 m³) of concrete was removed, as shown in Figure 3.11.

Following a procedure similar to that described in Appendix A, it was concluded that three layers of 16 in (406 mm) wide longitudinal CFRP sheets were needed to restore the original ultimate flexural capacity of the girder. The full details of the CFRP reinforcement are the same as those previously described for AASHTO2. The CFRP repair details are shown in Figure 3.9.

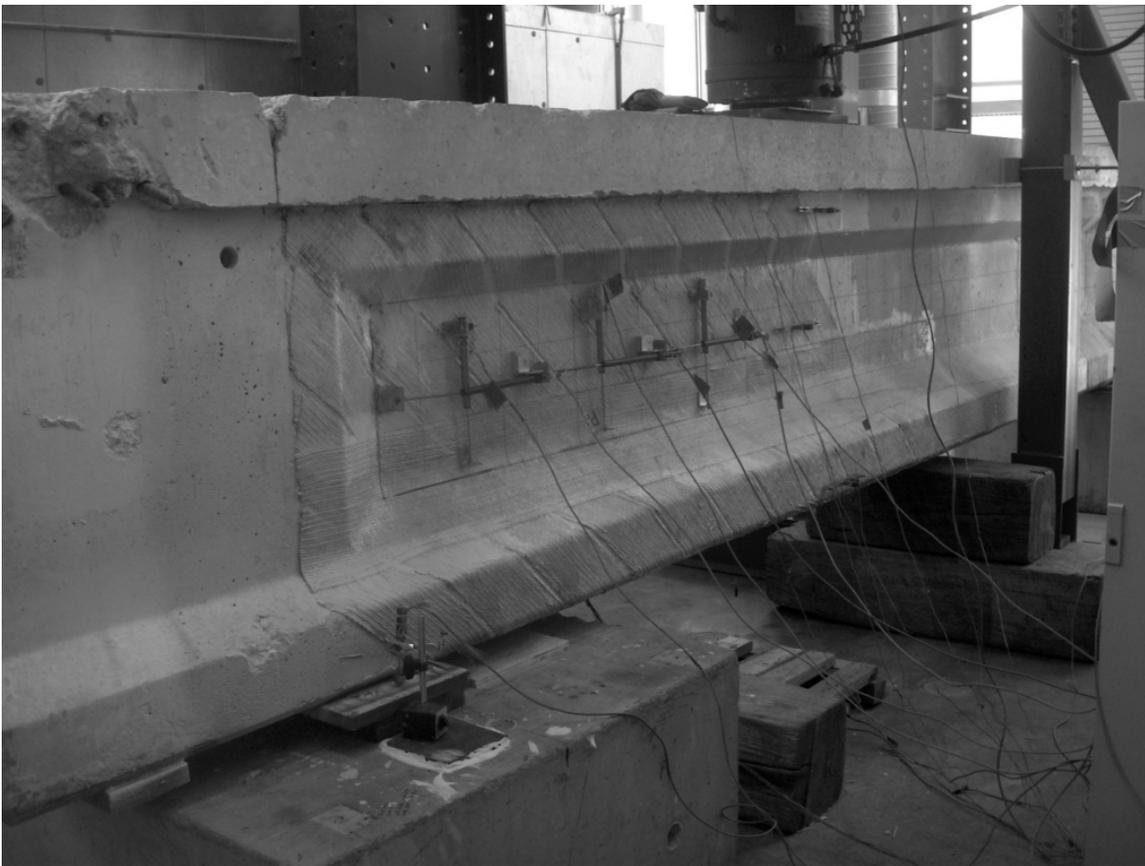
Figure 3.14 AASHTO2R test specimen

AASHTO2R was tested monotonically to failure as a shear critical member with simulated damage repaired with CFRP sheets as shown in Figure 3.14. The girder was prestressed with 28-7/16 in (11.1 mm) diameter 250 ksi (1724 MPa) strands. The total length of the girder was 20.67 ft (6.30 m), with a span of 17.83 ft (5.31 m) from center-to-center of the supports. Based on measurements taken at two foot intervals, the average width of the composite deck was determined to be 16.5 in (419 mm). Cross section and elevation drawings of AASHTO2R, including CFRP repair details, are shown in Figure 3.15. It should be noted that the section properties for AASHTO2R are the same as AASHTO2C but were not included for clarity.

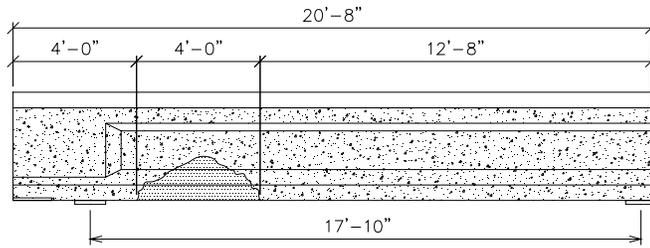
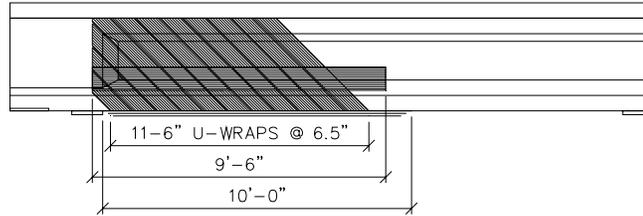
ELEVATION FRONT SIDE DAMAGED TEST GIRDER

ELEVATION FRONT SIDE REPAIRED TEST GIRDER

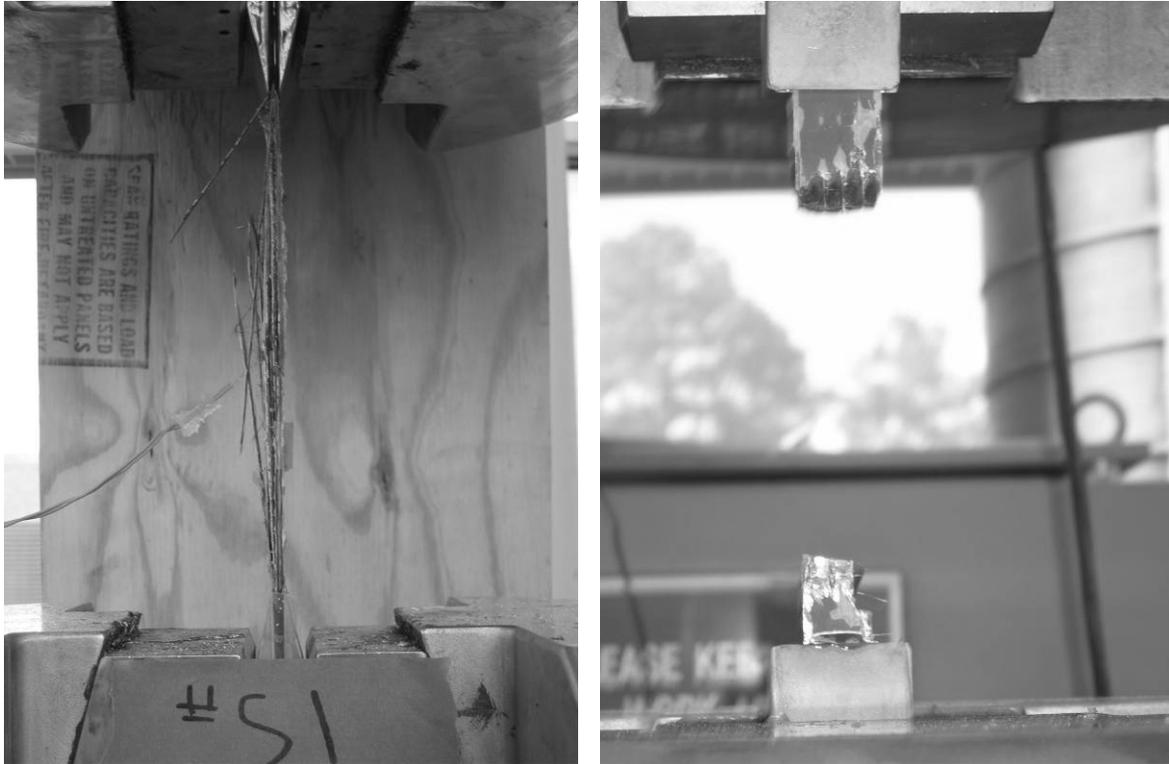
Figure 3.22 Failure through the fibers (left) and failure through cross section (right)

All CFRP samples were cut out of witness panels to a width of 1 in (25.4 mm) and a length of 17.5 in (445 mm). The samples were then bonded to aluminum tabs using Wabo MBrace© Saturant (Wabo 2002) to produce a gauge length of 6 in (152 mm). Figure 3.21 shows a typical CFRP tension test setup. The strain of the CFRP was measured using a 0.236 in (6 mm) TML FLA-6-11 120 Ω electric resistance strain gauge placed at the center of the width and gauge length of the specimen. The primary mode of failure was the sudden and brittle rupture of the fibers in the CFRP, as shown in Figure 3.22 (left). The second, and

less frequent mode of failure, was rupturing of the CFRP matrix through the cross section, as shown in Figure 3.22 (right).

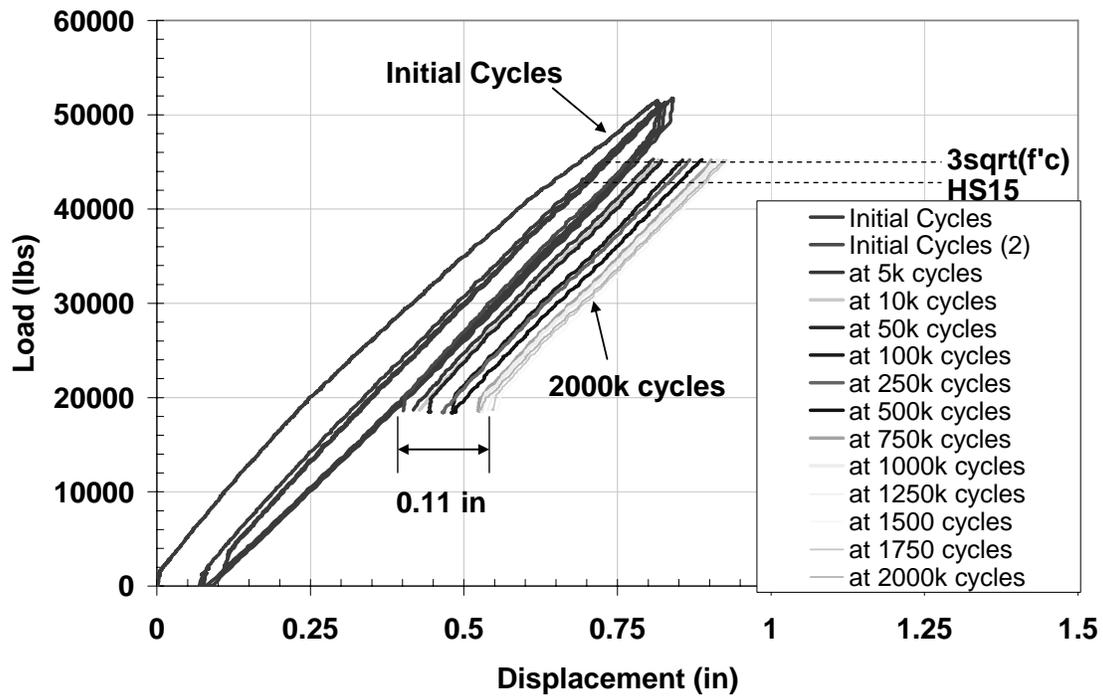
Figure 4.1 Load versus displacement for girder AASHTO1

The applied load versus midspan displacement relationship for the fatigue loading ranging between the load values 18.7 k to 45.2 k (83.2 kN to 201.1 kN) for the repaired AASHTO1 girder is shown in Figure 4.1. The girder survived 2 million cycles with very

little degradation or crack propagation in the repaired region after the initial cycles. Fatigue creep of concrete (El-Tawil et al. 2001) caused small amounts of displacement degradation totaling 0.11 in (2.8 mm) after 2 million cycles of loading. No stiffness degradation in the girder was observed after 2 million cycles of fatigue loading.

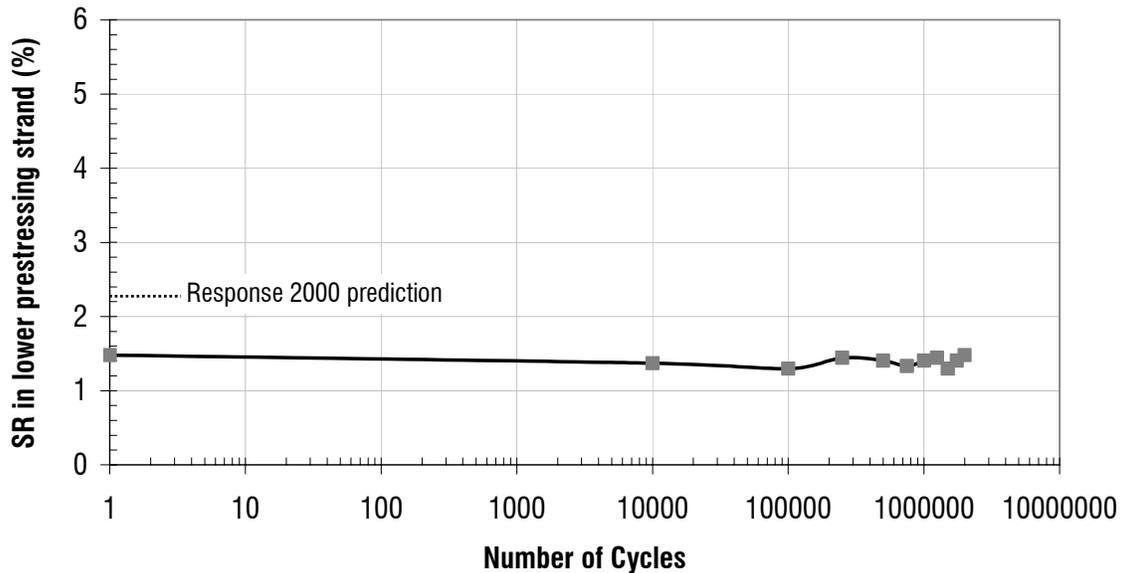
Figure 4.2 Stress ratios in prestressing strands versus number of cycles for AASHTO1

Due to the impact damage imparted on the AASHTO girder and the concrete restoration process, a good estimate of the effective prestress force in the prestressing strands was difficult to obtain. Using a prestress loss of 12.6 percent, the measured stress ratio in the lower prestressing strands at midspan during the initial cycles was found to be 1.7 percent. The stress ratio in the lower prestressing strands was also determined using a Response 2000[®] analysis and was determined to be 2.6 percent, slightly higher than the measured value. It should be noted that all of the prestressing strands were straight in girder AASHTO1. Previous work demonstrates that fatigue rupture of prestressing strands is rare at

such low stress ratio values in straight prestressing strands (Naaman 1991, Collins & Mitchell 1991) therefore no degradation was observed after completion of 2 million cycles, as shown in Figure 4.2.

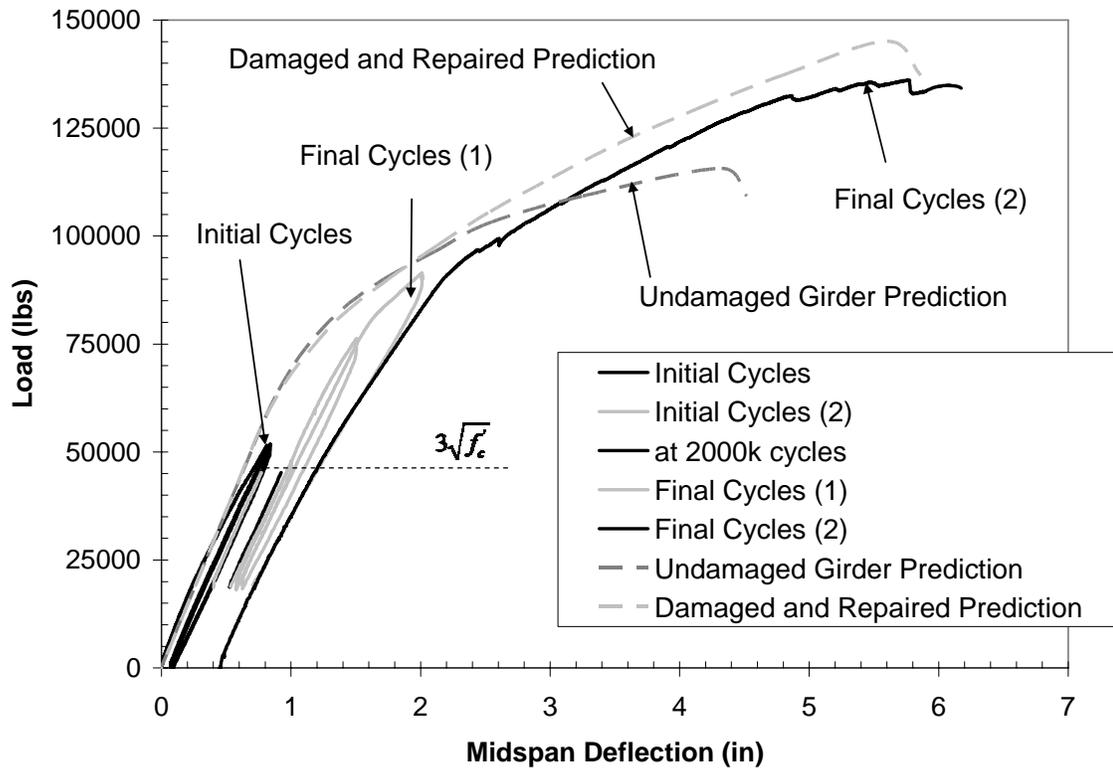
Figure 4.3 Final static test to failure of girder AASHTO1

A full description of the final static test on girder AASHTO1 is provided in Section 3.8. Flexure-shear cracks, which initiated outside the termination point of the longitudinal CFRP in the undamaged region, propagated in an inclined fashion towards the compression zone and eventually caused failure of the girder near midspan. Test results indicated that the presence of the main longitudinal CFRP significantly increased the flexural capacity of the damaged zone of the girder causing the failure outside this region. The presence of the tension-strut CFRP reinforcement and transverse U-wraps controlled crack propagation within the damaged zone as well as enhancing the shear capacity of the strengthened section. The overall behavior of the repaired girder far exceeded the predicted strength of the undamaged girder in both strength and ultimate displacement, as shown in Figure 4.3.

A prediction using Response 2000[®] was performed on the undamaged girder as well as the repaired girder, and is shown with the experimental results in Figure 4.3. Due to the difficulties in assessing the cracking load of the girder, the value for effective prestress used was determined from calculations (AASHTO 2004). In the analysis, the following scenarios were included: 1) all the longitudinal CFRP was modeled (including tension strut CFRP reinforcing), 2) a prestressing strand on the bottom layer was removed and considered to be ineffective throughout the length of the girder, and 3) one average value for the width of the composite deck (14.9 in (379 mm)) was used in the analysis in spite of the fact that the width varied slightly throughout the length of the girder. Response 2000[®] predicted concrete crushing failure for the damaged and repaired girder at an applied load of 145.1 k (645 kN)

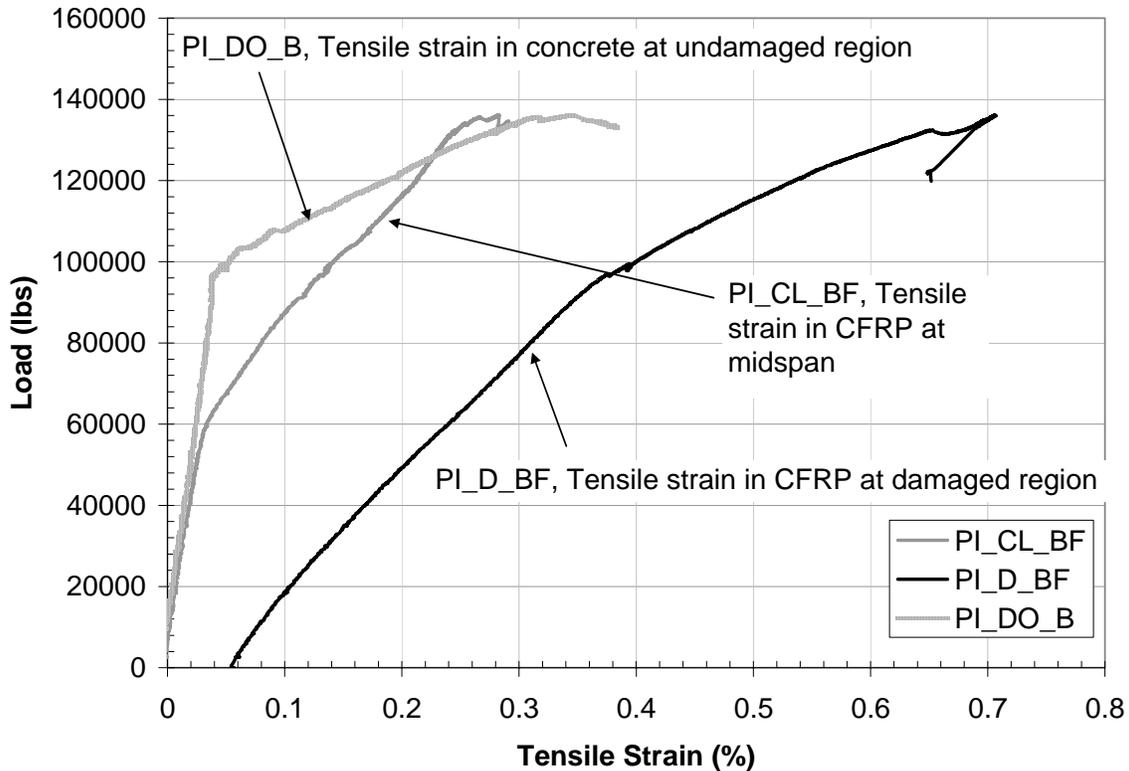
Figure 4.4 Load versus tensile strain during final static test of girder AASHTO1

The tensile strains in the repaired AASHTO girder during the final static test measured from various PI gauges is shown in Figure 4.4. Several items that should be noted in the figure include: 1) residual tensile strains in the CFRP of 0.07 percent can be seen in the repaired region after the fatigue cycling due to crack opening and aggregate interlock in the restored concrete, 2) flexural cracks first formed at the undamaged section at an applied load of 94.4 k (420 kN), 3) the stiffness of the damaged region and the undamaged region were almost the same after flexural cracking occurred in the undamaged region.

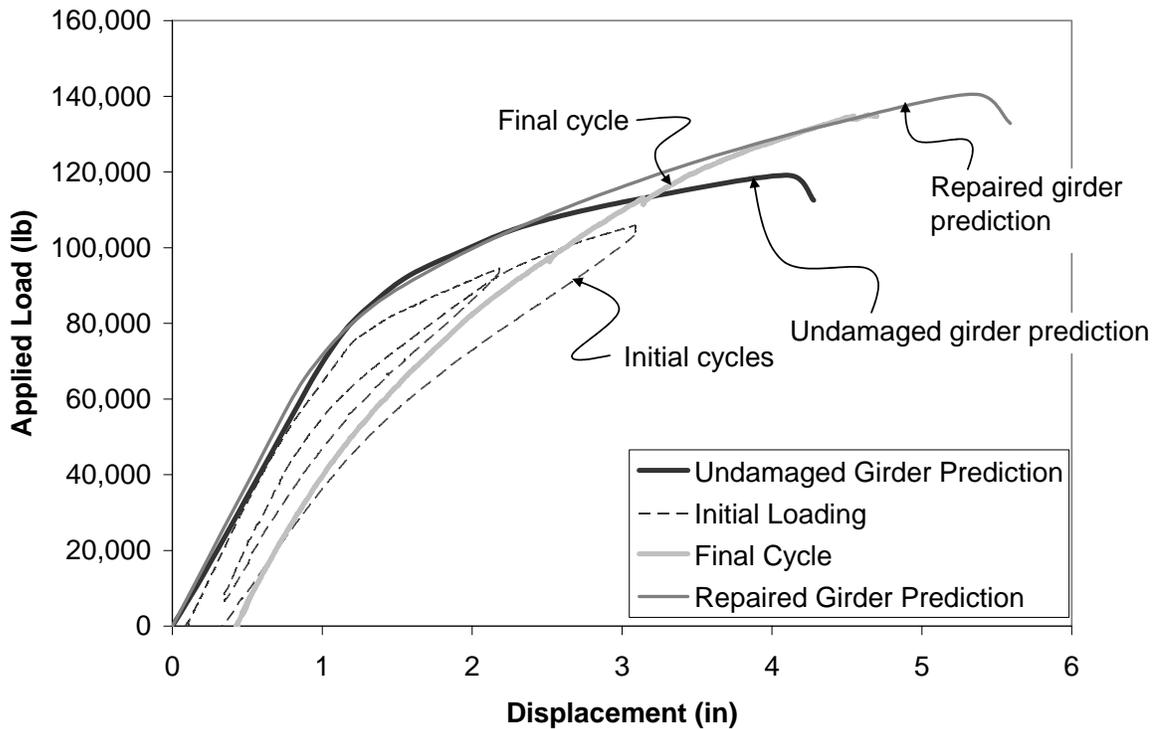
Figure 4.7 Load versus deflection of girder AASHTO2

After the section was restored with repair mortar and CFRP sheets were installed, girder AASHTO2 was subjected to two loading cycles up to failure. A full description of the final static test is provided in Chapter 3. Failure initiated in the concrete material around the loading plate, where localized crushing led to out-of-plane behavior rapidly causing failure. The maximum measured value of concrete compressive strain was $2630 \mu\epsilon$. The relatively low value at crushing of concrete was likely a result of the poor condition of the concrete at

midspan due to extant transverse cuts. The damaged and repaired girder far exceeded the strength and ultimate displacement of the original undamaged girder, as shown in Figure 4.7. The longitudinal CFRP system was able to adequately carry the tensile forces, and showed very little debonding or damage even after the failure event. The transverse CFRP sheets were also virtually unaffected during the loading, with only the U-wraps positioned directly below the loading area becoming damaged at failure.

In Figure 4.7, the load versus deflection predictions are shown for two scenarios: 1) the undamaged girder, and 2) for a repaired girder modeled with a similar amount of CFRP as the actual repaired girder. Both of the predictions were made using cracked section analysis described earlier in this chapter and constituent properties taken from material testing. The prediction of the undamaged girder matches closely the measured values from

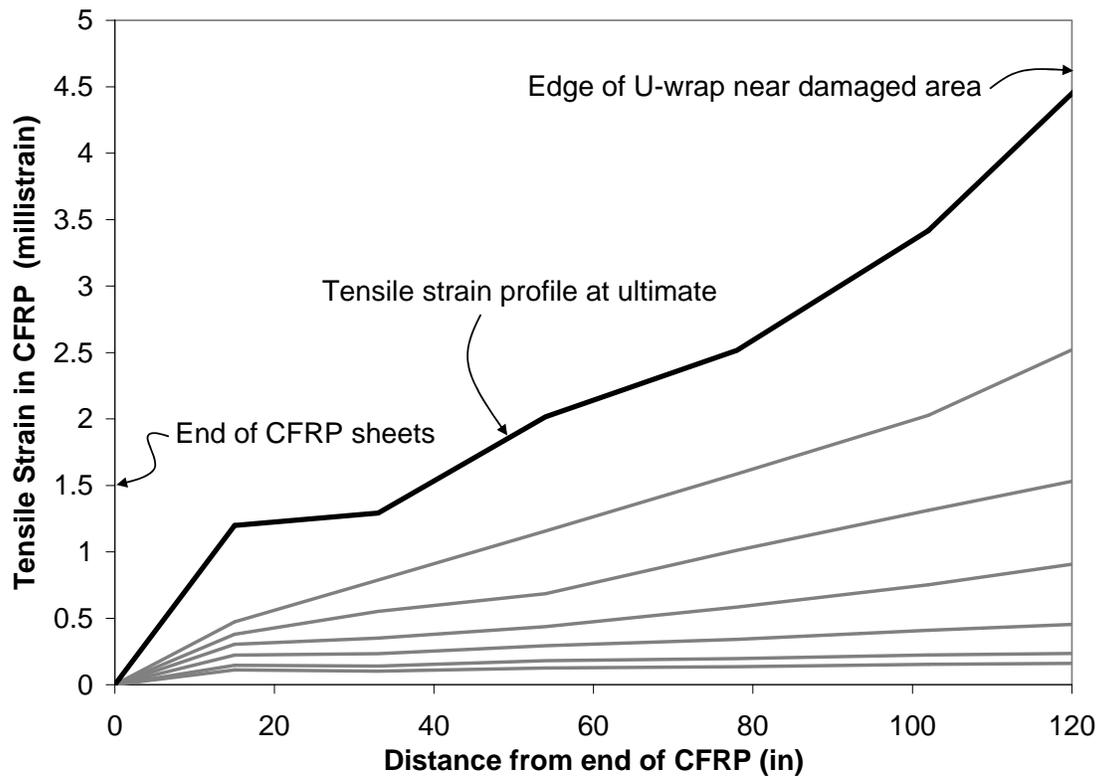
Figure 4.8 CFRP tensile strain profile during final static test of girder AASHTO2

The maximum tensile strain in the CFRP system at failure was 4620 $\mu\epsilon$, very close to the maximum tensile strain observed during the test of girder AASHTO1. Due to the location of several wide transverse U-wraps used to encapsulate the damaged region, tensile strain gauges could only be located at a distance approximately 3.94 ft (1.2 m) from midspan. Therefore, the maximum strain in the longitudinal CFRP was likely larger than the maximum measured value. Multiple strain gauges were affixed to the longitudinal CFRP throughout

the repaired area, and the measured tensile strain profile is shown in Figure 4.8. Due to the thickness of the longitudinal CFRP, the presence of the transverse U-wraps, and the large distance between the gauges, the effect of stress concentrations at the toes of the flexural cracks is not manifested in the plot. At failure the large increase in tensile strain which can be seen around 78.7 in (2000 mm) from the end of the CFRP repair is likely due to the yielding of the prestressing strands at that location along the length of the girder.

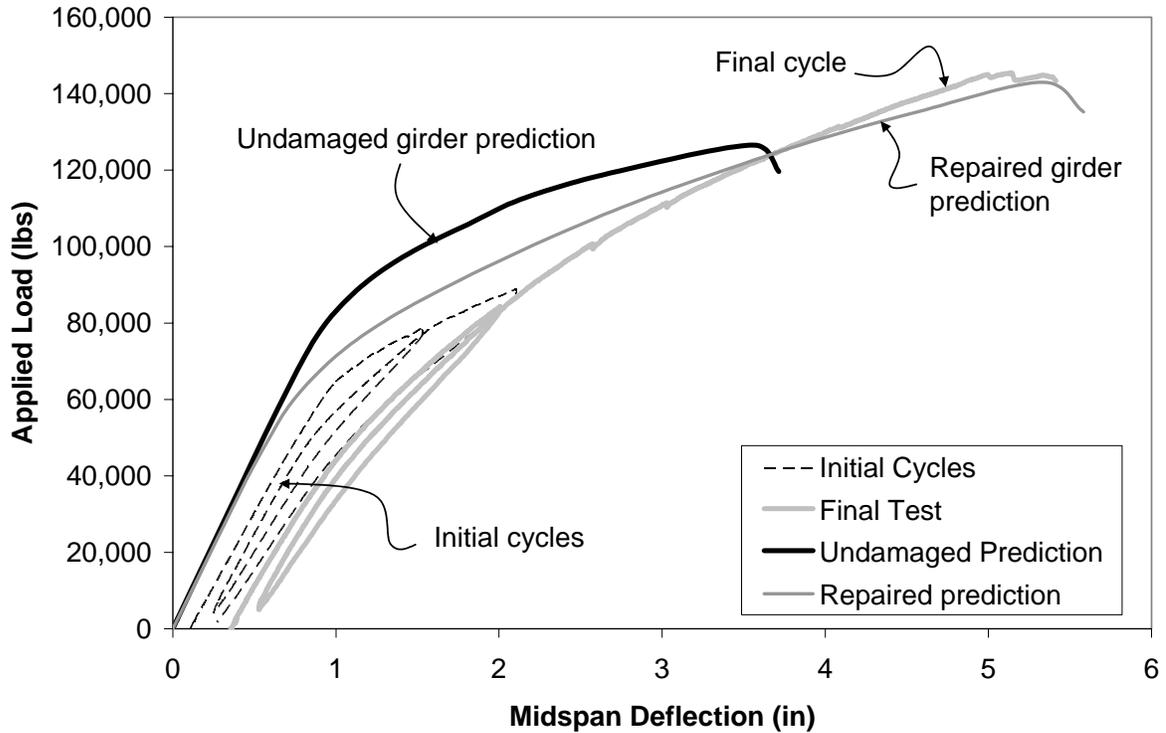
Figure 4.11 Load versus deflection of girder AASHTO3

After the section was restored with repair mortar and CFRP sheets were installed, girder AASHTO3 was subjected to two loading cycles up to failure. A full description of the final static test is provided in Chapter 3. Failure was due to concrete crushing in the compression region around the loading plate. The maximum measured value of concrete compressive strain at failure was $3090 \mu\epsilon$, significantly larger than the measured value for the previous AASHTO flexural tests. There was no evidence of debonding in the longitudinal CFRP at failure. The transverse U-wraps buckled at failure but contained most of the concrete damage. The load versus deflection behavior of girder AASHTO3 is shown in Figure 4.11.

Similar to girder AASHTO2, in Figure 4.11 the load versus deflection predictions from cracked section analysis are shown for two scenarios: 1) the undamaged girder, and 2) the repaired girder with all CFRP. The undamaged girder prediction with the measured effective prestress force does not adequately reflect the measured load versus deflection behavior. This is likely the result of the poor condition of this girder upon delivery to the laboratory, with numerous impact events evident on one side. This internal damage and cracked nature of the beam could have resulted in the lower cracking load and stiffness compared to the prediction. The load versus deflection prediction for the repaired girder corresponds extremely well to the measured response of the girder. The predicted ultimate load of the repaired girder is 1.7 percent lower than the measured value. It should be noted

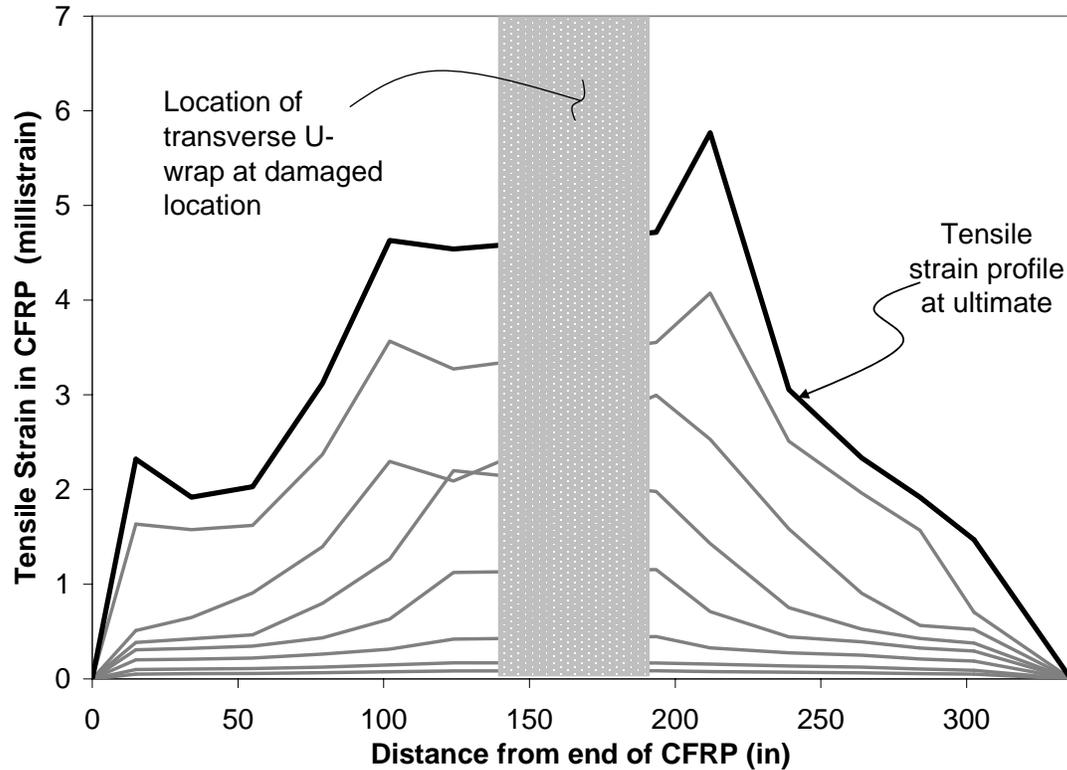
Figure 4.12 CFRP tensile strain profile during final static test of girder AASHTO3

The maximum measured tensile strain in the longitudinal CFRP at failure was $5760 \mu\epsilon$, significantly larger than the tensile strain measured in previous AASHTO flexural tests. The higher compressive strain capacity in the concrete led to a greater demand placed on the CFRP system which in turn led to a large increase in ultimate load compared to the undamaged girder. In this girder, tensile strain gauges were installed in the CFRP throughout the repaired area, and the measured tensile strain profile is shown in Figure 4.12. Also shown in the figure is the location of the 4.0 ft (1.22 m) wide transverse U-wrap which encapsulated the area of simulated impact damage. At a distance of 216.5 in (5500 mm) from the end of the CFRP the profile shows a strain peak, most likely the result of the strain gauge location near the toe of a flexural crack. The distance around midspan where the prestressing strands are yielding is also obvious in the figure, from approximately 98.4 to 236.2 in (2500 to 6000 mm) from end of the longitudinal CFRP.

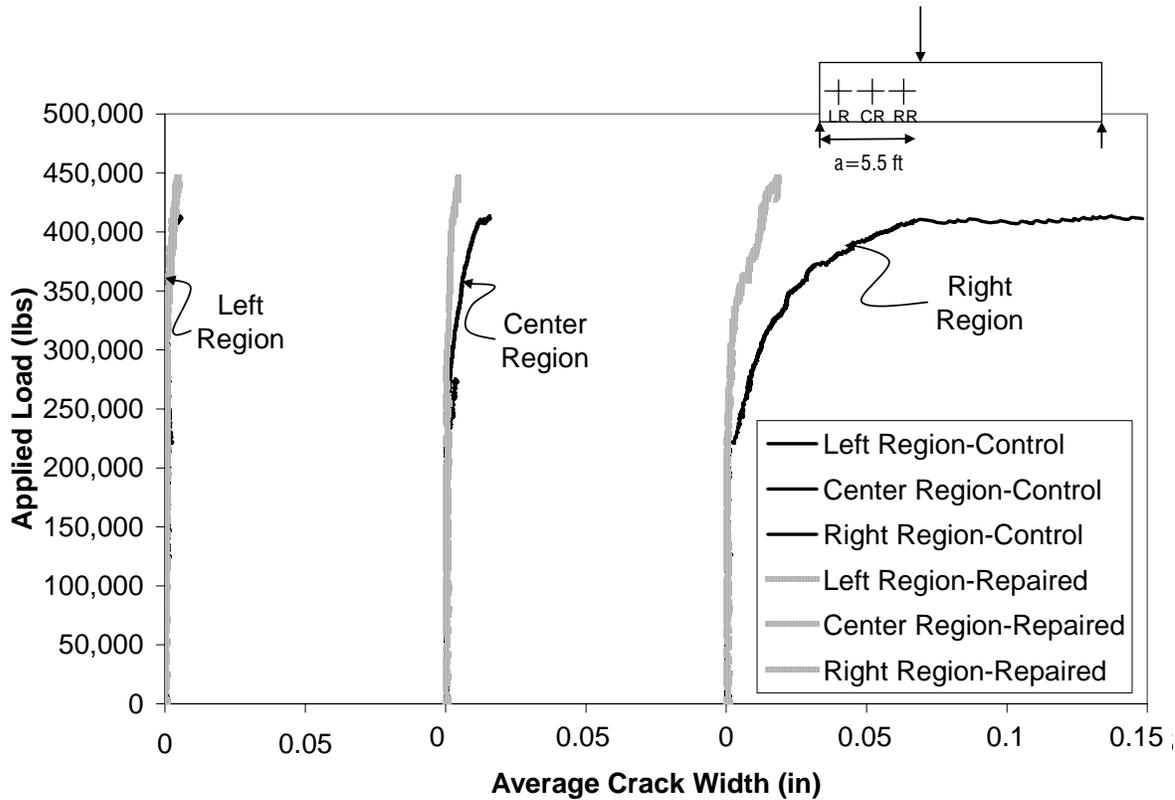
Figure 4.13 Average crack widths of AASHTO2C and AASHTO2R girders

Girder AASHTO2C and AASHTO2R were loaded in one cycle up to failure. During the loading process, several inclined cracks formed at 45 degrees from the support at various load levels. The number of cracks in the control specimen was visually obtained, however the cracks were not visible in the repaired girder as a result of the diagonal CFRP struts. In order to compare the average crack widths of the two specimens, it was assumed that the same number of cracks formed in the repair specimen that was visible in the control specimen. Figure 4.13 shows the average crack widths for both specimens at each of the three instrumented locations. It should be noted that the maximum crack widths formed closest to the loading point. The maximum crack width in AASHTO2C was 0.15 in (3.8 mm) and 0.02 in (0.5 mm) for AASHTO2R.

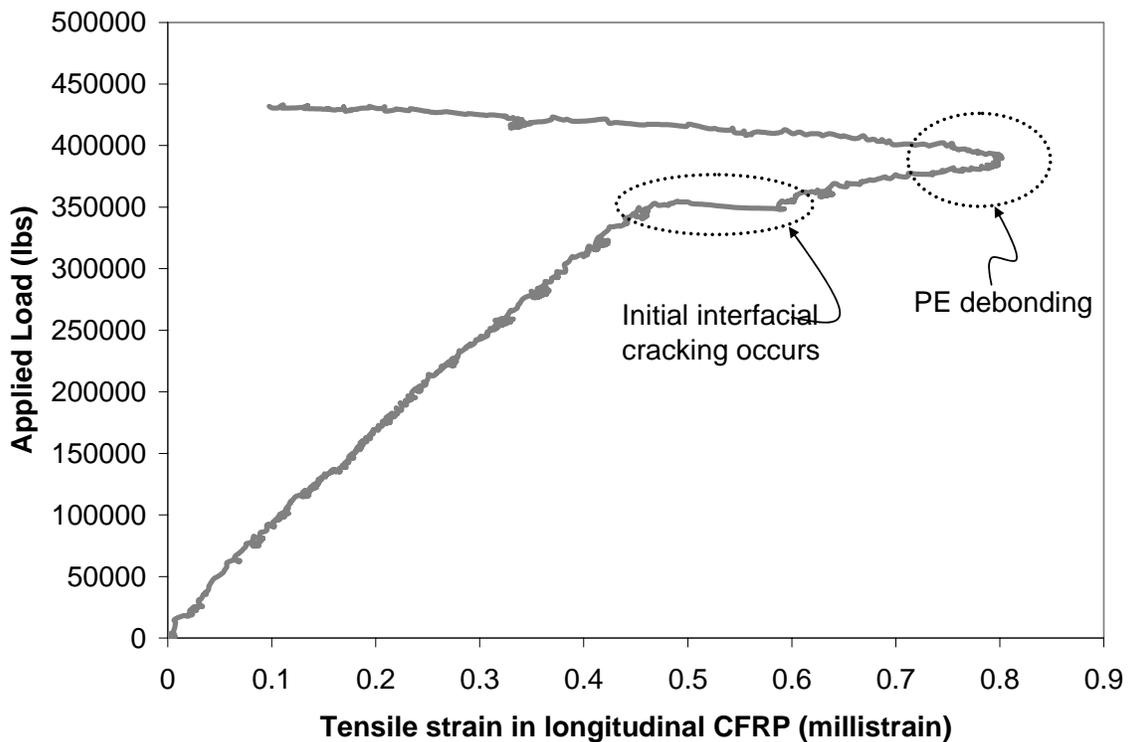
Figure 4.14 Tensile strain in longitudinal CFRP of girder AASHTO2R

The tensile strain in the CFRP was measured at the right end of the longitudinal CFRP sheets. Figure 4.14 shows the load versus tensile strain plot for AASHTO2R. Several points that should be noticed were the presence of interfacial cracking, followed by plate-end debonding of the CFRP. The strain value near the termination point of the longitudinal CFRP was low (810 $\mu\epsilon$) when plate-end debonding occurred. The presence of a U-wrap at this location would have minimized the plate-end debonding effects.

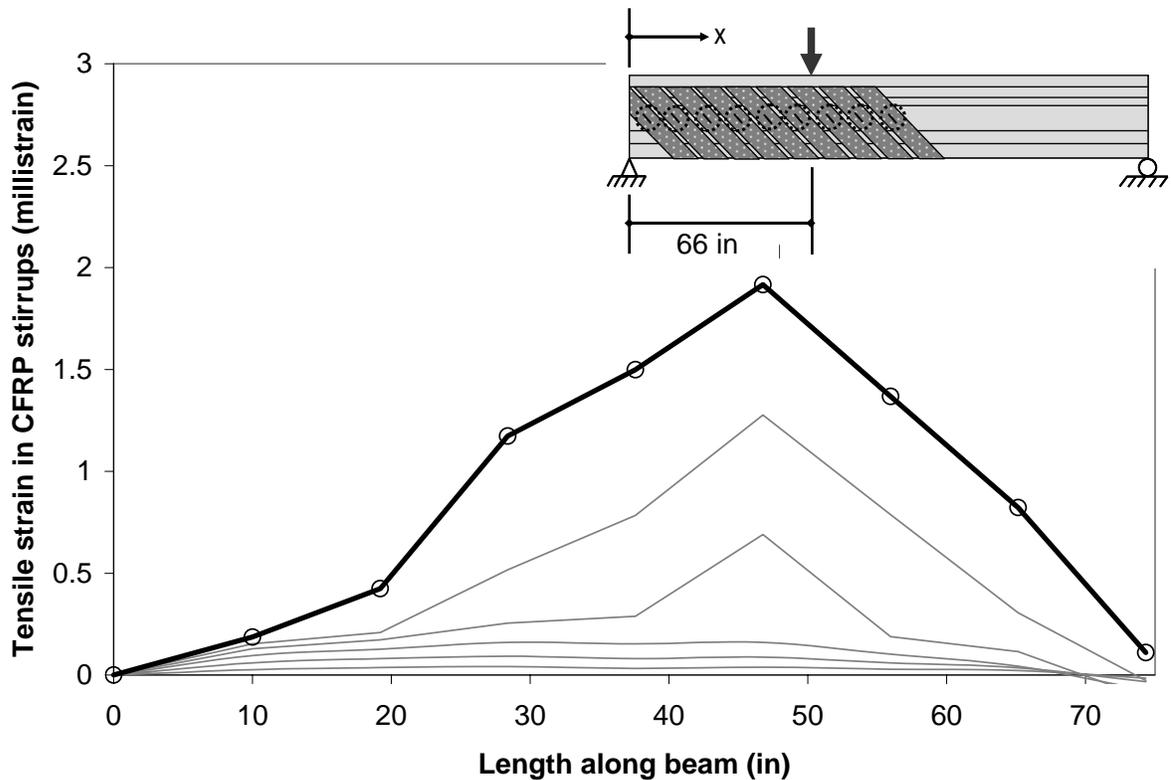
Figure 4.15 Distribution of tensile strain in diagonal CFRP struts

The tensile strain at the center of each diagonal CFRP strut was also measured during the loading of AASHTO2R, as shown in Figure 4.15. This figure indicates that the largest inclined crack openings were located approximately half way between the left support and load plate, as expected. Also, the strain induced in the diagonal CFRP struts was much lower

than the ACI Committee 440 (2002) rupture design value of 0.004 in/in, therefore not causing debonding or rupturing of the sheets.

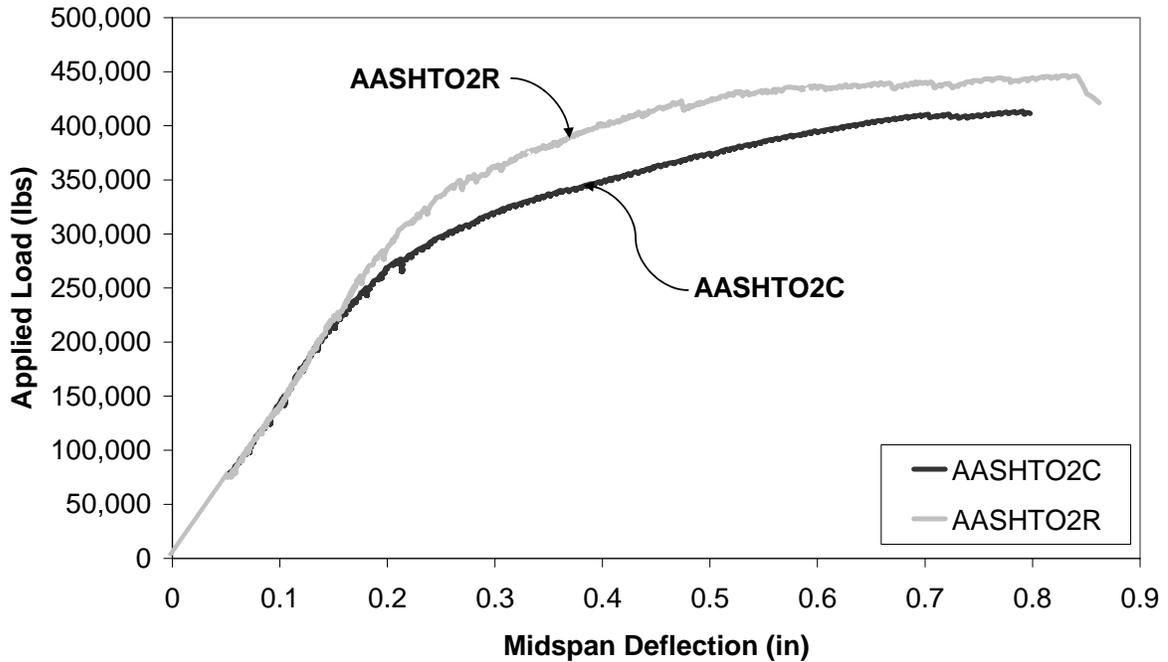
Figure 4.16 Load versus deflection of girders AASHTO2C and AASHTO2R

The ultimate load versus deflection behavior of girders AASHTO2C and AASHTO2R are shown in Figure 4.16. Full descriptions of the static tests to failure are provided in Chapter 3. Failure of AASHTO2C initiated in the inclined cracks that formed on the shear-critical side of the test specimen. The failure of AASHTO2R initiated beyond the longitudinal CFRP sheets after shear failure in the right transfer region had occurred. As flexural shear cracks began propagating through the web, caused by the debonding of prestressing strands resulting from the failure in the transfer region, plate-end debonding occurred. The diagonal CFRP struts remained intact after the failure of AASHTO2R.

The initial stiffness of both AASHTO2C and AASHTO2R was roughly identical. The cracking load of the repaired specimen was greater than the control specimen and is shown in Figure 4.16. The ultimate load capacity of AASHTO2R was 7 percent higher than that of AASHTO2C, and the ultimate displacement was slightly enhanced. The maximum compressive strain reached in each of the tests was $680 \mu\epsilon$ and $1400 \mu\epsilon$ for girders AASHTO2C and AASHTO2R, respectively.

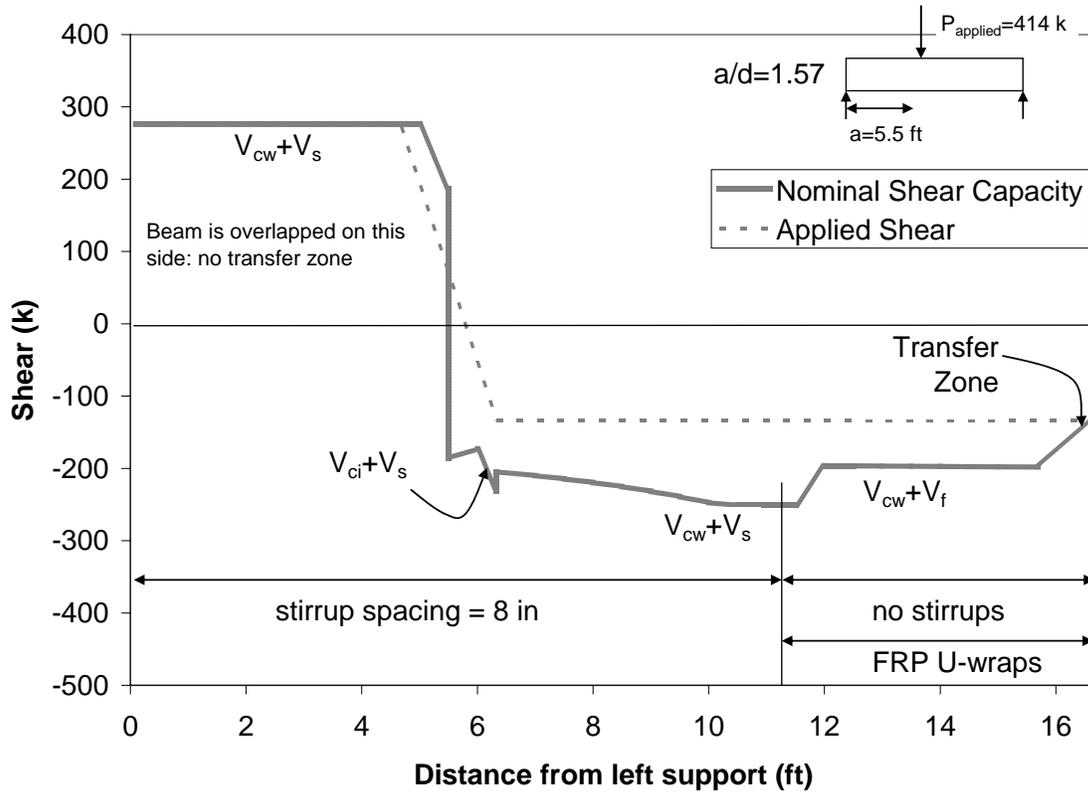
Figure 4.17 Modified AASHTO2C girder predicted and applied shear

After thoroughly examining the PCI (2006) equations for calculating shear capacity, and in comparison with AASHTO2C test results, it was discovered that replacing PCI's maximum effective depth of the prestressing strands (d) of 0.8 times the height (h) of the member with the true effective depth a far more accurate comparison to the test results could be obtained, as shown in Figure 4.17. It should be noted that the 0.8 times the height of the girder is intended for use as a conservative design value, however because this was an analysis of the girder and not the design, it was ignored. This method of examining the shear capacity will be referenced as the modified PCI method for here on out. The modified PCI method predicted an ultimate shear capacity of 414 k (1842 kN), similar to the experimental result of 413.7 k (1841 kN). It should be noted that the FRP U-wraps shown on the bottom of Figure 4.17 were left over from the flexural repair of girder AASHTO2.

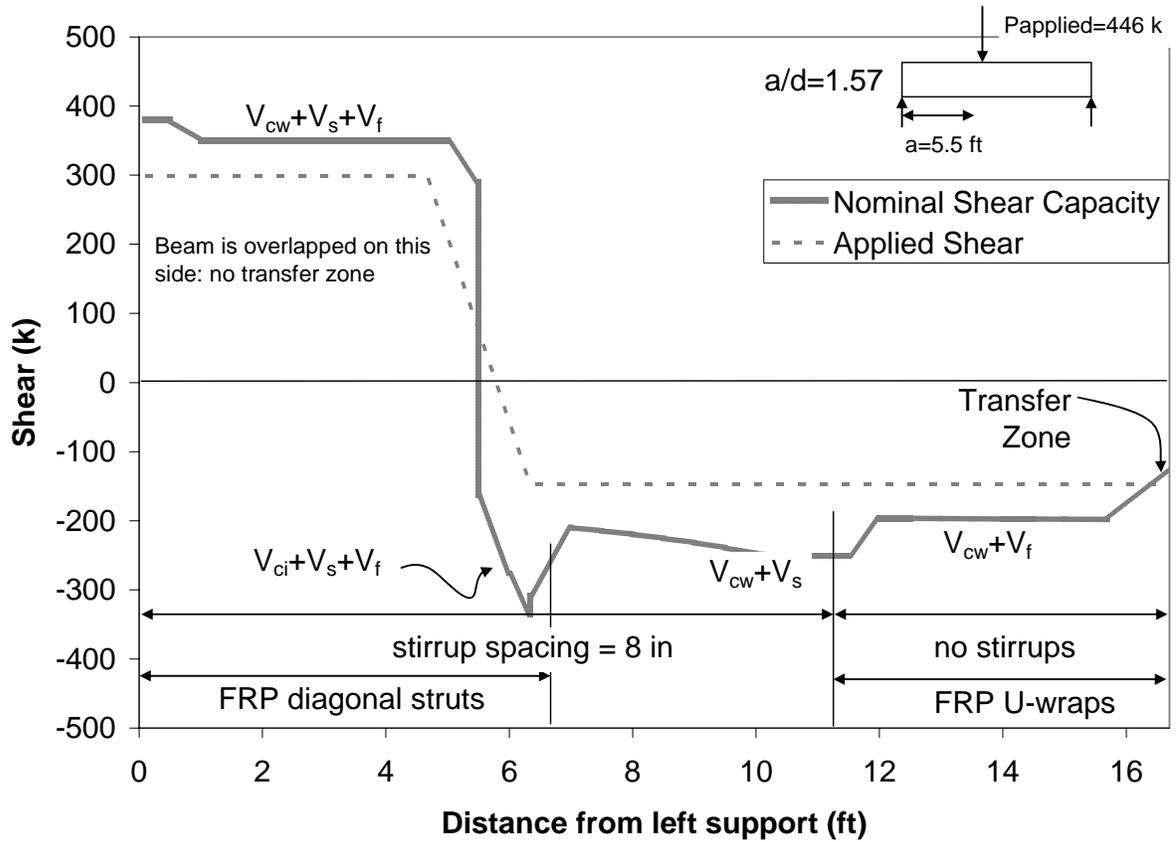
Figure 4.18 Predicted shear capacity versus the applied shear load of girder AASHTO2R

The predicted shear capacity of the CFRP repaired AASHTO2R girder, shown in Figure 4.18, was determined using the modified PCI design guidelines previously presented in conjunction with ACI Committee 440 (2002) shear FRP design guidelines. The predicted shear failure load was 519 k (2309 kN), but the test specimen failed at 446 k (1985 kN), as shown in Figure 4.18. Shear failure to the left of the applied load, the shear-critical span, was not the failure mode of the test specimen, which led to further inspection of possible failure modes. In Figure 4.18, it is evident that the applied shear at the right end exceeded the allowable shear in the transfer region. Shear failure in the transfer region allowed the prestressing strands to debond, in turn lowering the moment capacity of the section on the right end. The moment capacity of the girder prior to debonding of the strands is shown in
