MILLER, ANTHONY D. Repair of Impact-Damaged Prestressed Concrete Bridge Girders Using Carbon Fiber Reinforced Polymer (CFRP) Materials. (Under the direction of Dr. Sami Rizkalla).

**REPAIR OF IMPACT-DAMAGED PRESTRESSED
CONCRETE BRIDGE GIRDERS USING CARBON FIBER
REINFORCED POLYMER (CFRP) MATERIALS**

A thesis submitted to the Graduate Faculty of
North Carolina State University
in partial fulfillment of the requirements for
the Degree of Master of Science

2006

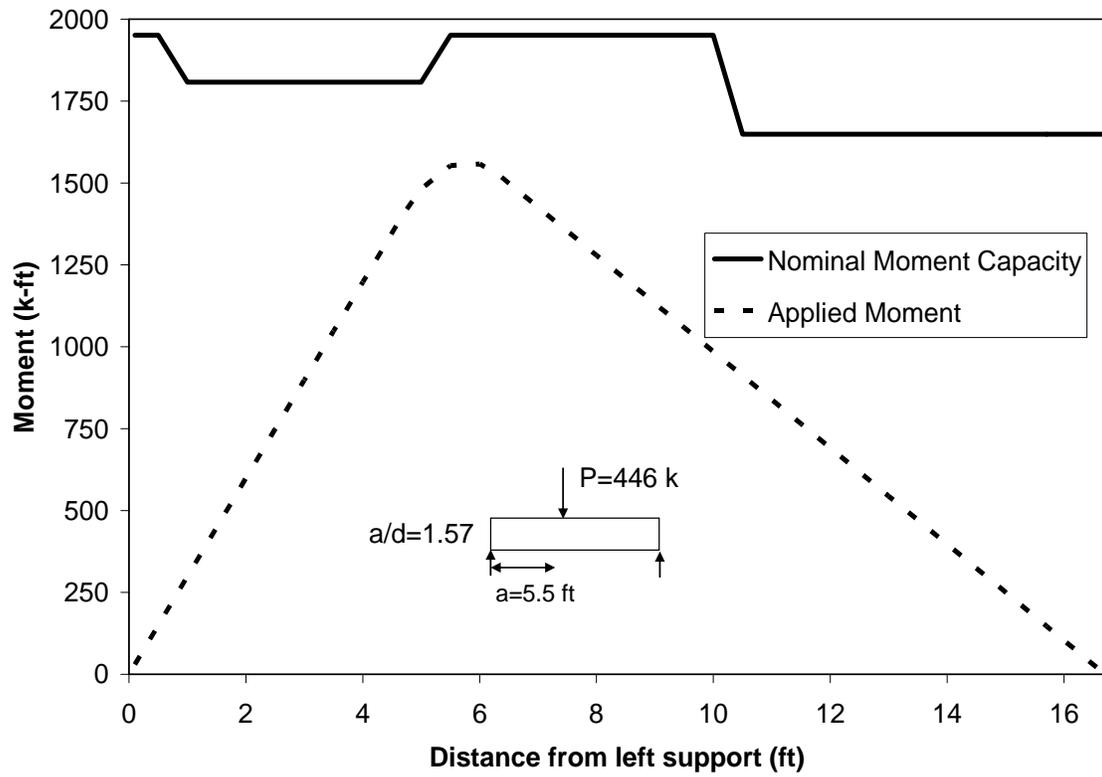
Figure 4.19 Repaired moment capacity of girder AASHTO2R

The predicted shear capacity of the CFRP repaired AASHTO2R girder, shown in Figure 4.18, was determined using the modified PCI design guidelines previously presented in conjunction with ACI Committee 440 (2002) shear FRP design guidelines. The predicted shear failure load was 519 k (2309 kN), but the test specimen failed at 446 k (1985 kN), as shown in Figure 4.18. Shear failure to the left of the applied load, the shear-critical span, was not the failure mode of the test specimen, which led to further inspection of possible failure modes. In Figure 4.18, it is evident that the applied shear at the right end exceeded the allowable shear in the transfer region. Shear failure in the transfer region allowed the prestressing strands to debond, in turn lowering the moment capacity of the section on the right end. The moment capacity of the girder prior to debonding of the strands is shown in

Figure 4.19, but became much less after the contribution of the prestressing strands is progressively lowered due to debonding.
