Fatigue and Failure Behaviour of a Mechanically Loaded Ferritic Pipe Bend in High Temperature Water With Elevated Oxygen Content

K. KUSSMAUL, H. DIEM, D. UHLMANN
University of Stuttgart, Stuttgart, FRG

The trial delineated relates to cracks with an axial orientation at a pipe bend of DN 425 nominal width.

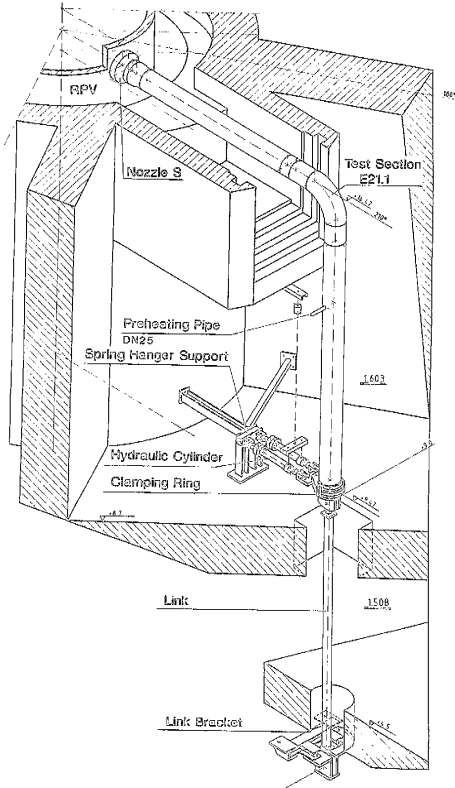
Fig. 1: Test piping E21.1

The experiment E21.1, Figure 1, was set up in analogy with experiment T20.2 during Phase II of the HDR Safety Program /6/. The pipe bend is made of low alloy ferritic material 20 MnMoNi 5 5 similar to ASTM A508 Cl. 3. The major dimensions are: external diameter $D_a = 482,2$ mm, wall thickness $t = 28,7$ mm and a radius of curvature $R = 686$ mm. The bend is considered to belong to the category of thin-walled components which means a pronounced cross-sectional oval as a result of bending. At $T = 240$ °C the material used for the pipe bend has its yield strength at 440 N/mm² and an ultimate strength of 599 N/mm². The corresponding strain to the ultimate strength is $19,5 \cdot 10^{-2}$ m/m. At the test temperature (240 °C) the pipe bend is in the upper shelf of the charpy energy. The value of the charpy energy in the direction of dismantling TS which is relevant to crack loading is 136 J at 240 °C. The load is applied by two hydraulic cylinders in a parallel arrangement. Their movement in the test is displacement controlled. The level of loading during the first loading phase is a specified strain range of $\pm 2,5 \cdot 10^{-3}$ m/m (roughly corresponding to $\pm R_{p0,2}$) so that incipient cracks can be generated at the pipe bend.

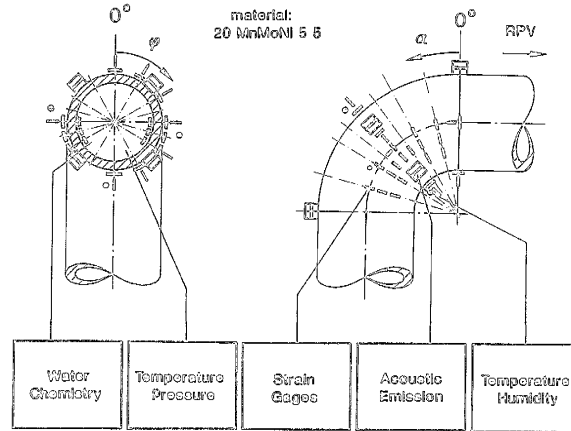
Fig. 2: On-line measurement instrumentation during test

The operating conditions selected are as follows: temperature $T = 240$ °C and internal pressure $P_i = 10,6$ MPa. The pressurizing agent was stagnant deionate with 8 ppm oxygen content. Temperature and pressure sensors were used to monitor the operating parameters. Besides, the cylinder force, the the vibration force and the cylinder stroke were measured. The global response of the piping system to the external load was recorded with displacement transducers, the resulting stress with strain gauges (DMS). On the outer surface of the pipe bend 54 appropriate foil strain gauges were applied to record high vibration amplitudes and high numbers of stress cycles. Acoustic emission probes which recorded the onset of cracking were attached to the pipe bend. Off the bend, temperature and moisture sensors were provided for early detection of a starting leakage. A survey of the measuring instruments used at the pipe bend is given in Figure 2.

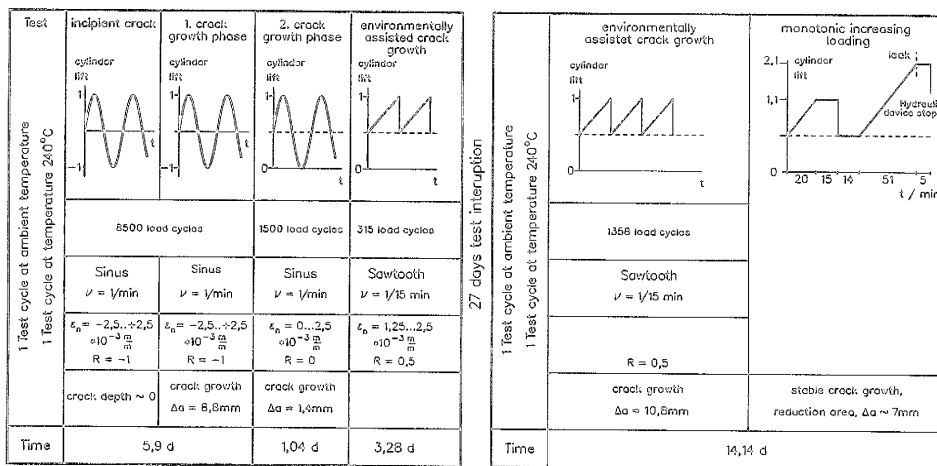
Fig. 3: Loading history E21.1

The test was performed in two stages because the total testing time of approx. 4 weeks was rather long, Figure 3. In the first stage, the already mentioned formation of incipient cracks was studied together with the subsequent cyclic crack growth and the first phase of the so-called "corrosion cycles". During the corrosion cycles the frequency was 1 cycle per 15 minutes with a rise time of $14,5$ min. The mode of loading was sawtooth-shaped cyclic loading. The R-ratio was $R = 0,5$ which led to a theoretical strain rate at the point of maximum loading of the bend (related to the nonweakened structural component) of $\dot{\epsilon} =$
