THE FAILURE ROOT CAUSE ANALYSIS OF RECIRCULATING SENSING LINE IN TAIWAN CHINSHAN NUCLEAR POWER PLANT

K. Ting

Atomic Energy Council, Taipei, Taiwan, R.O.C. and Institute of Nuclear Energy Research, Lung-Tan, Taiwan, R.O.C.

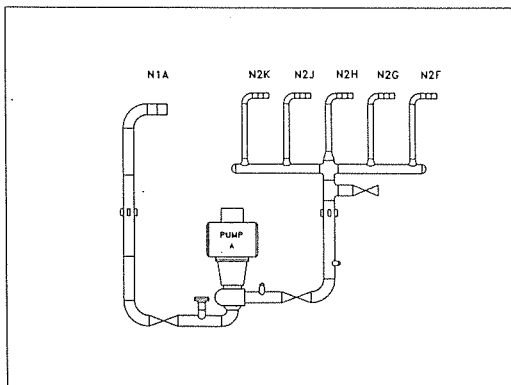
Fig.1 Recirculating piping system

In Chiushan Nuclear Power Plant, there are two recirculating loops as shown in Fig.1. The coolant in the recirculating loop will be injected into the reactor through 10 risers. Risers N2F, N2G, N2H, N2J and N2K belong to A loop. Risers N2A, N2B, N2C, N2D and N2E belong to B loop. Corresponding to each riser, a pressure sensing line is attached by weldolet, reference to Fig.2. However, sensing lines for N2D and N2E are combined to an unified U-type line which use the common sensor in loop B. The sensing lines for N2G and N2F in loop A are the same type as loop B, displayed in Fig.3.

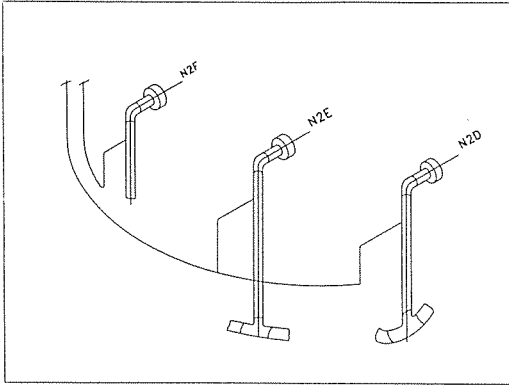
Fig.3 Sensing lines combined to U-type line

- (2) Only N2E sensing line which presents the U-type line failed. The differentiation with the other sensing lines must be proven by vibration test and stress analysis.
