Cladding Breaches in a Fast Reactor Mixed-Oxide Fuel Assembly

U.P. Nayak, P.J. Levine, A. Boltax

Summary

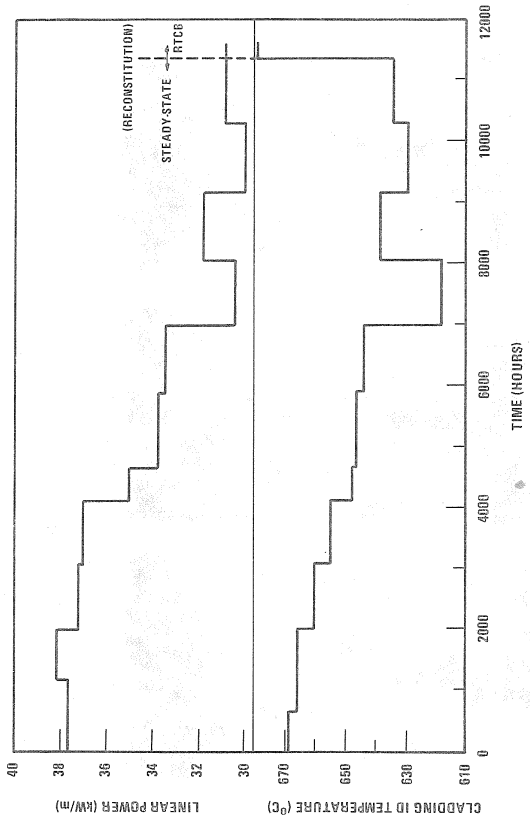
The WSA-8 mixed-oxide fuel experiment was designed to study the comparative behavior of three types of 20% cold-worked claddings under nominally identical conditions. The cladding materials included AISI 316, AISI 321 and titanium-modified AISI 316 stainless steels. A grid-spaced vehicle was used in the experiment to eliminate any possible pin-to-pin interactions. Details of the grid-spaced assembly and fuel pin design have been described previously [1]. The assembly was irradiated in EBR-II for 11,376 effective full power hours at a peak linear power of 39 kW/m to a peak burnup and fluence of 10.6% and 9.1×10^{22} n/cm² (E>0.1MeV), respectively, prior to interim discharge. At the interim discharge, several fuel pins were removed for destructive examination, results of which have been published [2]. The assembly was reconstituted as a run-to-cladding-breach (RTCB) assembly, omitting pins with AISI 321 cladding, and the irradiation was continued with a resized coolant inlet orifice to obtain substantially higher cladding temperature. A typical set of calculated power and cladding ID temperature histories for one of the peak pins is illustrated in Figure 1.

FIGURE 1. Power and Temperature History for Pin W8-45
