## **Latest SCC Issues of Core Shroud and Recirculation Piping in Japanese BWRs**

Tokyo Electric Power Co. (TEPCO), Japan

### **ABSTRACT**

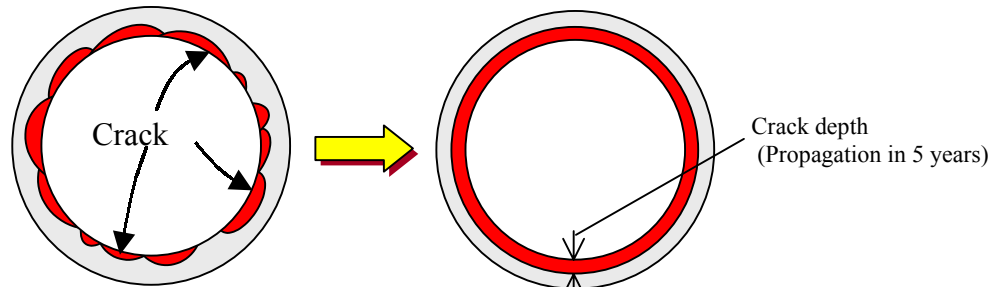
Fig. 11. Model for a Cracked Shroud Ring

Since cracking was observed almost all around shroud ring, it was assumed that a circumferential crack of uniform depth would propagate uniformly in the radial direction. The crack was conservatively assumed to exist even in areas where cracking was not apparent. The average depth of the crack was measured by an ultrasonic inspection. The crack propagation in five years was then predicted by the following procedure:

- (1) Establish the initial crack configuration (depth).
- (2) Calculate the weld residual stress distribution by FEM in the crack propagation area.
- (3) Calculate stress intensity factor  $K_I$  from the crack depth and the residual stress distribution.
- (4) Use the SCC crack growth rate diagram from the experimental data to determine the crack growth rate for the calculated  $K$  value and then add the propagation to the initial crack depth.

By repeating calculations (3) and (4), the crack propagation in 5 years can be estimated. A limit load analysis to evaluate the structural integrity can then be performed.

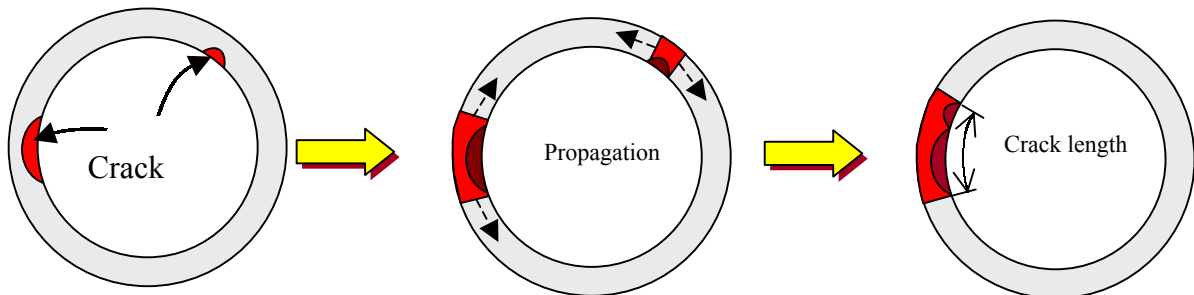
Fig. 12. Model for a Cracked Shroud Shell

In the shroud shell, a single crack has arisen and spread two-dimensionally on the surface. Since horizontal cracking is deleterious to shroud integrity, the spread crack is projected horizontally and regarded to be horizontal and straight. Although no through-wall cracking was found, all cracks are conservatively assumed to have penetrated. When the shroud shell has two or more cracks, even if these are not present at the same height, they are assumed to exist in the same level. To estimate the crack propagation in 5 years, the cracks are considered circumferentially with maximum SCC crack growth rate of low carbon SS. These grown cracks are gathered finally. A limit load analysis to evaluate the structural integrity can then be performed.

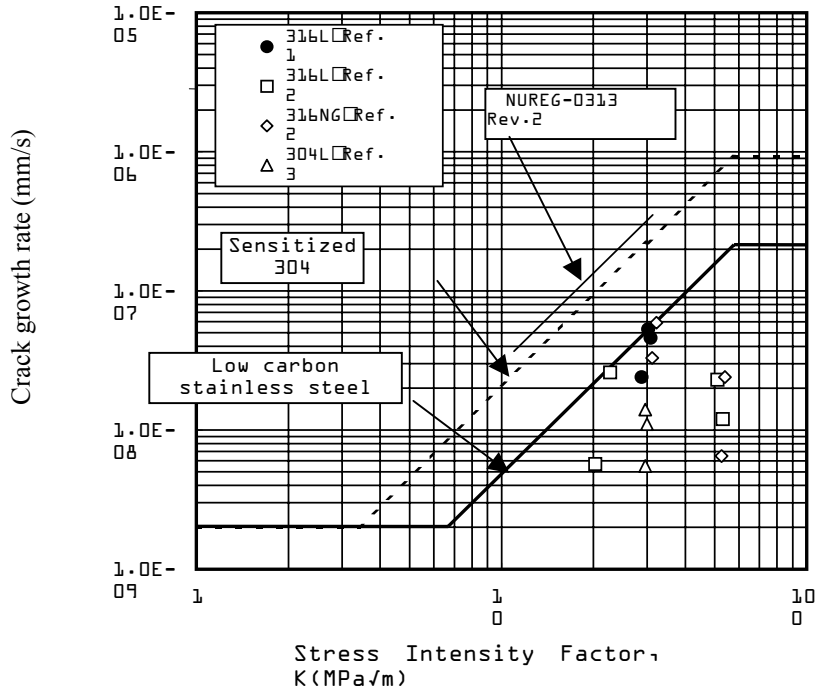
Fig. 13. SCC crack growth rate diagram for low-carbon stainless steel

The crack growth rate diagram shown in Fig. 13, which represents the upper bound of the data obtained in the experiment on low-carbon SS, was used for estimating the crack propagation rate.
