PWSCC observations in Ringhals 3 and 4 safe ends

Lars Skånberg

*Department of Structural Integrity
Swedish Nuclear Power Inspectorate*

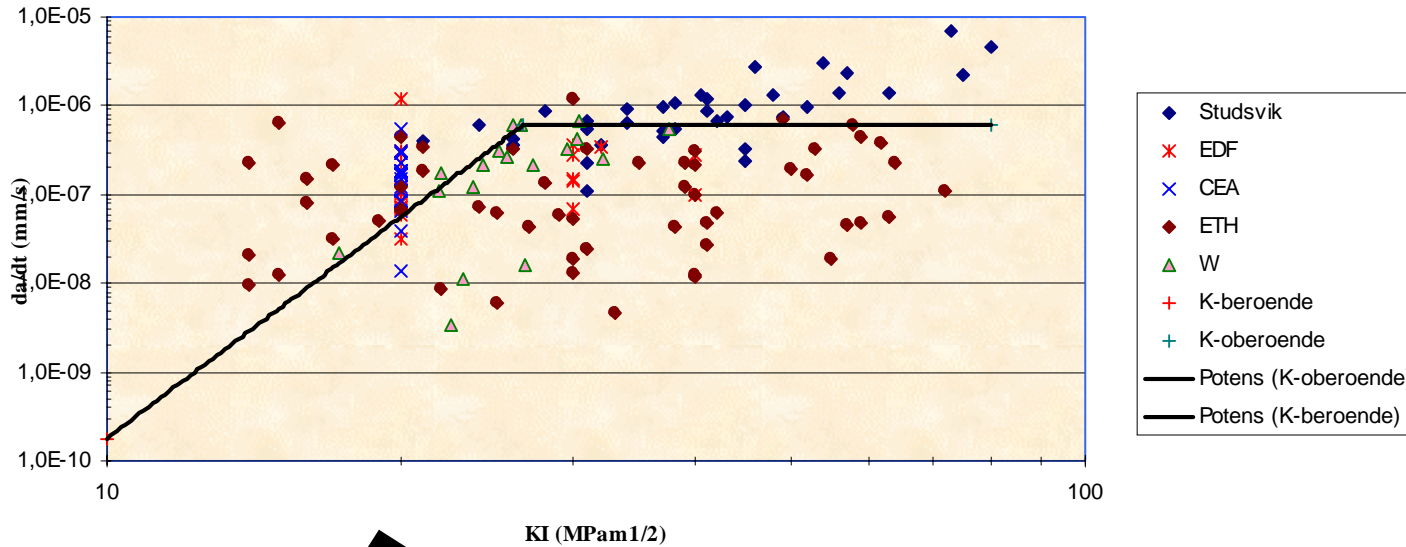
Used crack growth data

Crack Growth Rate in PWR environment
 Studsvik, W o EDF TS (parallellt dendritriktning) medan CEA o ETH vinkelrät
 T=290 - 360 grad C

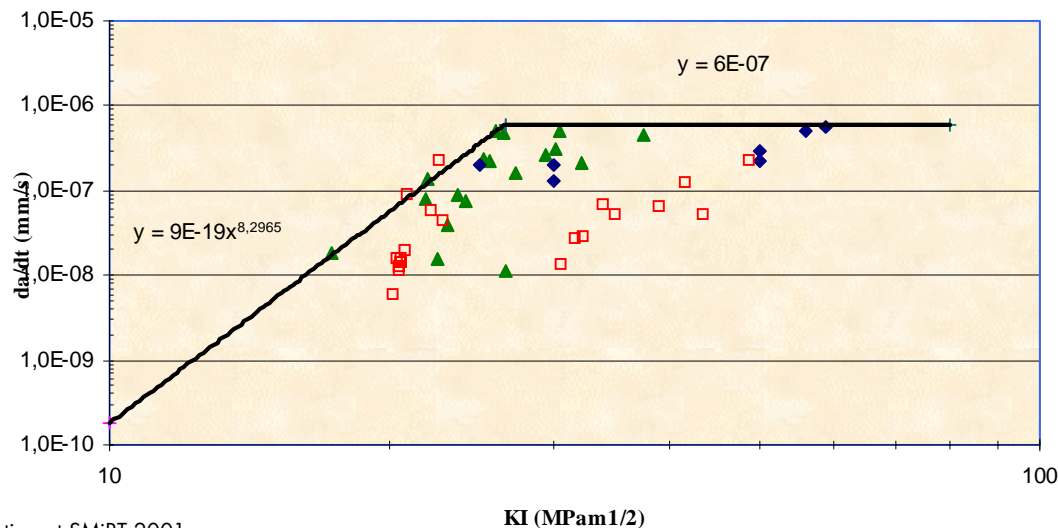
Crack Growth Rate in PWR environment
 Studsvik, W o EDF TS (parallellt dendritriktning) medan CEA o ETH vinkelrät
 Datapunkterna har korrigerats m a p KI och da/dt
 T=320 grad C
