## Analysis and Solution for Angra 1 Electric Generator Lead Box Vibration

Othon Luiz P. da Silva, Lúcio Ferrari, Renato Victorio, Rodolfo Suanno, Carlos Prates, Joaquim Leães  
Eletronuclear - Eletrobrás Termonuclear S.A.- Brazil

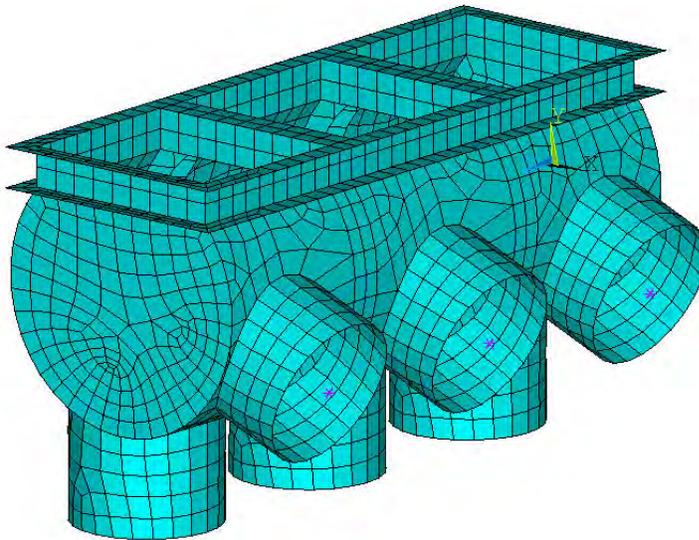
Figure 6: Finite Element Model of the Lead Box – Original Design

In order to evaluate the effectiveness of the solution – Stiffening of the Lead Box with Ribs, Finite Element Models, using ANSYS FE software, were prepared to represent the original configuration and the modified structure by the introduction of stiffeners at the flange corners. The Figure 6 shows the finite element model for the original design.

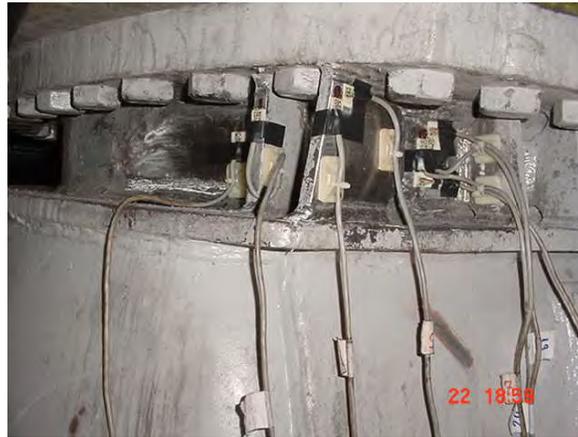
Figure 11 – Strain gages installation.

Strain Gage measurements were used to monitor the dynamic behavior of the ribs and shell of the Lead Box, during the start-up of Angra 1. It was measured simultaneously the deformation in 7 points of the Lead Box and 2 points in the EG

support pads, during the over-speed test, synchronism and 84% power. The results showed that all the deformations were below the fatigue limits.
