## HIGH CYCLE THERMAL FATIGUE FATHER EXPERIMENT: NON DESTRUCTIVE AND METALLOGRAPHIC EXAMINATIONS

S. Courtin<sup>1</sup>, J.A. Le Duff<sup>1</sup>, B. Tacchini<sup>1</sup>, A. Fissolo<sup>2</sup>, L. Vincent<sup>2</sup>, J.M. Stephan<sup>3</sup>, R. Tampigny<sup>4</sup>

<sup>1</sup>AREVA NP, 92084 Paris La Défense, FRANCE

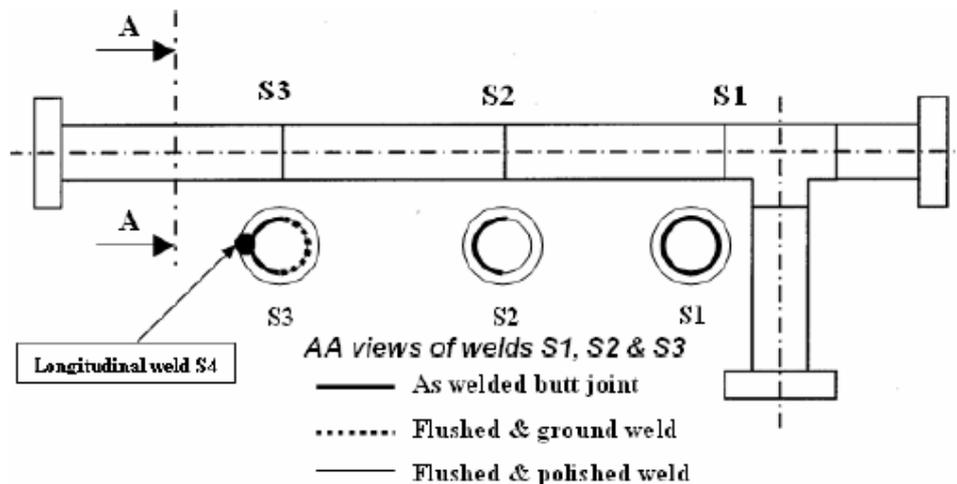
Fig. 1: FATHER mock-up - Description of the three welds

A good correlation was obtained between these four different NDT techniques. Main localizations of the thermal fatigue damage were near the as welded butt joints S1, S2 and S3 (Fig. 1).
