## DEFECT ANALYSIS OF RECIRCULATION PUMP SHAFT CRACKING

U.R. Blumer and A. Frei

Sulzer Winterthur, Switzerland

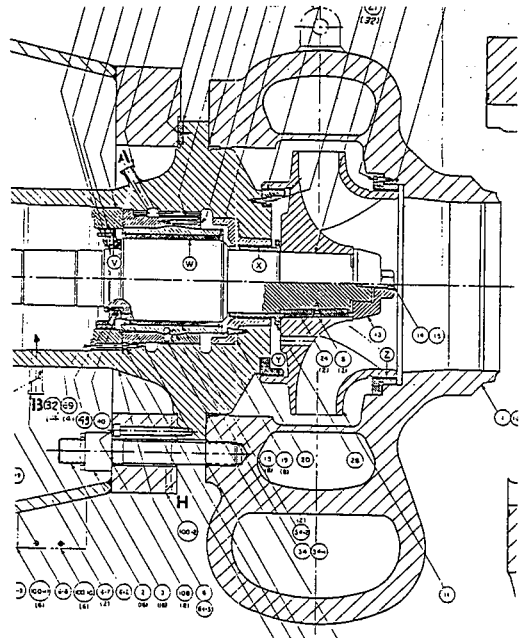
BWR recirculation pumps have to be cooled in the bearing and in the sealing parts by injection water that is considerably cooler (typically 50°C) than the pumped water (typically 280°C). The flows of these two fluids have to join at some part of the pump. This region of the pump is especially prone to thermal fatigue by temperature fluctuations between the two extreme values mentioned. Therefore, in many designs, special precautions have been taken to mitigate the fatigue problem. Fig. 1 shows the design of such a pump. The critical area, where the injection water flows towards the hot water, has been protected by sacrificial material in design, i.e. by a thermal sleeve on the inside towards the shaft and a thermal bushing on the outside towards the casing.
