General description of the great Devnya's accident of a gas explosion

Dzhupanov V.A.

Bulgarian Academy of Sciences, Bulgaria

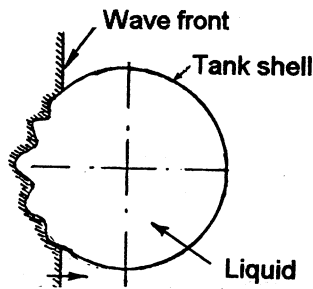
5.3.1. *Transversal irradiation of a cylindrical shell, [02].* It is known that in case of a real irradiation of a circular cylindrical shell filled with liquid by a simple shock wave the frontal part of the cylindrical surface of the shell deforms itself in several characteristic waves, as it is shown on Fig. 11. The depths of the shell wave profiles depend on the velocity of the falling wave

field, on the density of the outside fluid serving as a media of the falling SW, and the characteristics of the inside fluid (liquid), see Mnev & Pertzev [02].

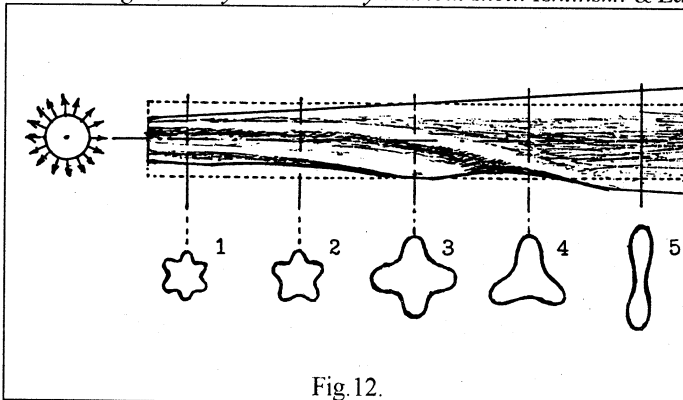
experimentally had proved that the transversal sections of an empty thin-walled long circular cylindrical shell, after a longitudinal irradiation by an air shock wave deform themselves in developing e.g. consequently 6, 5, 4, 3, and 2 well expressed and deep waves along the circular coordinate of the shell, as it is shown on Fig. 12.
