SUPERPHENIX Fuel Storage Tank Investigations Concerning the Sodium Leak - Dimensional and Material Aspects

J. C. Blaix, J. Archer, N. Foucher, C. Escaravage
NOVATOME, Lyon, France

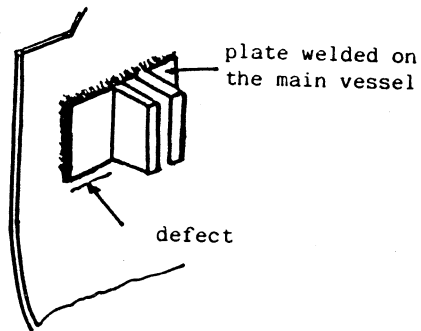
In September 1987, the leak was located at level 10400 in azimuth 270°, which corresponds to the lower weld of a fastener guide plate of the cooling systems (figure 5). In this region, austenitic 316 L and ferritic 15D3 steels are welded together.

- The thermal loadings induced by the normal operating conditions may provoke mechanical efforts on the plate, if we assume that structures designed in order to expand freely may be blocked owing to a jamming phenomenon or an insufficient gap.

Stresses are therefore due to temperature differences and to the difference of the expansion coefficients between 15D3 vessel steel and austenitic 316 L cooling system steel (tubes and supports).

- Stresses may be induced by axial temperature gradients, in the same way as it occurs on the junction between vessel and strongback.
- Stresses may be provoked by the differential expansion, at 200°C, due to the difference of expansion coefficients between ferritic and austenitic steels.
