Irpinia 1980, Southern Latium and Abruzzi National Park 1984, Zafferana Etnea (Sicily) 1984, Mexico City 1985 earthquakes: Catalogues of damage

G.Sofò

ENEA, Commission for Nuclear and Alternative Energy Resources, Rome, Italy

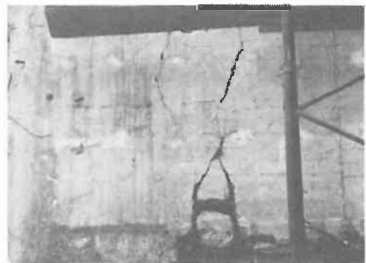
Fig. 6. IV) Failure of longitudinal steel in a beam. This type of damage is much less common than brittle type failure of heavily reinforced concrete.
