# Requalification for Beznau (Switzerland) NPP Auxiliary Building

## Abstract

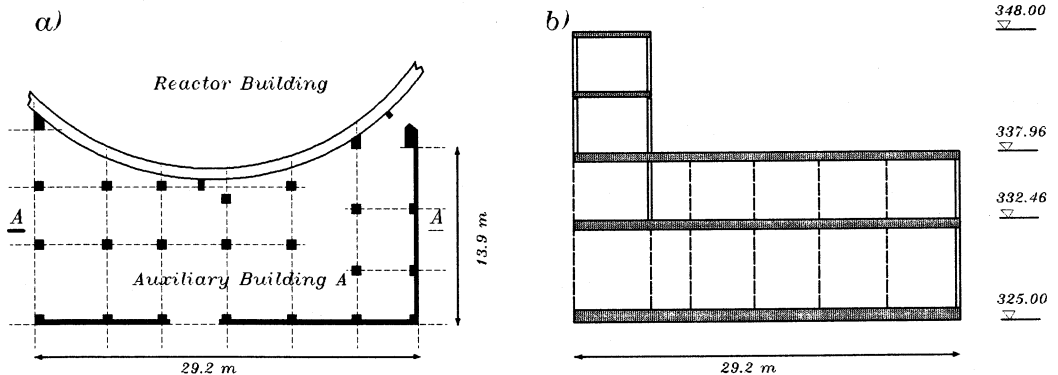
Fig. 1 Auxiliary Building A; a) Plan view of ground floor; b) Section A-A

The dynamic behaviour of the Auxiliary Building A is primarily influenced by the asymmetric configuration of the shear walls in the ground floor, as shown in Fig. 1. This leads, as shown in Fig. 3, to a rotational motion of the building in the first mode, with the centre of motion near the intersection of the two perpendicular shear walls. This in turn produces large moment and shear forces in the outer columns (left side of the building in Fig. 1).

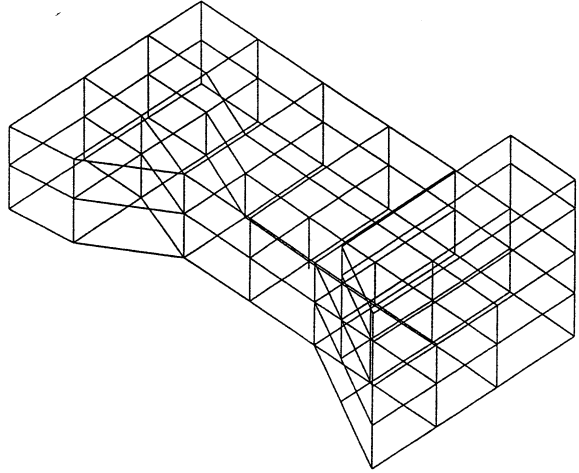
Fig. 2 FE-model for Auxiliary Building A
