## EXPERIMENTAL SEISMIC ASSESSMENT OF FULL SCALE NON-SEISMICALLY DETAILED RC STRUCTURE BY PUSHOVER METHOD

Akanshu Sharma<sup>1</sup>, G.R. Reddy<sup>1</sup>, R. R. Babu<sup>2</sup>, D. Revanna<sup>2</sup>, K.K. Vaze<sup>1</sup>

<sup>1</sup>Reactor Safety Division, Bhabha Atomic Research Centre, Mumbai 400085, India

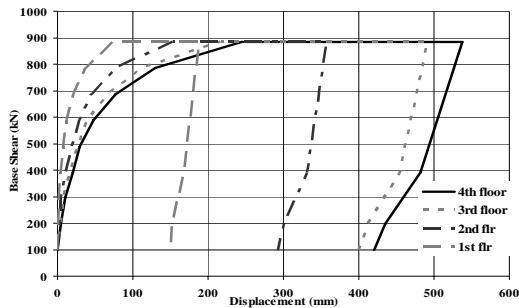
Fig.5 Pushover Curve for CL 16 Side

The pushover curves as obtained for CL16 side and CL20 side are shown in Figs 5 and 6 respectively. Since the experiment was conducted under load control, the drooping part of the curves could not be obtained. As can be seen from the two figures, the maximum displacement for CL16 side was obtained as 537mm and that on CL20 was obtained as 765mm. This clearly demonstrates torsion due to eccentricity raised from column orientation. The difference in the curves is as expected showing more displacement on CL20 side due to less stiffness offered by CL19 in loading direction. The average top drift is therefore equal to around 4% of the total height of the building.

The structure behaved linearly till a base shear value of around 300 kN. At this point the flexural tension cracks at the base of the columns started to get generated and the structure displayed a reduced stiffness. After reaching a base shear value of approx 500 kN, the cracks at the base of the columns opened wider and failures at other locations namely beams and beam-column joints started to show up. As a result the stiffness of the structure further went down, as can be seen from the pushover curves. After reaching the base shear values of 700 kN, the joints of the structure displayed rapid degradation and the inter-storey drift increased rapidly. On further increase in

the lateral load, the structure displayed a very soft behavior with large displacement increase for the same increase in the base shear. After reaching a base shear of 90t (882.90 kN), i.e. 9t load at first floor, 18t at second floor, 27t at third floor and 36t at fourth floor, the structure started undergoing increasing displacement and the resistance offered by the structure started to reduce.

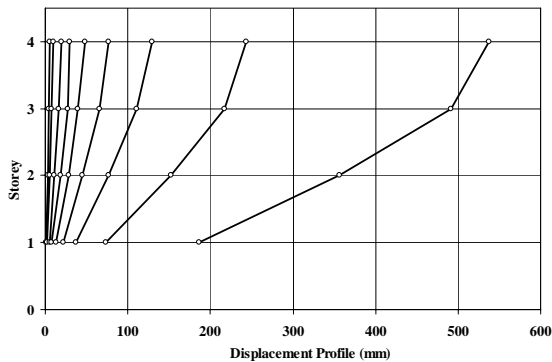
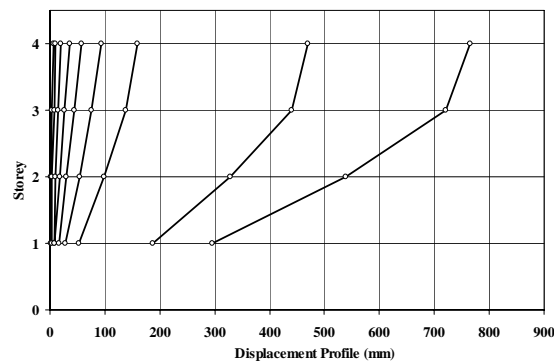
Fig.7 Displacement Pattern for Increasing Top Drift for the structure

Fig.7 shows complete displacement profile of each storey with respect to top displacement level. Each curve corresponds to the displacement profile of a load step. The first load step is depicted by the very first curve on extreme left with the curves corresponding to further load steps to the right of the curve of previous load step with the last step (ninth step) corresponding to a base shear of approx 900 kN is shown in extreme right. Initially, when the structure was loaded, it went fairly linearly till the third load step corresponding to a base shear of 300 kN. As the lateral load on the structure was increased, the inter-storey drift increased and the structure went into inelastic (nonlinear) range. It was observed that as the displacement increases, the contribution of relative displacement between third and fourth floor reduces, which is attributed to the joint failure at the third floor level.

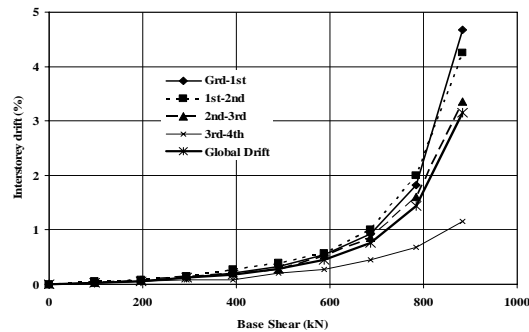
Fig.14 Inter-storey drift as a function of base shear

Fig.14 shows the inter-storey drift between ground to 1st floor, 1st to 2nd floor and so on as a function of base shear on CL 16 side. Also, in the same plot, the global drift obtained as the lateral roof deflection divided by the total height of the structure expressed as percentage is given. As seen by the graph, maximum inter-storey drift were obtained between the ground to first floor and first to second floor and were of the order of 4.5%. The same between second to third floor was around 3.5%, which was also the order of global drift. The inter-storey drift between the third and roof level were around 1-1.5%, which shows that most of damage was concentrated within lower floors.
