Full-Scale Aircraft Impact Test for Evaluation of Impact Forces

Part 1: Test Plan, Test Method, and Test Results

W. A. von Riesenmann, R. L. Parrish, D. C. Bickel,
S. R. Heffelfinger
Sandia National Laboratories, Albuquerque, NM USA
Kiyoshi Muto, Tadashi Sugano, Haruji Tsubota
Norihide Koshika, Masayasu Suzuki, Satoshi Ohrui
Muto Institute of Structural Mechanics, Inc., Tokyo, Japan

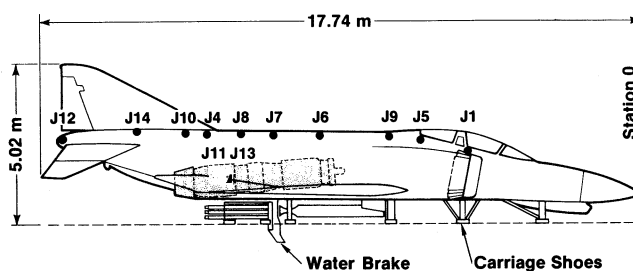
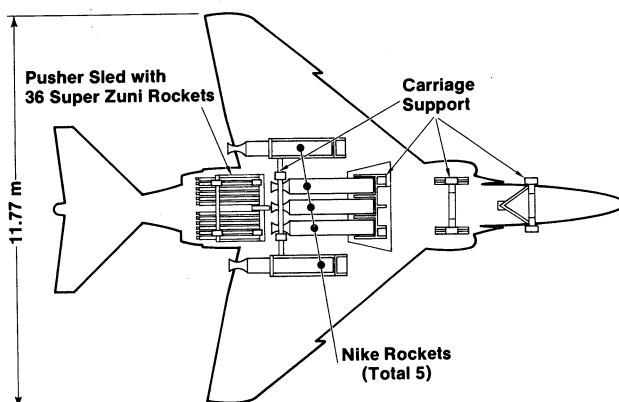
Fig. 1 F-4 Phantom Test Configuration

- Accelerometers for Fuselage (10 total)
- Accelerometers for Engine (1 on each engine)

A flyable F-4D aircraft was acquired by Sandia. The aircraft was modified slightly in order to support the aircraft at four locations with a special carriage structure (Figure 1). The carriage structure had shoes that were wrapped around the flanges of the rails to prevent lift-off and to guide the aircraft. As acquired, the aircraft weighed 12.7 tonnes (with some avionics removed). The impact weight was 19.0 tonnes, which included the weight of five rocket casings and 4.8 tonnes of water that was added to simulate the fuel weight and at the same time provide the proper mass distribution. The mass distribution of the F-4D, as configured for the impact test, is shown in Figure 2, while the mass distribution for an 'original' F-4D is shown in Figure 3.

Ten accelerometers were placed along the top of the fuselage of the aircraft (Figure 1) to acquire the decelerations as functions of time during the impact sequence. One accelerometer was also attached to the aft flange of each engine. A telemetry package that was mounted in the tail section of the aircraft was used to transmit the readings. Figure 10 shows the readings from station J10 on the fuselage and Figure 11 from station J13 on the left engine. Time integration of these decelerations provided the reduction in velocity versus time from initial impact until the sensors were destroyed. Red vertical stripes were painted on the fuselage at the same axial locations as the accelerometers. The differential crushing of the fuselage could then be examined from both the accelerometer measurements and the high-speed photography data.

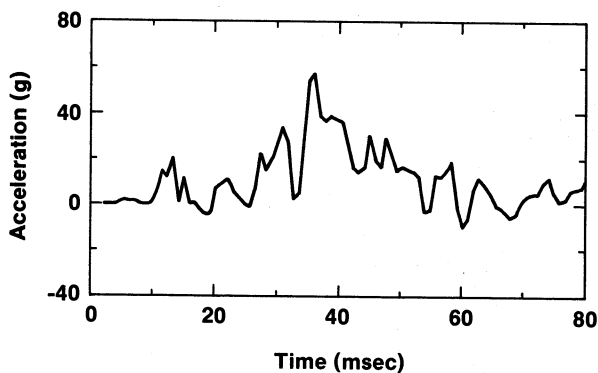
Fig. 7
Average of the Five Target
Acceleration Measurements

Some typical acceleration, velocity, and displacement measurements are shown in Figures 7-9. Also shown are the results of integration of the measured accelerations and velocities, which are in excellent agreement with the measured velocities and displacements, respectively (Figures 8, 9). The major acceleration began about 20 msec after impact and ended about 60 msec after impact. The velocity also began to increase rapidly after 20 msec, indicating that the major force was applied at about that time. The average velocity was nearly constant after 65 msec. This indicates that the impact force was

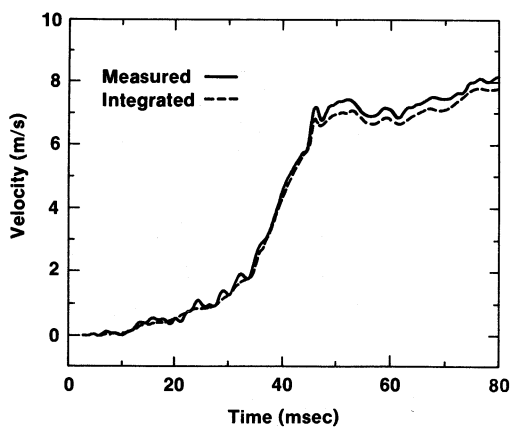
Fig. 8
Measured Velocity and Time Integrated
Acceleration at West Side of Target

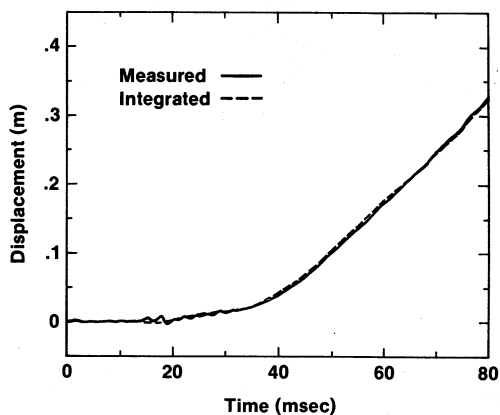
Fig. 9
Measured Displacement and Time Inte-
grated Velocity at West Side of Target

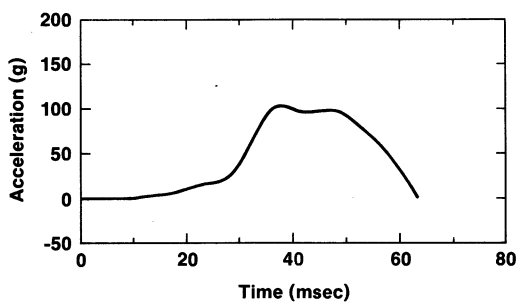
Fig. 10
Measured Acceleration at
Station J-10 on the Fuselage

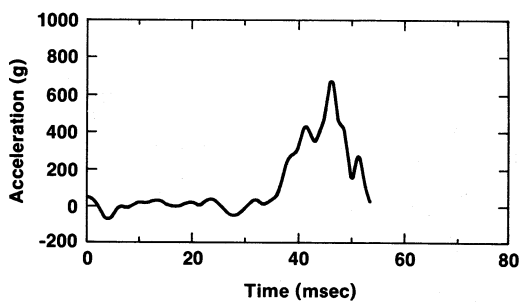
Fig. 11
Measured Acceleration at
Station J-13 on the Left Engine
