MINERAL, VIRGINIA USA M_w 5.8 EARTHQUAKE OF 2011: RESPONSE AND LONG TERM INITIATIVES AT NORTH ANNA NUCLEAR PLANT

Divakar Bhargava¹, David Heacock², and Eric Hendrixson³

¹Principal Engineer, Dominion Nuclear, USA

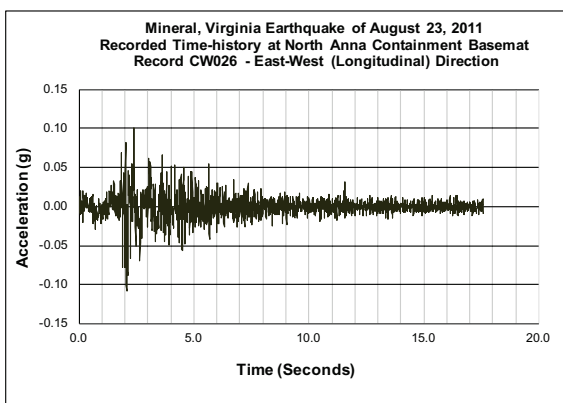
Figure 1 - Mineral, VA Earthquake Time-History – Cont. Basemat, East-West Direction

The instruments that recorded the earthquake motions at the North Anna plant were located at various elevations in two structures, the Reactor Containment building and the Auxiliary Building. Two types of instruments were used: the Engdahl scratch plates that recorded 12 discrete spectral accelerations between 2 and 25 Hz, and the Kinometrics Model FBA-3 analog recorders that recorded the acceleration time-histories. Based on analyses and discussions with experts, Dominion Nuclear determined that the Kinometrics recorder data at the containment basemat of Unit 1 provided the most reliable indication of the earthquake characteristics. Amplified response spectra (ARS) were developed from the recorded and baseline corrected time-histories at this location. The corrected time-histories, labeled as CW026, were digitized at 0.005 second intervals and had durations of about 18 seconds. They are shown in Figures 1, 2 and 3 for the East-West, North-South and the vertical orientations respectively.

Figures 1, 2 and 3 visually indicate that the strong motion duration of the earthquake was small. This was confirmed by developing the cumulative energy plots for each of the three time-history records labelled as CW026. The effective strong motion durations of these records, defined as the duration between the times associated with 5% and 75% of the total cumulative energy, were calculated to be 3.1 seconds in the East-West direction, 1.5 seconds in the vertical direction and 1.0 second in the North-South direction.

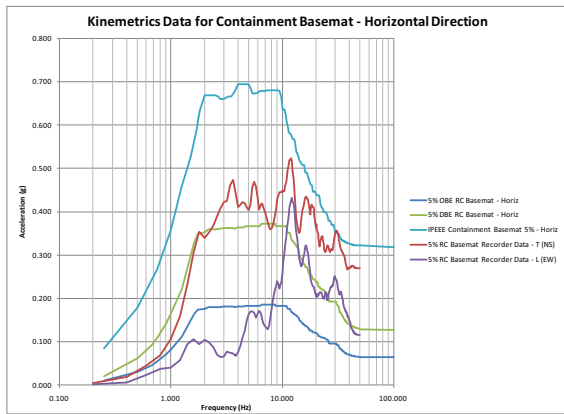
Figure 5 - Comparison of Horizontal Spectra

The time-history data captured by the Kinometrics recorder at the containment basemat was analyzed to calculate the 5% damped response spectra in all three orientations. These spectra were compared with the design OBE, DBE and IPEEE response spectra (Figures 5 and 6). The Kinometrics data shows that the OBE and DBE response spectra at the containment basemat were exceeded in all three directions; however, in the frequency range most damaging to equipment, 2 to 10 Hz, the DBE was not exceeded in the E-W direction, it was exceeded on average by about 12% in the N-S direction, and by about 21% in the vertical direction. While these exceedances are at the basemat of the containment, a comparison of the response spectra from the recorded time-histories of this earthquake to the calculated DBE in-structure response spectra (ISRS) at the operating deck of the containment structure showed that the exceedances were smaller and only in narrow frequency bands in the 2 to 10 HZ range. This implied that the design ISRS were likely calculated in a conservative manner. This is significant because other than a few tanks and yard equipment, safety-related SSCs are located within structures and are designed and qualified to the calculated DBE and OBE ISRS. It can be seen that both the horizontal and vertical spectra from the Mineral event were completely enveloped by the corresponding IPEEE spectrum.
