FINAL REPORT

RESEARCH PROJECT 2001-16

A Sign Inventory Study to Assess and Control Liability and Cost

Department of Civil Engineering
North Carolina State University
Raleigh, NC

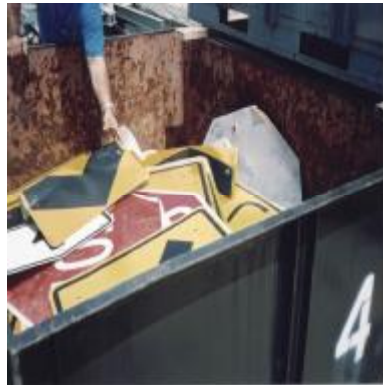
Figure 3.2: Damaged and Replaced Signs in Bins

The signs taken down are collected in bins (Figure 3.2). The reflective sheeting is removed from aluminum substrate that is not damaged and these pieces are returned to the sign plant for new signs to be created (Figure 3.3). Aluminum pieces not able to be reused are recycled.

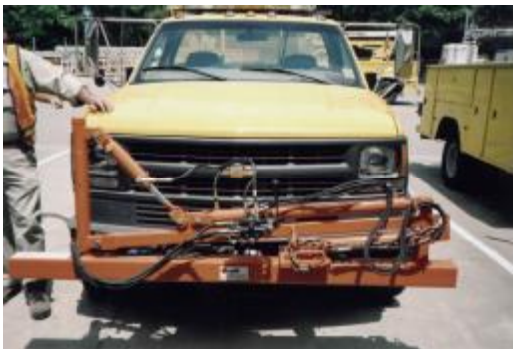
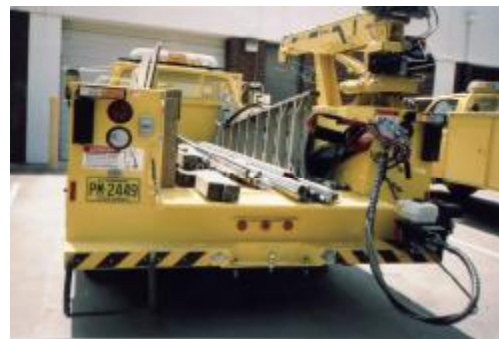
Figures 3.4 and 3.5: Front and Rear Views of a Typical Signing Truck

Each division is equipped with signing trucks. Each truck cost approximately \$40,000. This cost includes the truck itself, a front-end post pull, an auger, a crane, and other miscellaneous hand tools. The trucks are used to transport and install signs (larger signs require alternate transportation methods). Figures 3.4 and 3.5 show a typical sign truck.

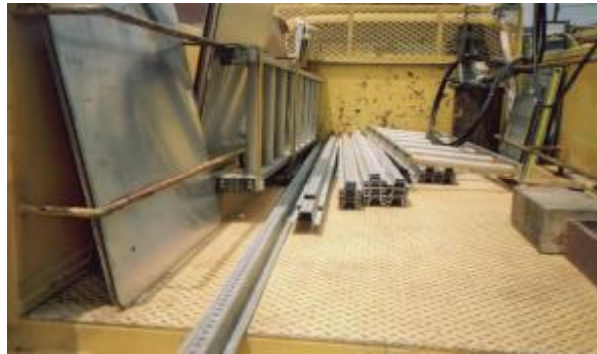
Figure 3.6: Sign Storage Racks on a Signing Truck

Signs are sometimes damaged on trucks before they are even installed. It is difficult for workers to maneuver signs in and out of the storage racks on the trucks and they often get scratched. Figure 3.6 shows a close up view of the racks on the back of a signs truck.

Scratches cause signs to deteriorate more quickly. A protective paper is placed on signs during manufacturing and stays on signs while in inventory. But the paper must be removed before being placed in a truck because moisture caused by humidity and rain causes the paper to stick to signs creating a watermark on the sheeting, which ruins it. Protective spacers are available to keep signs in place on the truck and reduce scratching. However, the spacers are cumbersome and trucks not able to return to the warehouse everyday need to carry numerous signs so there is no room available for them.

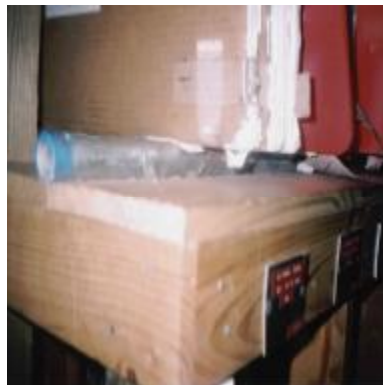
Figure 3.7: A Pipe Keeps Signs Elevated

Each division keeps frequently used signs in stock. Proper storage conditions can ensure that signs last for their warranty life and far beyond. In Division 6, a representative from the 3M Company assisted with design of their sign storage area. The shelf system designed involves keeping the signs elevated using metal pipes as shown in Figure 3.7. Signs also remain wrapped in the packaging in which they were received from the Department of Correction Sign Shop. This protects the signs from scraping against each other while in storage as shown in Figure 3.8.

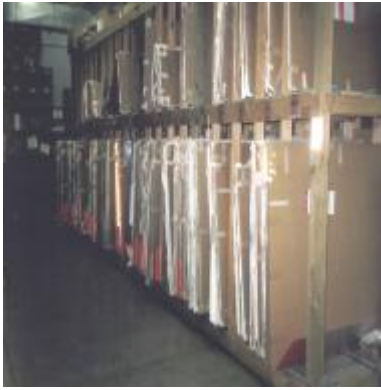
Figure 3.8: Stored Signs Kept Wrapped

Signs may be unbundled (not unwrapped) during yearly inventory checks or to verify that a sign is in the correct place but they remain wrapped to help protect the sheeting.

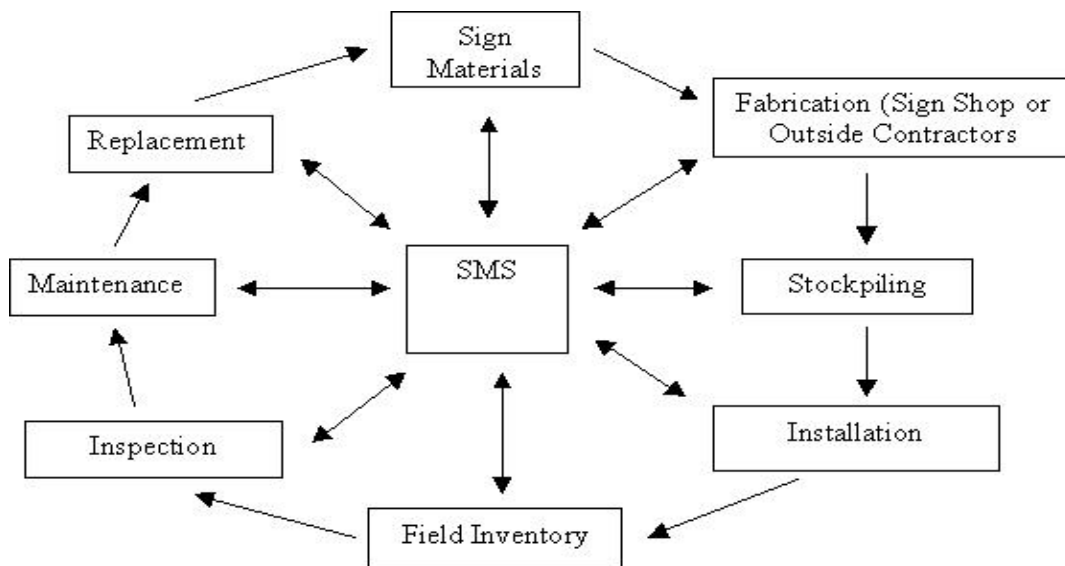
Figure K-1: A Comprehensive Sign Management System (SMS) [McGee and Paniati 1998]

From Figure K-1, it is clear that a sign inventory and management system (SIMS) is an essential component of an SMS. An SIMS encompasses only the inventory management aspect of SMS. It keeps information about the signs, which may be either in-warehouse or on-road. While it is beneficial to know the information about the signs in-warehouse, the essential functionality of SIMS is to keep information about signs on-road. In the context of this research, an SIMS serves the five main purposes listed below: [McGee and Paniati 1998]
